12.0 BUILDING 5636: MAYO AIR TANKER BASE DAY USE BUILDING

TITLE WATER SYSTEM DISTRIBUTION/TREATMENT SCHEMATIC SYSTEM ID.: 5636 DAY USE BUILDING - MAYO, YT.			
DATE SEPT. 2005	DWN. JSB	CHKD. RMM	FILE NO. 1260002.004	DWG.: FIGURE 5636-B

SMALL PUBLIC WATER SYSTEM ASSESSMENT

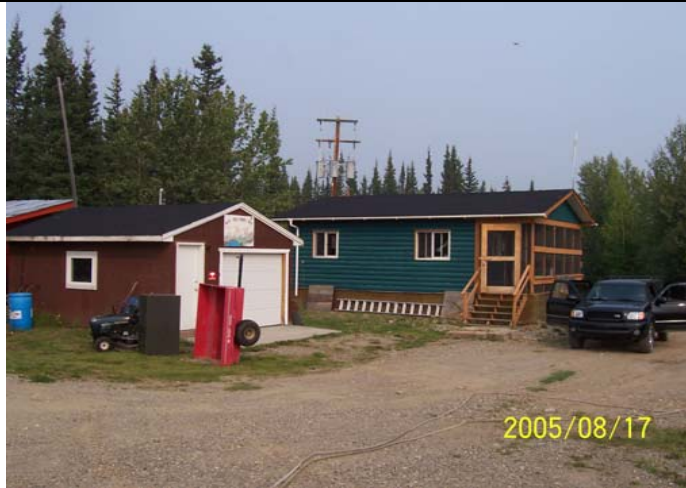
Photo 033: 5636 Day use area and garage.

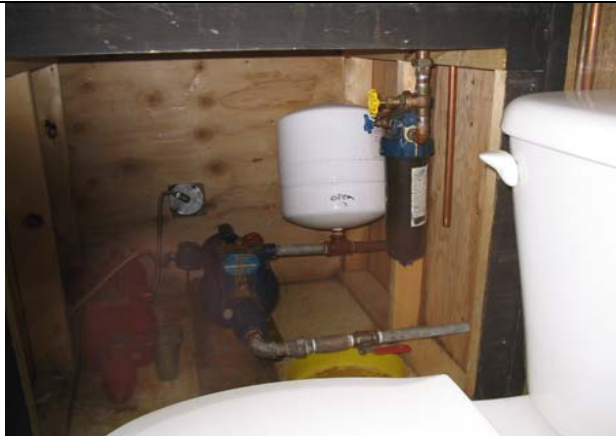
Photo 190: 5636 Jet pump and pressure tank.

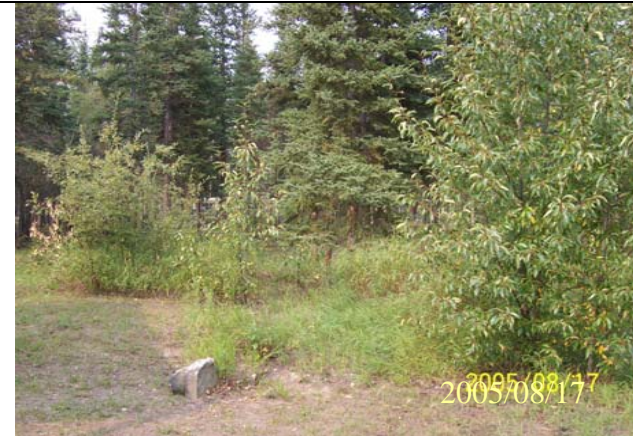
Photo 036: 5636 Potential well location to service day use area and crew quarters.

Consideration could be given to drilling a cluster type water well to serve both the ATB day use building and the adjacent crew quarters which currently has a similar “camp” style seasonal use system.
