22.0 BUILDING 5622: KENO CITY FIRE HALL

SMALL PUBLIC WATER SYSTEMS ASSESSMENT
WESTERN REGION

SMALL PUBLIC WATER SYSTEM ASSESSMENT

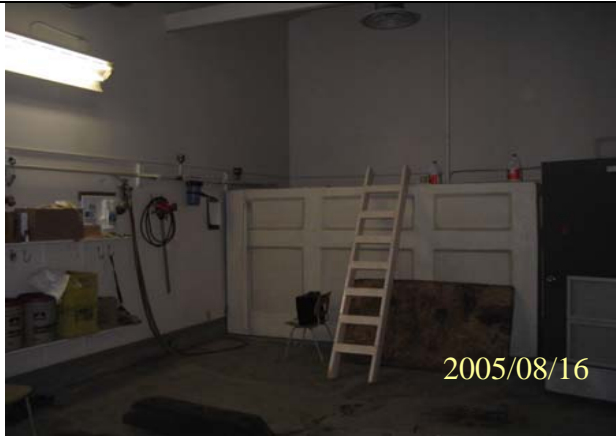
THE SYSTEM IS IN REASONABLY GOOD CONDITION.
THE TANK IS RELATIVELY CLEAN WITH SOME
IRON OXIDE AT THE BOTTOM. THE CHLORINATOR
SYSTEM IS NOT IN SERVICE. THERE IS NO
CHLORINE INJECTION PUMP ON SITE.
THE PRESSURE TANK IS WATER LOGGED; THIS
CAUSES THE JET PUMP TO SHORT CYCLE.
THE TANK LID IS LOOSE.

**Photo 179:** 5622 Main water storage tank.

CLEAN THE STORAGE TANK, DISINFECT IT.
INSTALL CHLORINE INJECTION PUMP WITH
FLOW METER TO EFFECT PROPORTIONAL
CHLORINATION.
INSTITUTE FREE CHLORINE RESIDUAL TESTING
AT REGULAR INTERVALS.
