17.0 BUILDING 2575: DAWSON CITY WILDLIFE OFFICE

SMALL PUBLIC WATER SYSTEMS ASSESSMENT
NORTHERN REGION

DAWSON WILDLIFE OFFICE
BUILDING # 2575
SITE LOCATION DIAGRAM
WELL ID: 2575

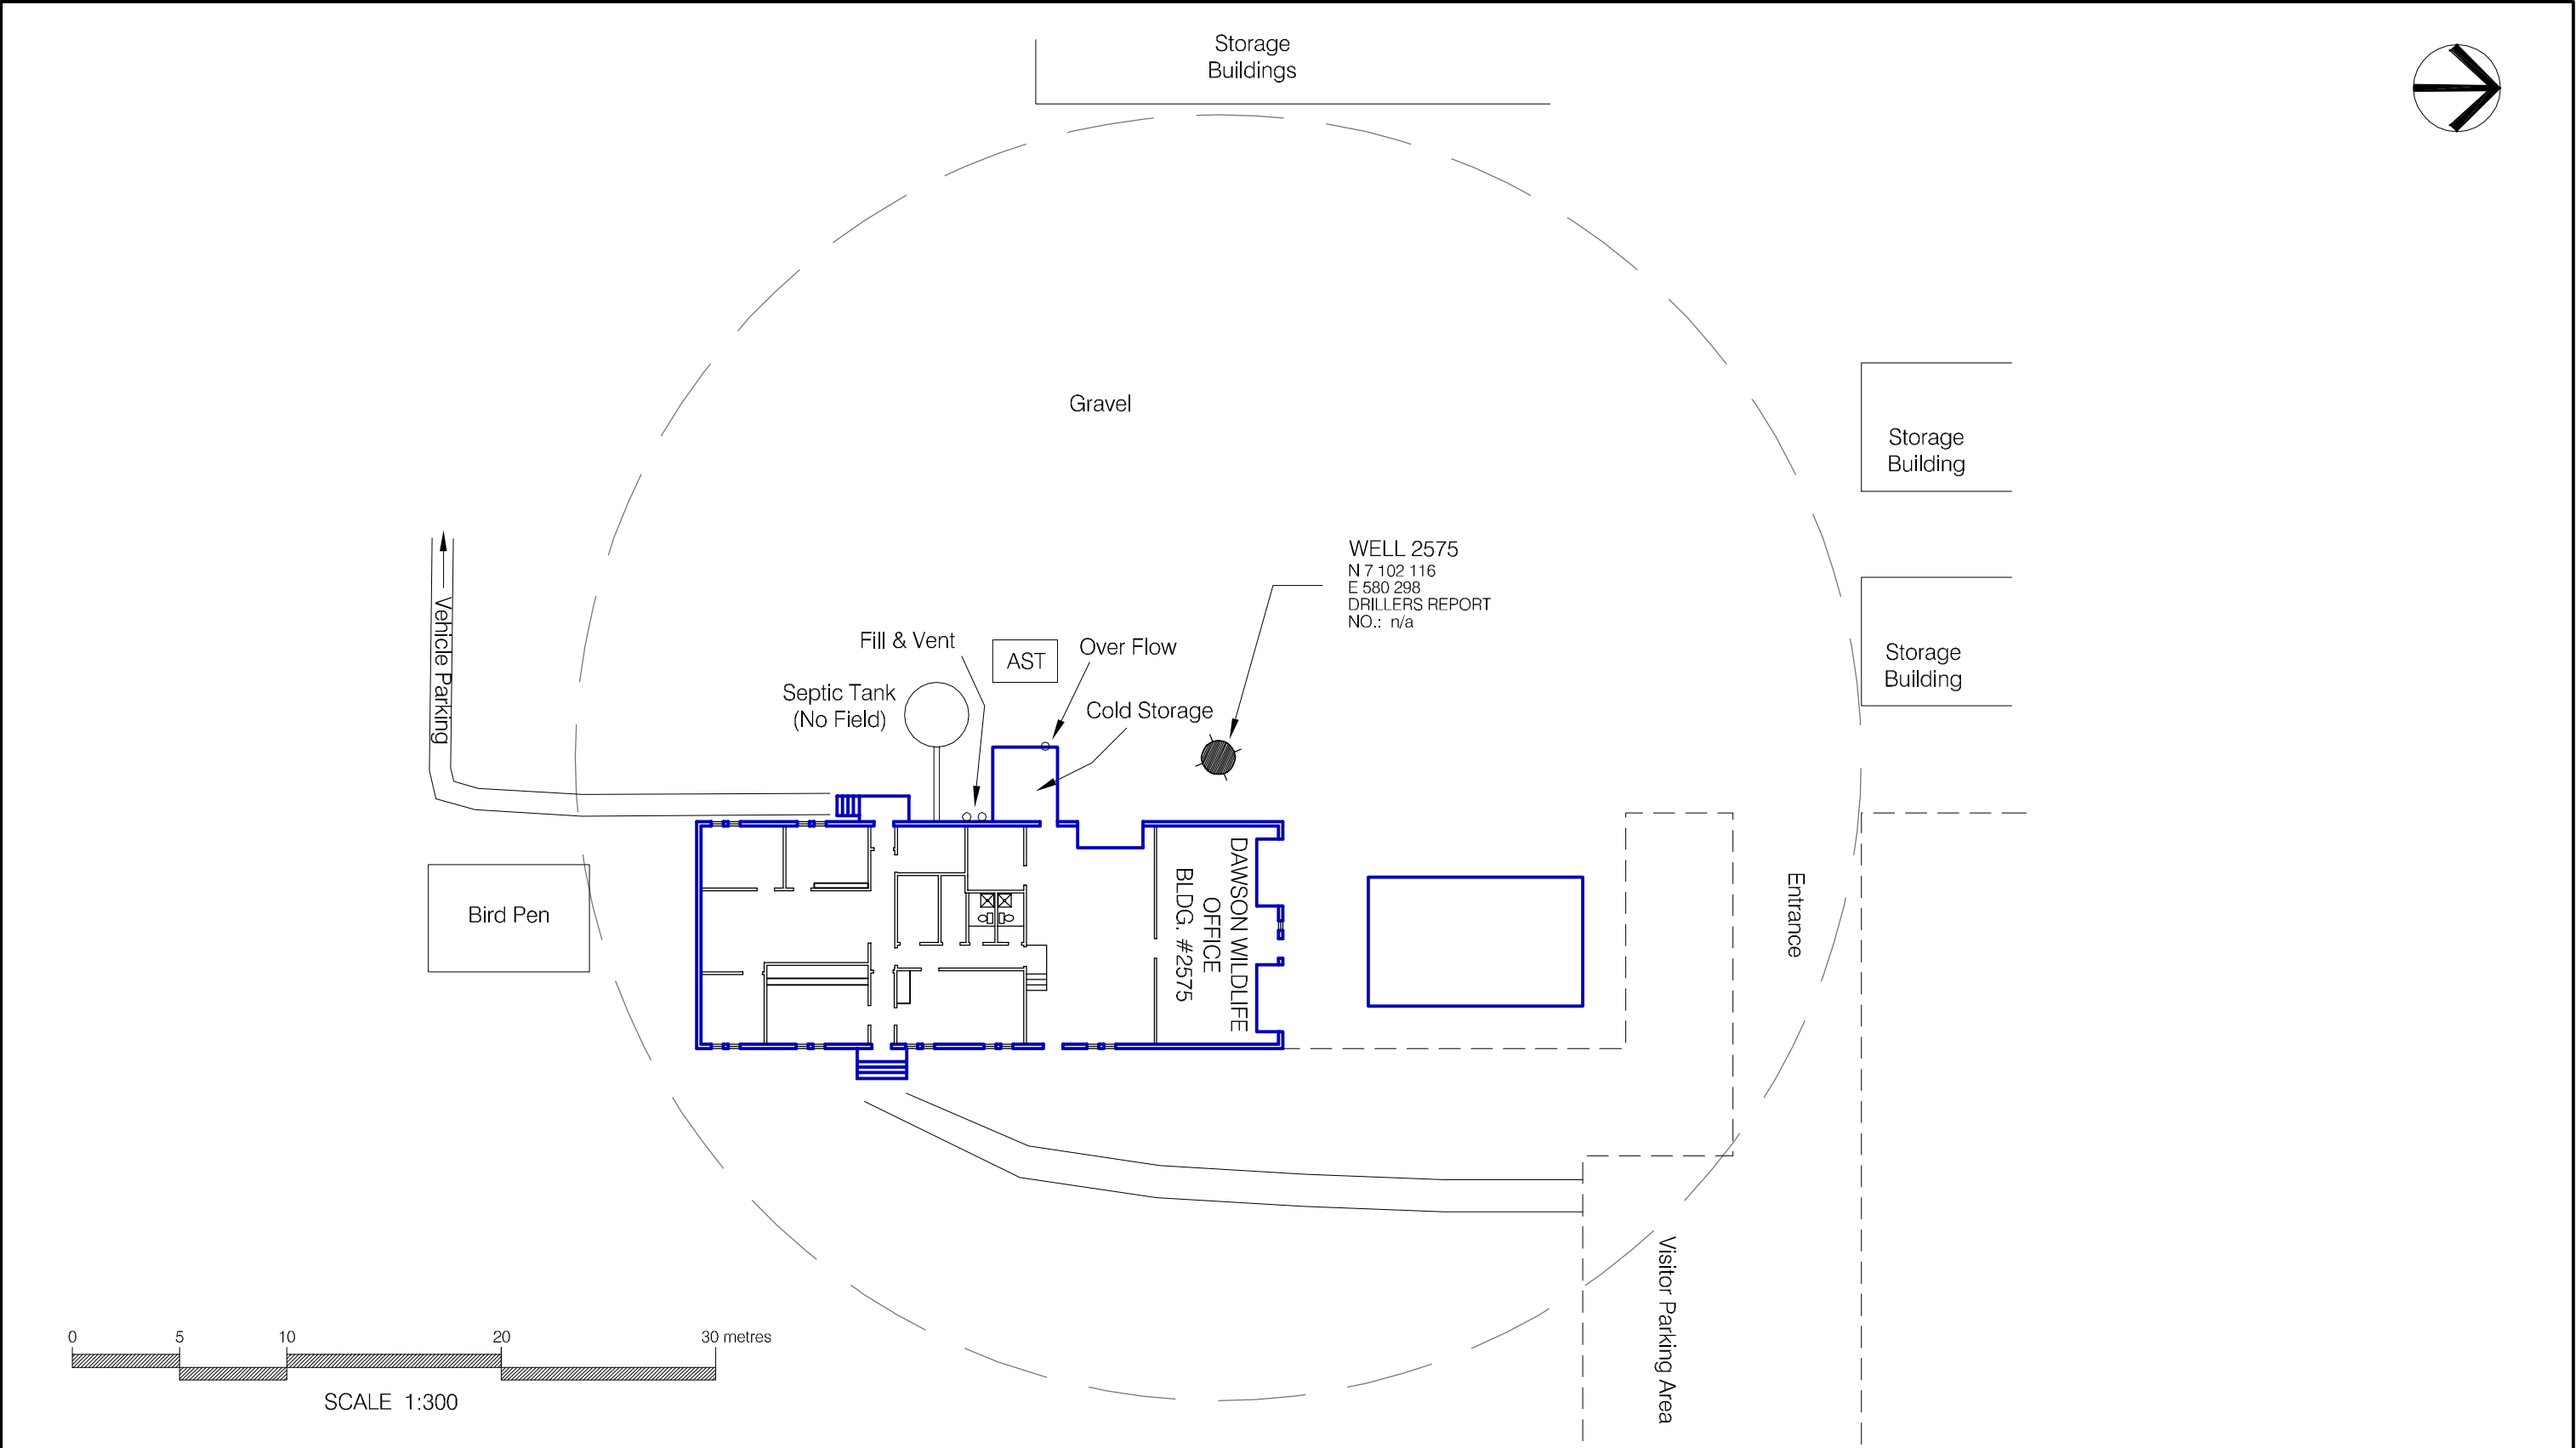
REVISION	ISSUE
	0
FIGURE No.	
FIGURE 2575-A

30 m RADIUS FROM WATER WELL FOR CONSIDERATION OF PROXIMITY TO POTENTIAL CONTAMINANT SOURCES.

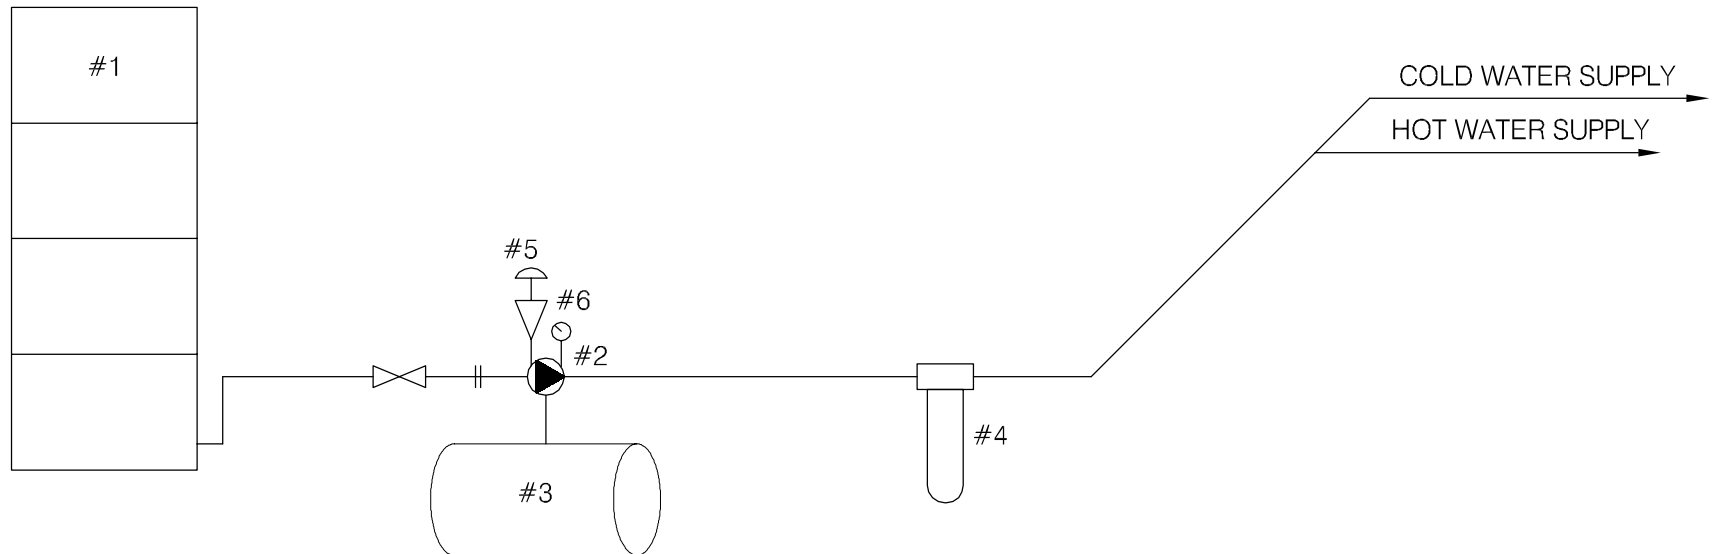
<div>Yukon Highways and Public Works Property Management Branch</div>			TITLE WATER SYSTEM DISTRIBUTION/TREATMENT SCHEMATIC SYSTEM ID.: 2575 WILDLIFE OFFICE - DAWSON, YT.		
DATE SEPT. 2005	DWN. JSB	CHKD. RMM	FILE NO. 1260002.004	DWG.: FIGURE 2575-B

DRAWING IS BASED UPON SCHEMATIC PROVIDED BY BERT ALBISSER OF AQUA TECH SUPPLIES AND SERVICES LTD.

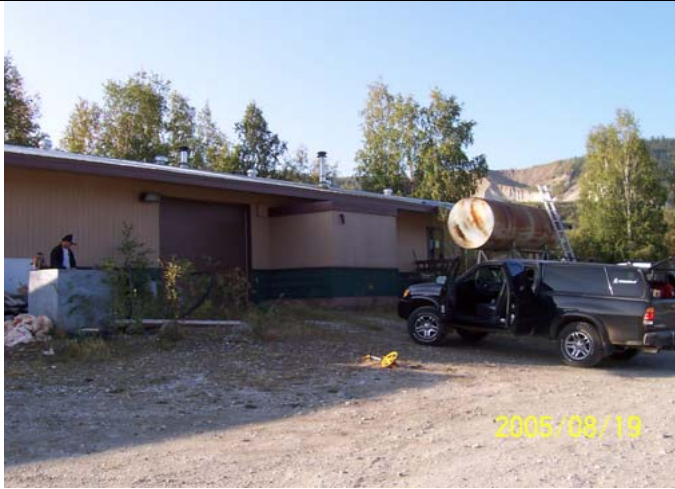
Photo 077: 2575 Environmental office facing south.

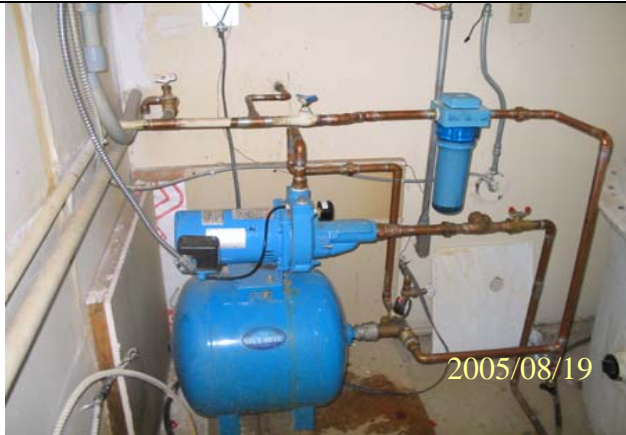
Photo 223: 2575 Jet pump, pump controls and inline filter.

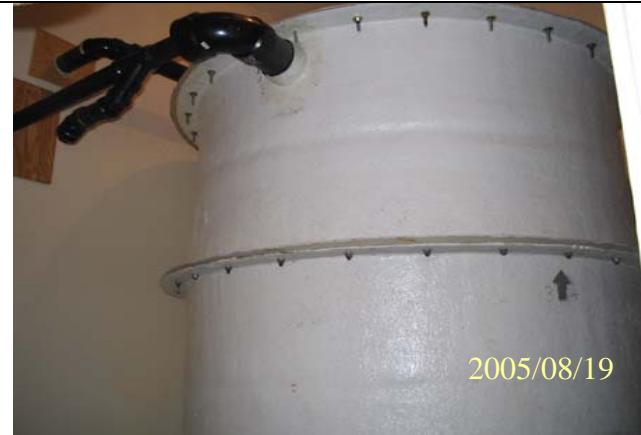
- There is no access port in the water storage tank to make it available for cleaning.
- There is no cap on the fill pipe and no vermin screen on the vent/overflow and insects and vermin could potentially enter the water system.

Photo 225: 2575 Water storage tank.

- Retrofit the water holding tank to make it accessible for routine inspection and cleaning. This may involve reducing the overall height of the tank, or, installing a side access port to facilitate access to the tank;
- Install a cap on the fill pipe and a vermin proof screen on overflow/vent;
- Monitor Free Available Chlorine Concentrations to ensure that they are at least 0.2 mg/L at the point of use; and,
- Institute a routine tank-cleaning program.
