19.0 BUILDING 2599: DAWSON CITY GRADER STATION

SMALL PUBLIC WATER SYSTEMS ASSESSMENT NORTHERN REGION	
GOVERNMENT OF YUKON HIGHWAYS & PUBLIC WORKS	
DAWSON GRADER STATION BUILDING # 2599 SITE LOCATION DIAGRAM WELL ID: 2599	REVISION ISSUE 0 FIGURE No. FIGURE 2599-A

SMALL PUBLIC WATER SYSTEM ASSESSMENT

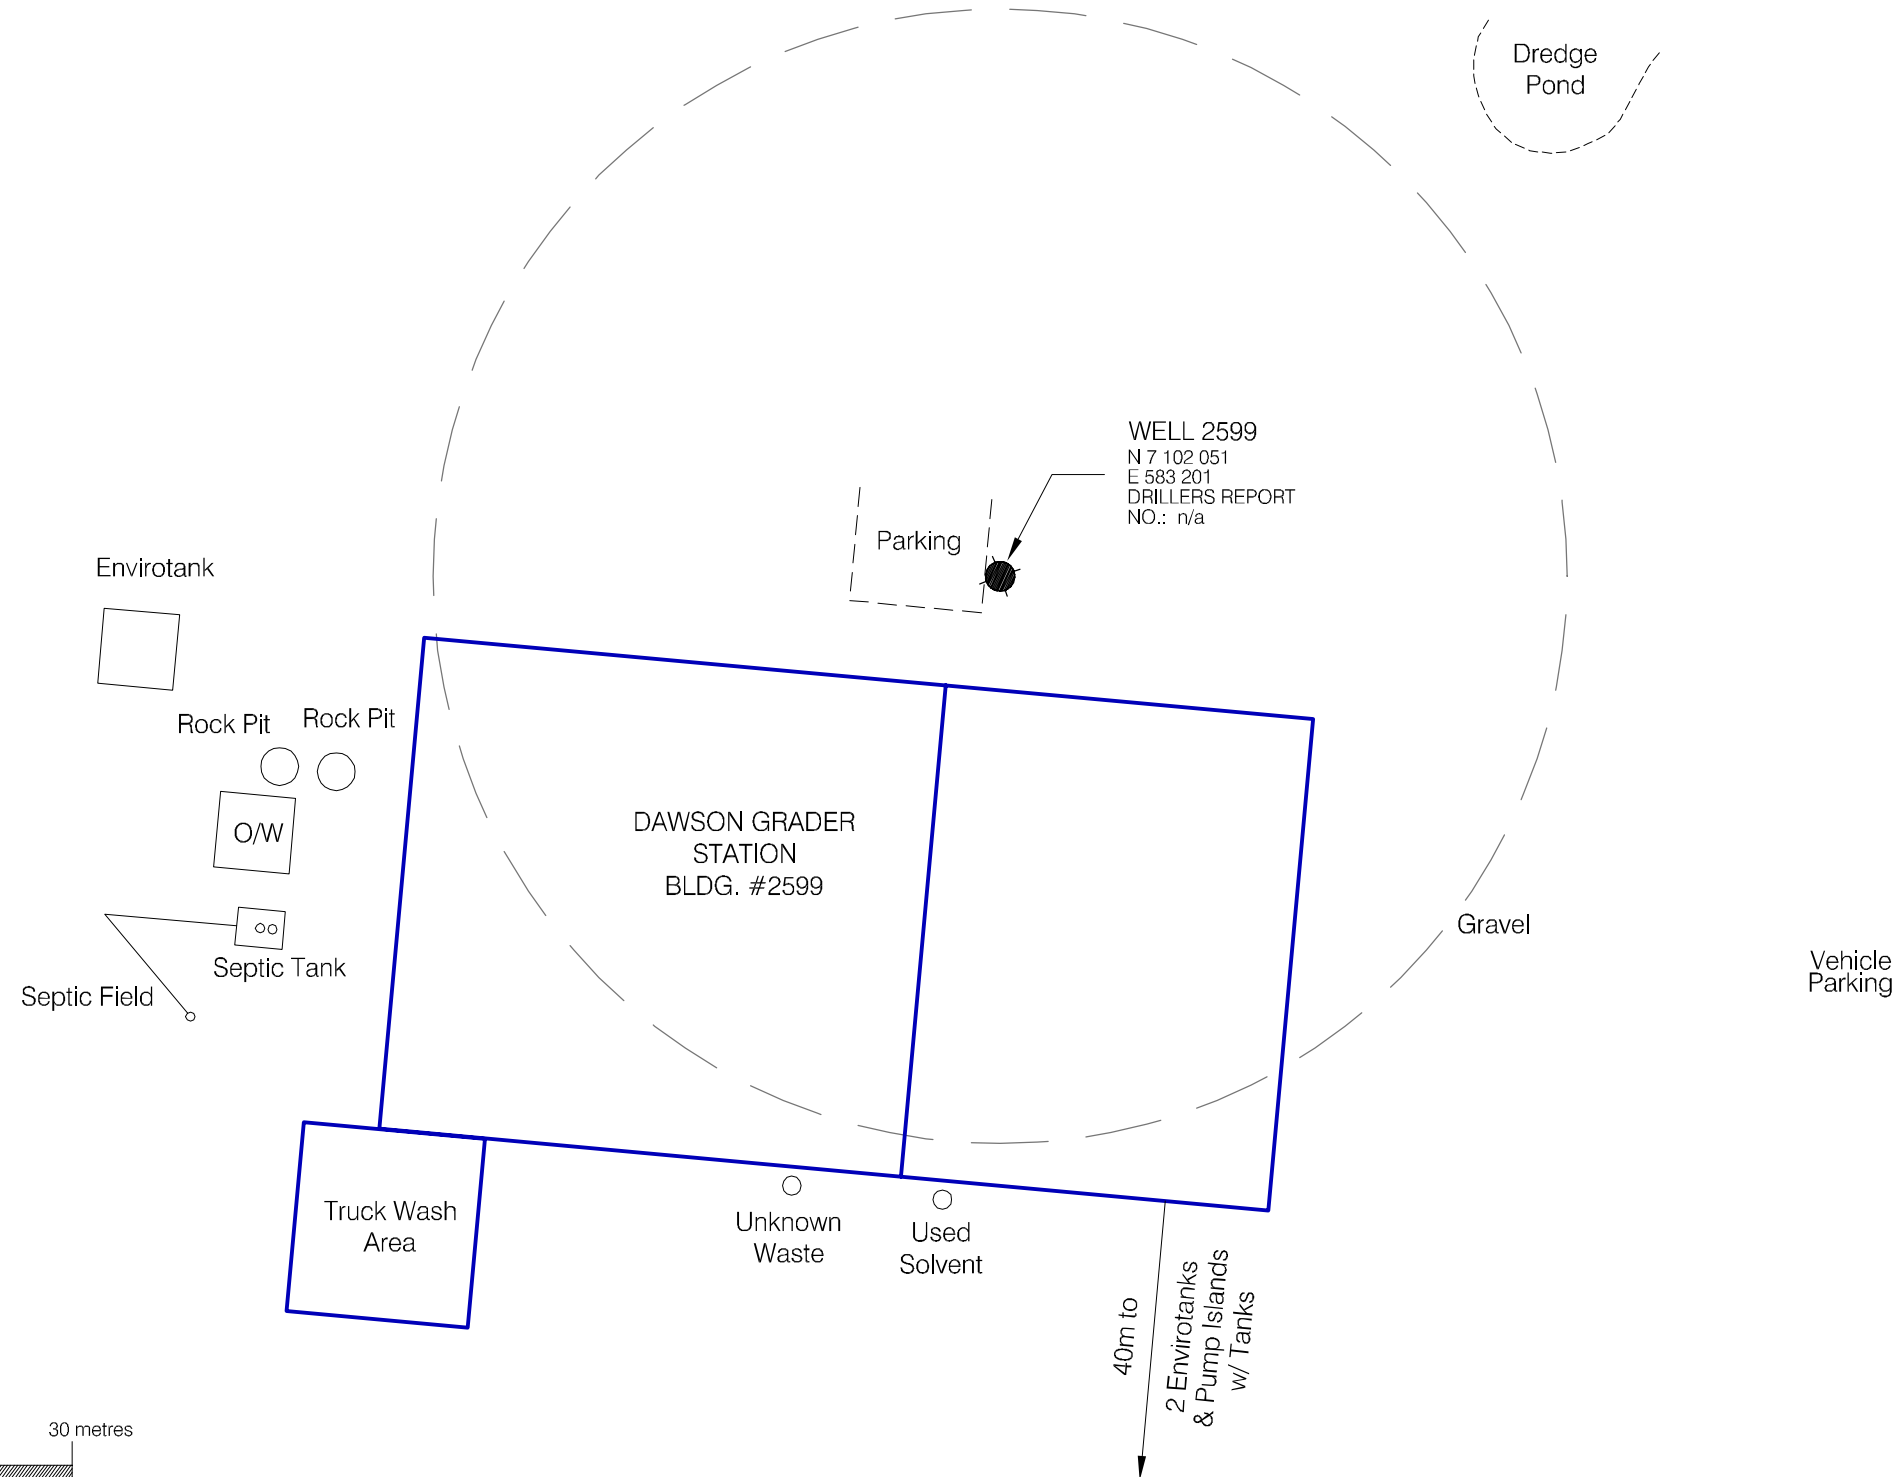
30 m RADIUS FROM WATER WELL FOR CONSIDERATION OF PROXIMITY TO POTENTIAL CONTAMINANT SOURCES.

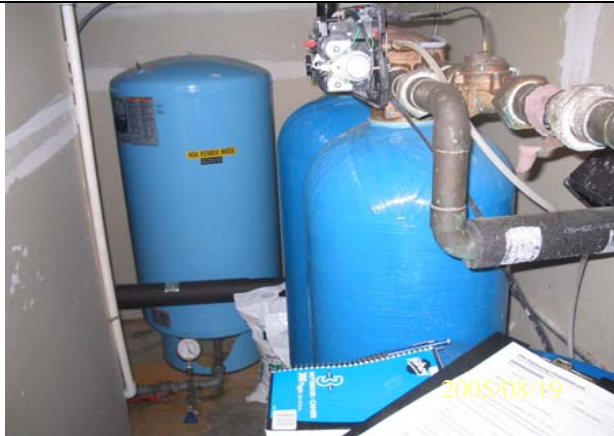
**Photo 230:** 2599 Pressure tank, pump controls and softener system.

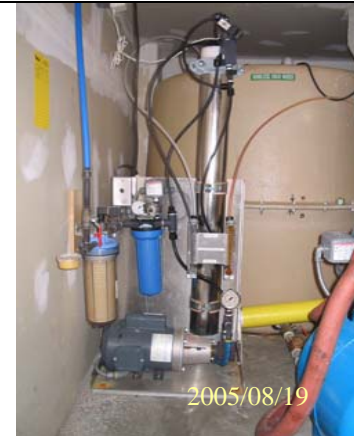
- The pH of the reverse osmosis treated water was below the CDWQG AO at the time of analysis.

**Photo 234:** 2599 Reverse osmosis system (front) water storage tank (back)

- Install an NSF/ANSI certified UV treatment system (or equivalent) post softener and in advance of RO system to ensure disinfection of potable water. These are conceptual design recommendations based on the information available for planning and budgeting purposes. Engineering input will be required for final system specifications; and,
- Superchlorinate well and water system.
