20.0 BUILDING 2600: KLONDIKE GRADER STATION

SMALL PUBLIC WATER SYSTEMS ASSESSMENT NORTHERN REGION	
GOVERNMENT OF YUKON HIGHWAYS & PUBLIC WORKS	
KLONDIKE GRADER STATION BUILDING # 2600 SITE LOCATION DIAGRAM WELL ID: 2600	REVISION ISSUE 0 FIGURE No. FIGURE 2600-A

SMALL PUBLIC WATER SYSTEM ASSESSMENT**PART A: EBA Site Inspection**Inspector: Ryan Martin, Luke LebelDate August 18, 2005

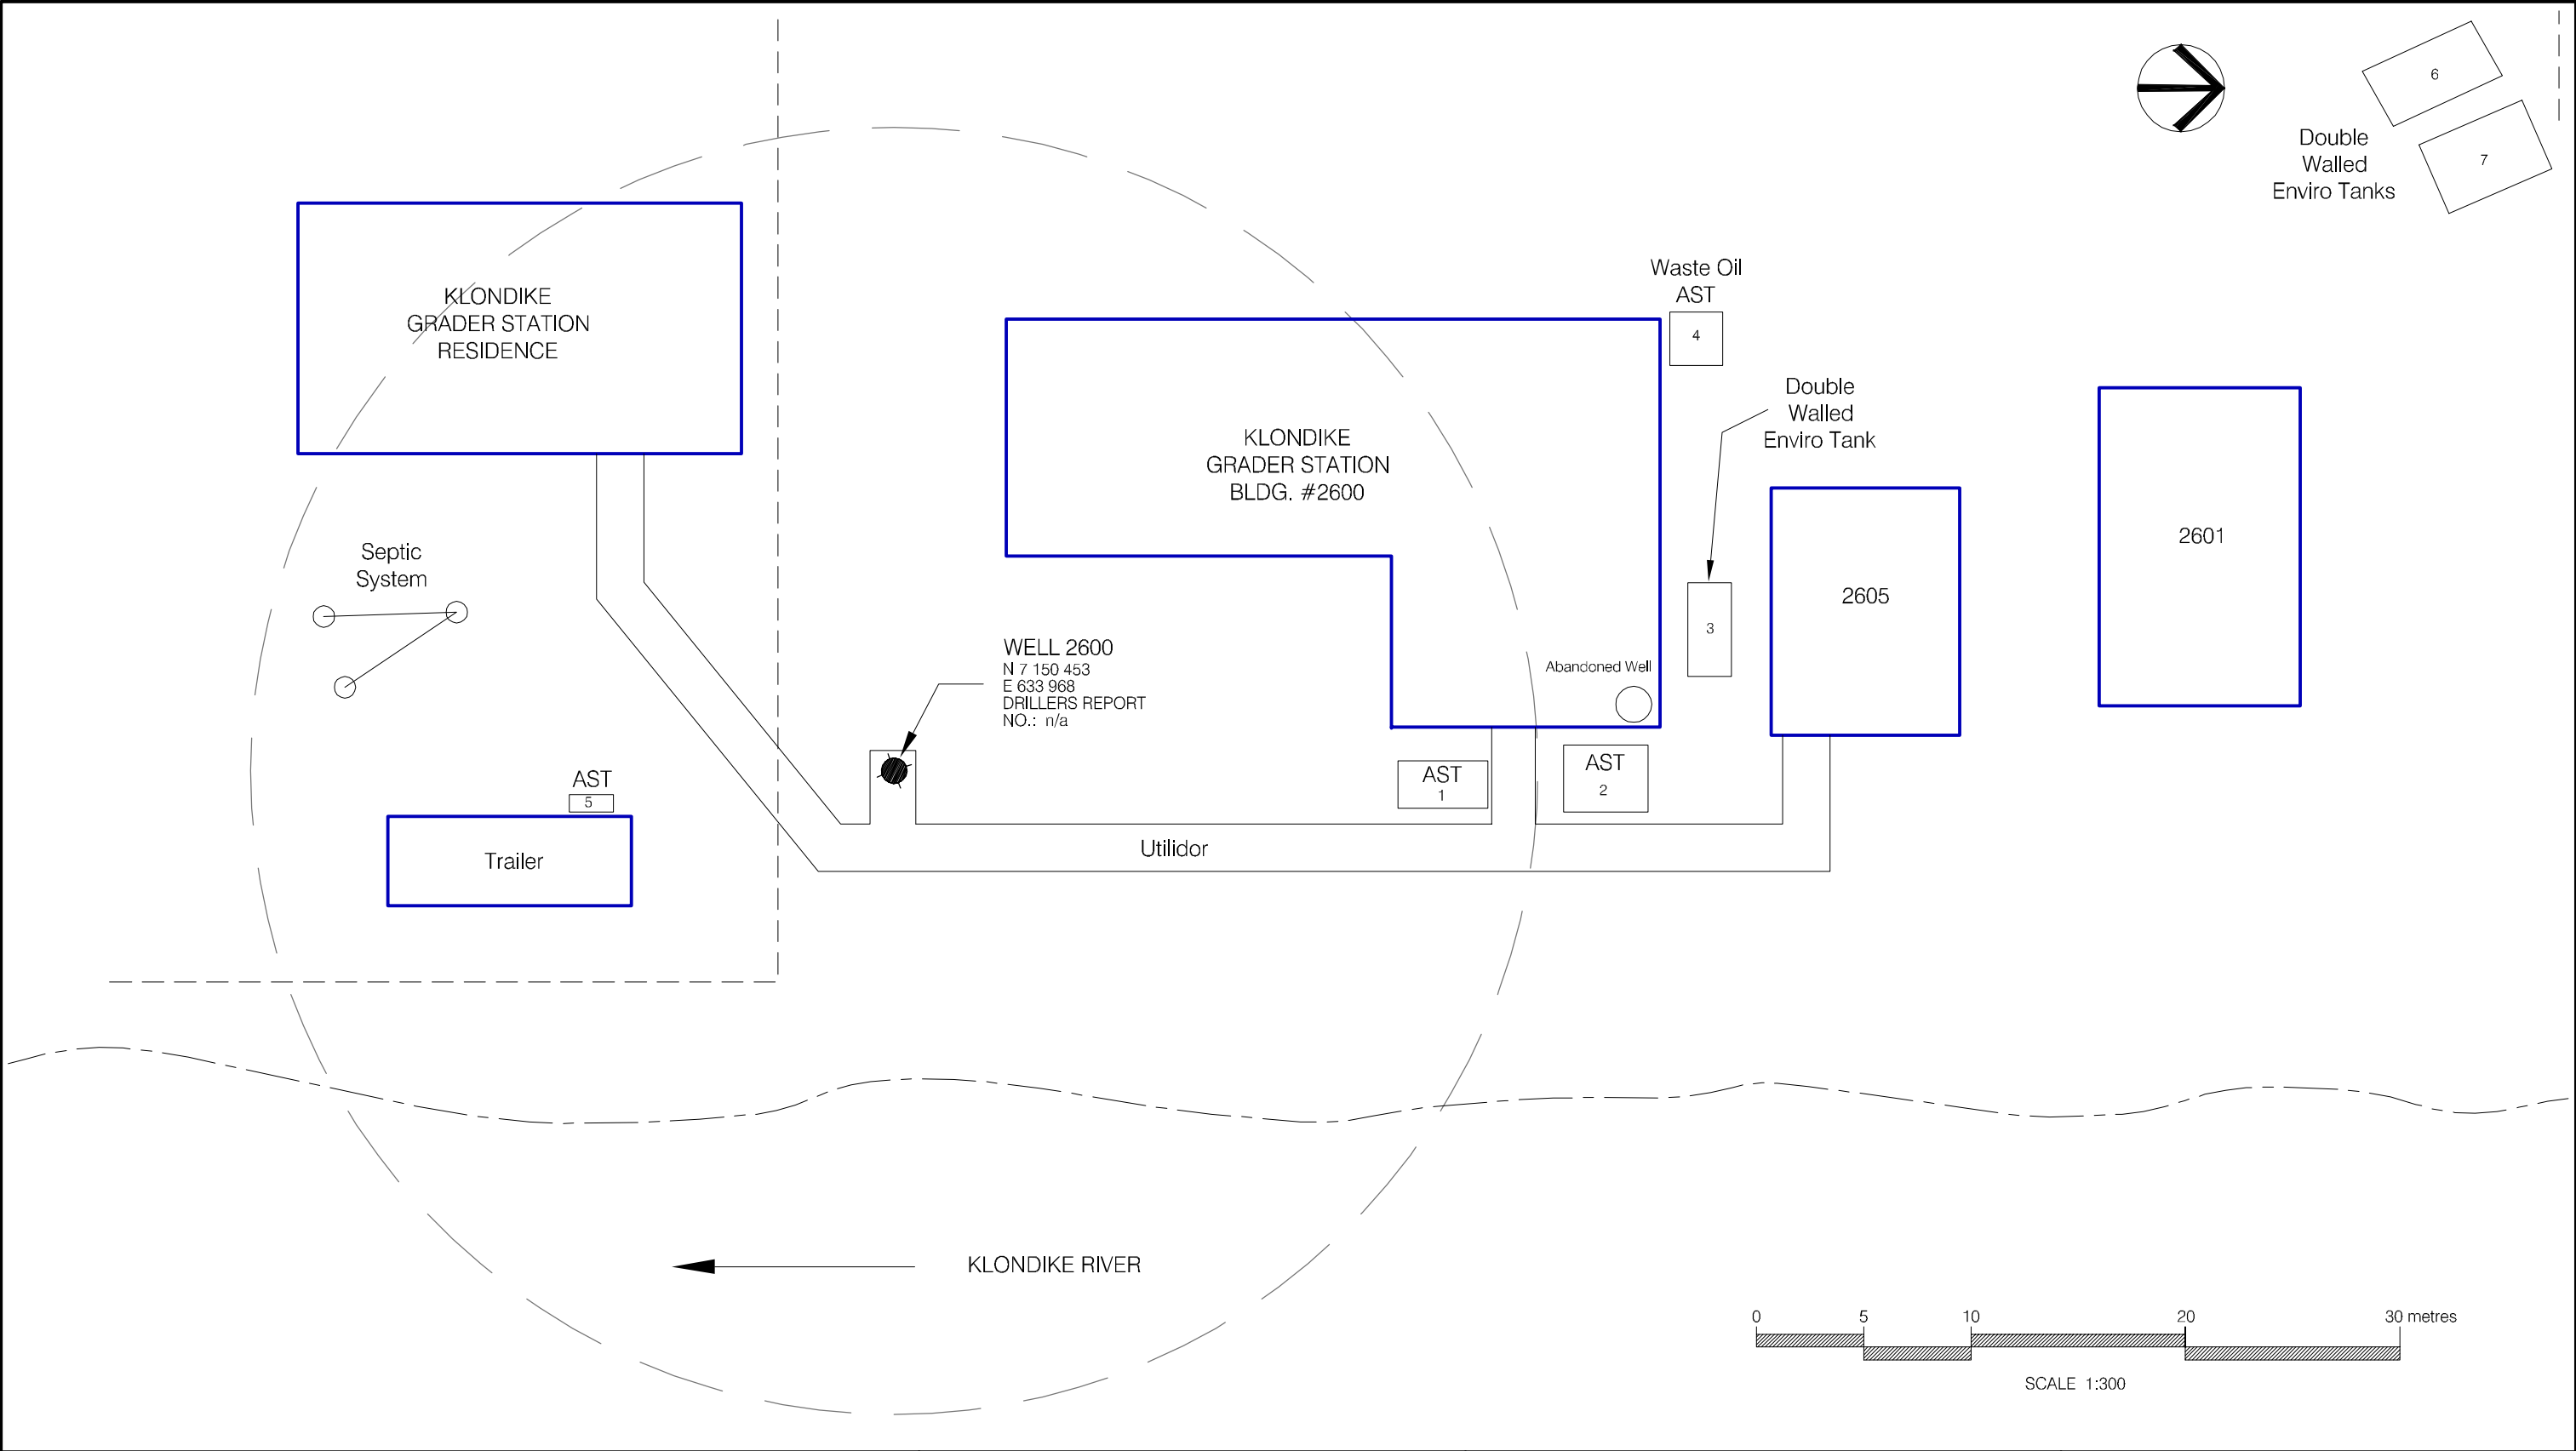
- The well is located within 30 m of potential contaminant sources including a on-site sewage disposal system (possibly septic field or leach pits), and various ASTs;

30 m RADIUS FROM WATER WELL FOR CONSIDERATION OF PROXIMITY TO POTENTIAL CONTAMINANT SOURCES.

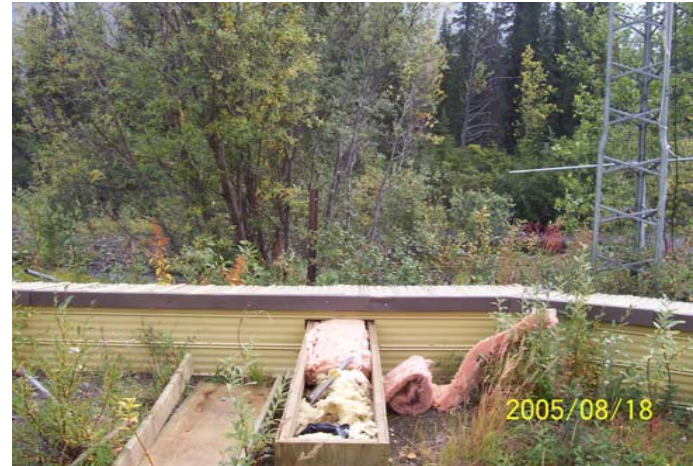
Photo 067: 2600 Wellhead with surrounding enclosure and utilidor.

- The utilidor should be cleaned out and replaced with blown in foam insulation, the well cap replaced (if not completed already) and a localized near surface bentonite seal installed immediately around the wellhead;
- Sampling for EPH, PAH and BTEX should be completed during the spring snow melt and routinely (every 3 months) thereafter;
- The well and water system should be super-chlorinated;
- Disinfection treatment consisting of filtration to 1 micron (absolute), and a UV system that is NSF/ANSI certified (or equivalent) should be installed to ensure disinfection. Pretreatment consisting of a water softener may be necessary for optimum UV performance. These are conceptual design recommendations based on the information available for planning and budgeting purposes. Engineering input will be required for final system specifications.

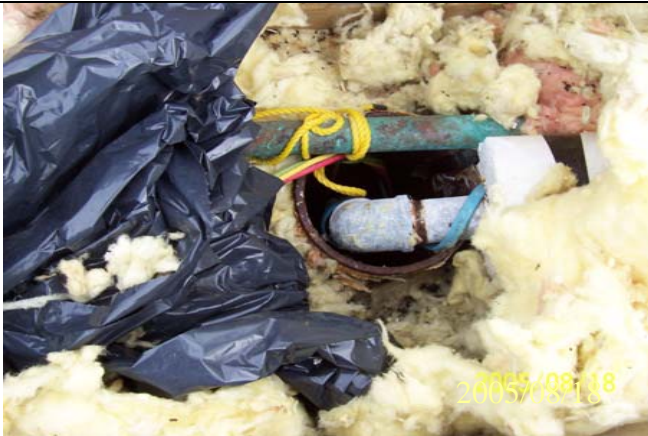
- Poor surface completion of the wellhead (was not equipped with a sanitary cap on the casing, there is evidence of rodents in the wellhead enclosure, the casing does not extend the required 500 mm above grade);

Entrance by animals? ☐ Yes ☒ No
Access possible. Mouse droppings observed. No cap on well

- i. Is the well head below grade? describe in detail ~0.15 m above grade
- ii. Are there signs of ponding on the enclosure(e.g. water stains, etc.)? ☐ Yes ☒ No
- iii. Is the wellhead enclosed by fiberglass insulations? ☒ Yes ☐ No
- iv. Any evidence of rodents? Specify Yes. Mouse droppings in insulation
- v. Does the well casing have a proper seal cap? ☐ Yes ☒ No
- If no, describe condition None present. Well is open

Photo 065: 2600 Wellhead – note that at the time of the assessment there was no well cap and evidence of mice around the wellhead.

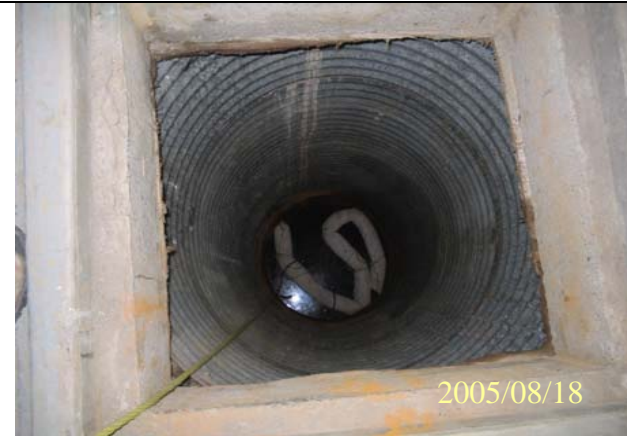
In addition, there is an abandoned dug well located inside the present maintenance garage that is approximately 35 m upgradient of the well. It appears to have a hydrocarbon absorption pad in it which implies that it is being impacted from the adjacent soil and groundwater contamination.. Various monitoring wells were also observed on the property.

Photo 196: 2600 Abandoned dug well.
