21.0 BUILDINGS 2661 AND 2665: OGILVIE GRADER STATION COMPOUND

21.1 Description of Existing Water Supply System

SMALL PUBLIC WATER SYSTEMS ASSESSMENT NORTHERN REGION	
GOVERNMENT OF YUKON HIGHWAYS & PUBLIC WORKS	
OGILVIE GRADER STATION & LIVING COMPLEX BUILDING # 2665 SITE LOCATION DIAGRAM WELL ID: 2665	REVISION ISSUE 0 FIGURE No. FIGURE 2665-A

SMALL PUBLIC WATER SYSTEM ASSESSMENT

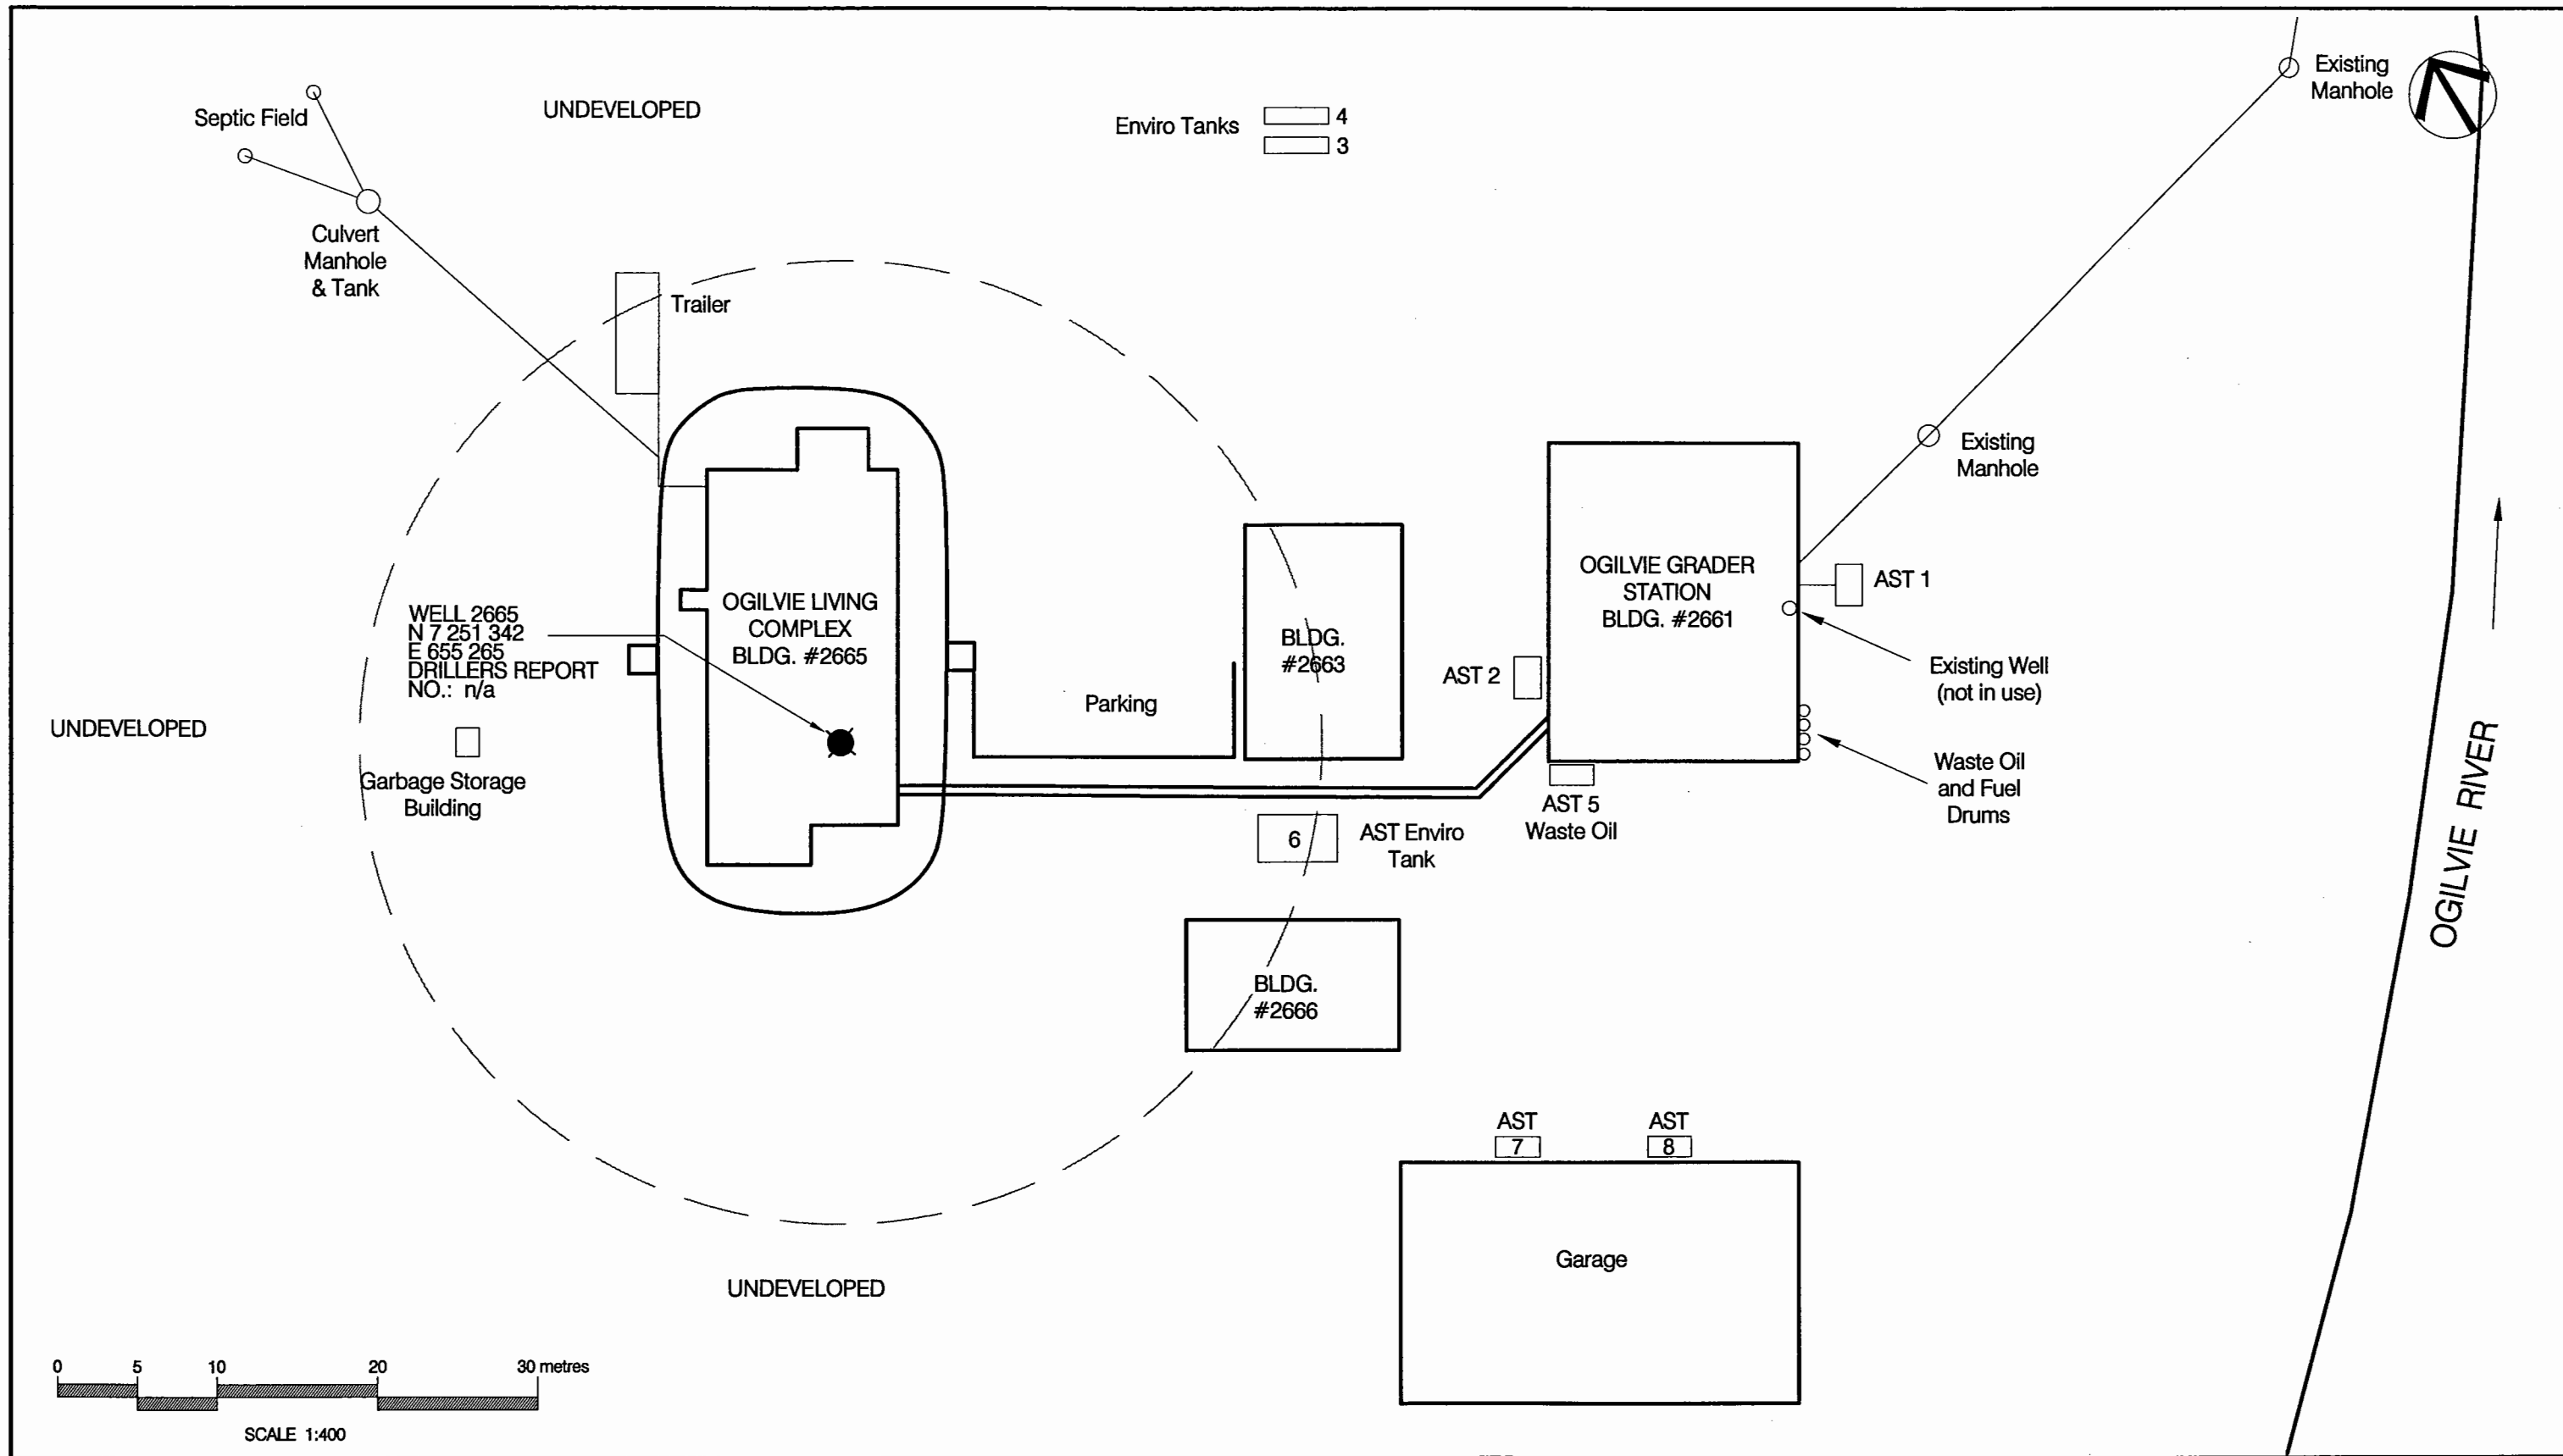
greater than 30 m north and likely crossgradient from the well. The septic system serving the maintenance garage is located on the east side of the building approximately 25 m, and likely downgradient from the abandoned well, and greater than 30 m downgradient from the well that currently serves this system. Septic systems locations are shown on Figure 2665-A in Appendix A21.

30 m RADIUS FROM WATER WELL FOR CONSIDERATION OF PROXIMITY TO POTENTIAL CONTAMINANT SOURCES.

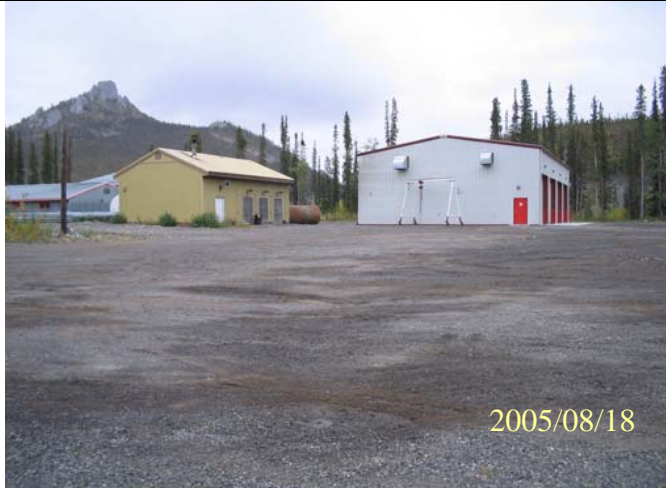
Photo 206: 2661 Olgilvie grader station.

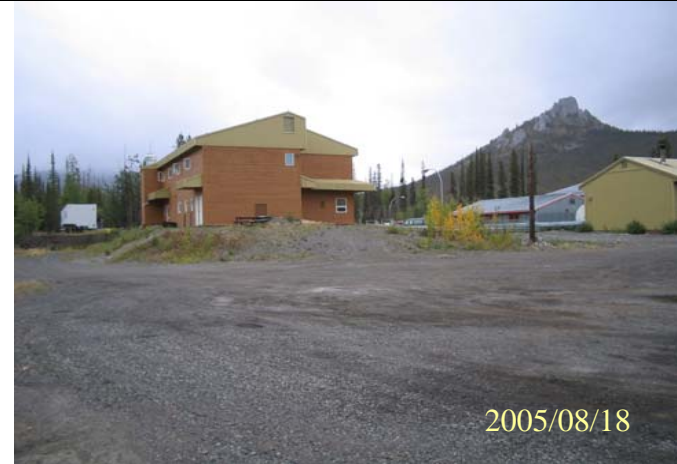
Photo 205: 2665 Olgilvie living complex.

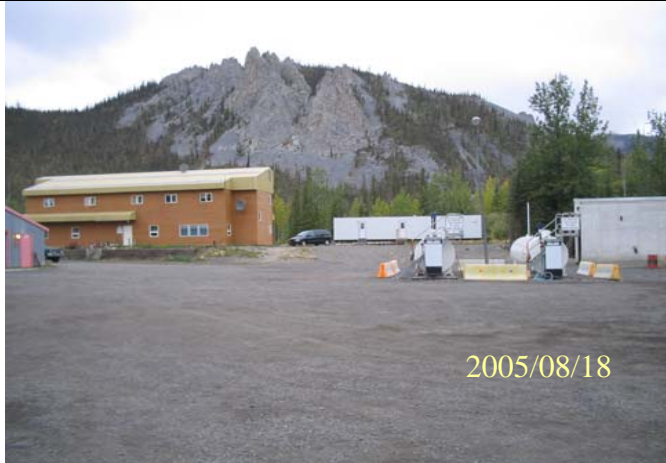
Photo 210: 2665 Fueling station.

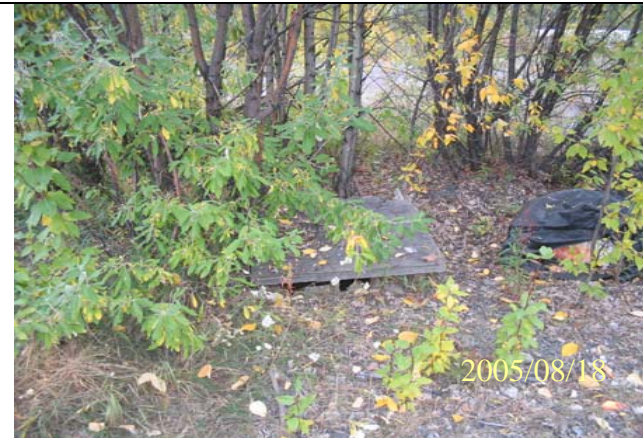
Photo 213: 2665 On site sewage disposal for grader station.
