20.0 BUILDING 3186: DESTRUCTION BAY GRADER STATION 20.1 Description of Existing Water Supply System

Western Region – Destruction Bay Grader Station Building # 3186

SMALL PUBLIC WATER SYSTEM ASSESSMENT

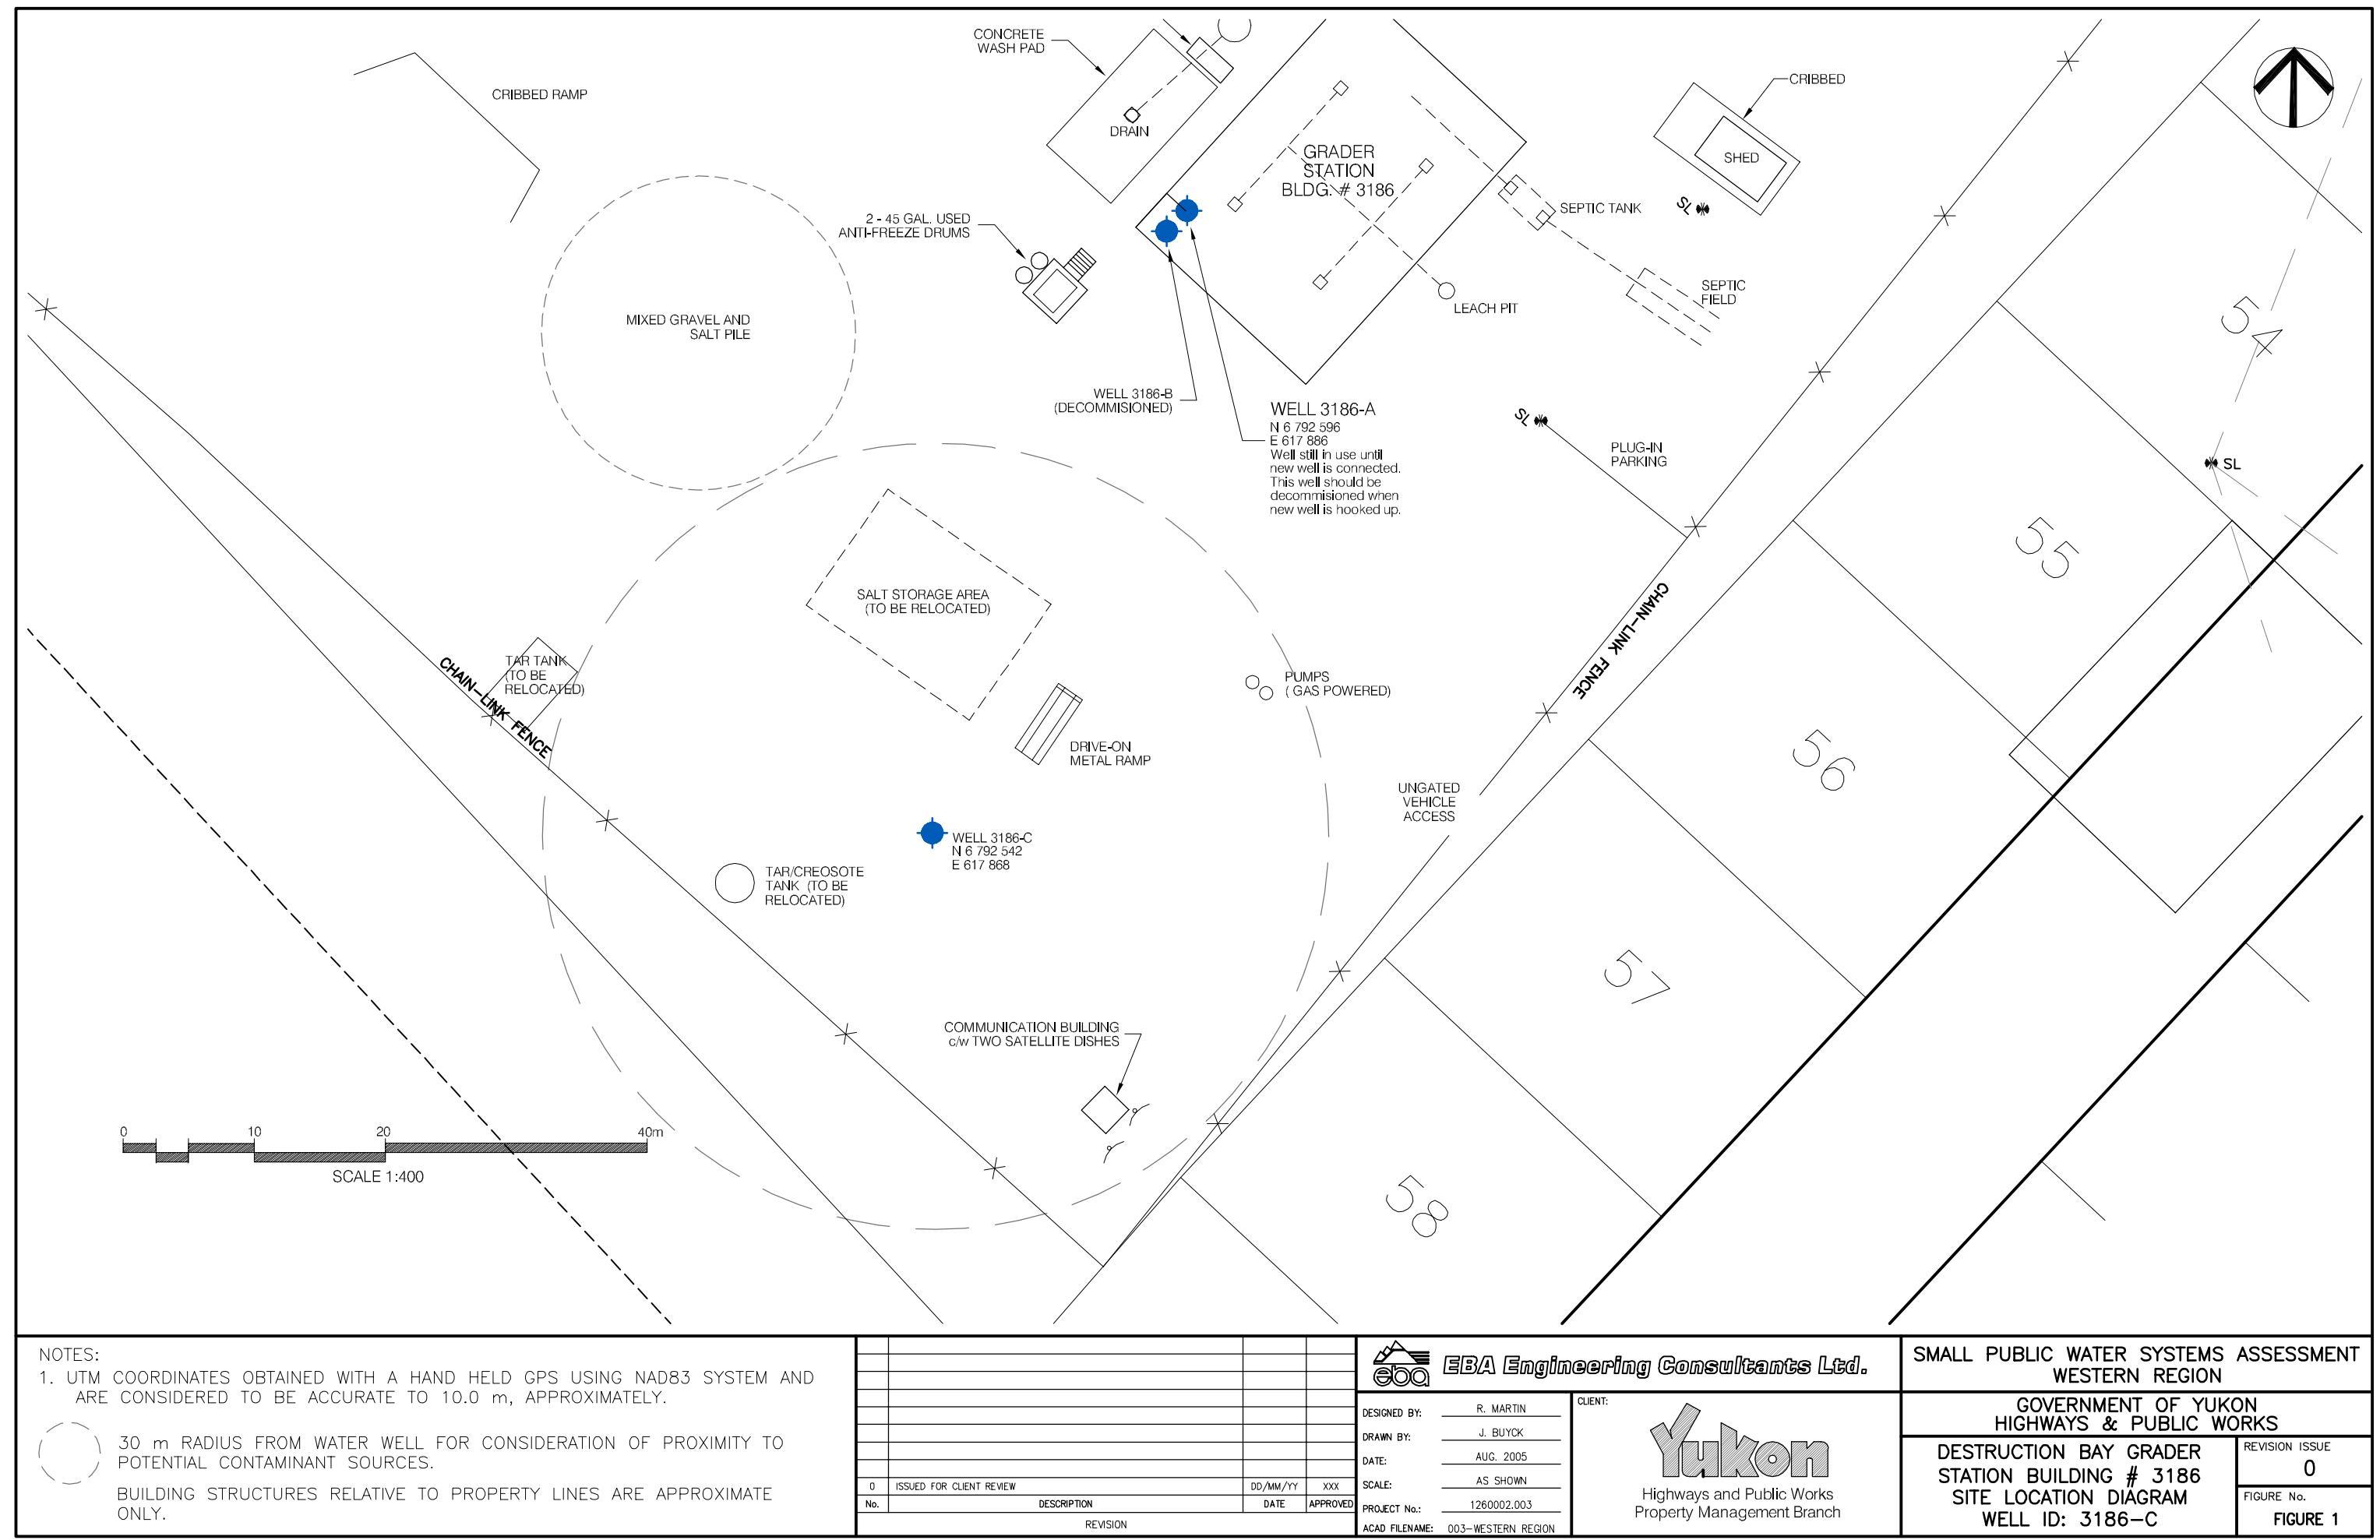
There are three Septic effluent disposal systems that were identified during the water system assessment. There is a septic tank near the northeast corner of the building, located approximately 23 m east and downgradient from the well. This tank likely serves the domestic sewage system, and effluent is likely discharged to an in ground disposal system southeast of the tank. There is a leach pit located near the northwest corner of the building, approximately 13 m northeast and likely downgradient from the well, and it likely serves the sump in the wash pad. There is a rock pit located off from the southeast side of the building that likely serves the sumps in the garage, and it is approximately 17 m east and cross-gradient from the well. A site plan showing the septic systems is provided as Figure 3186-A in Appendix A20.

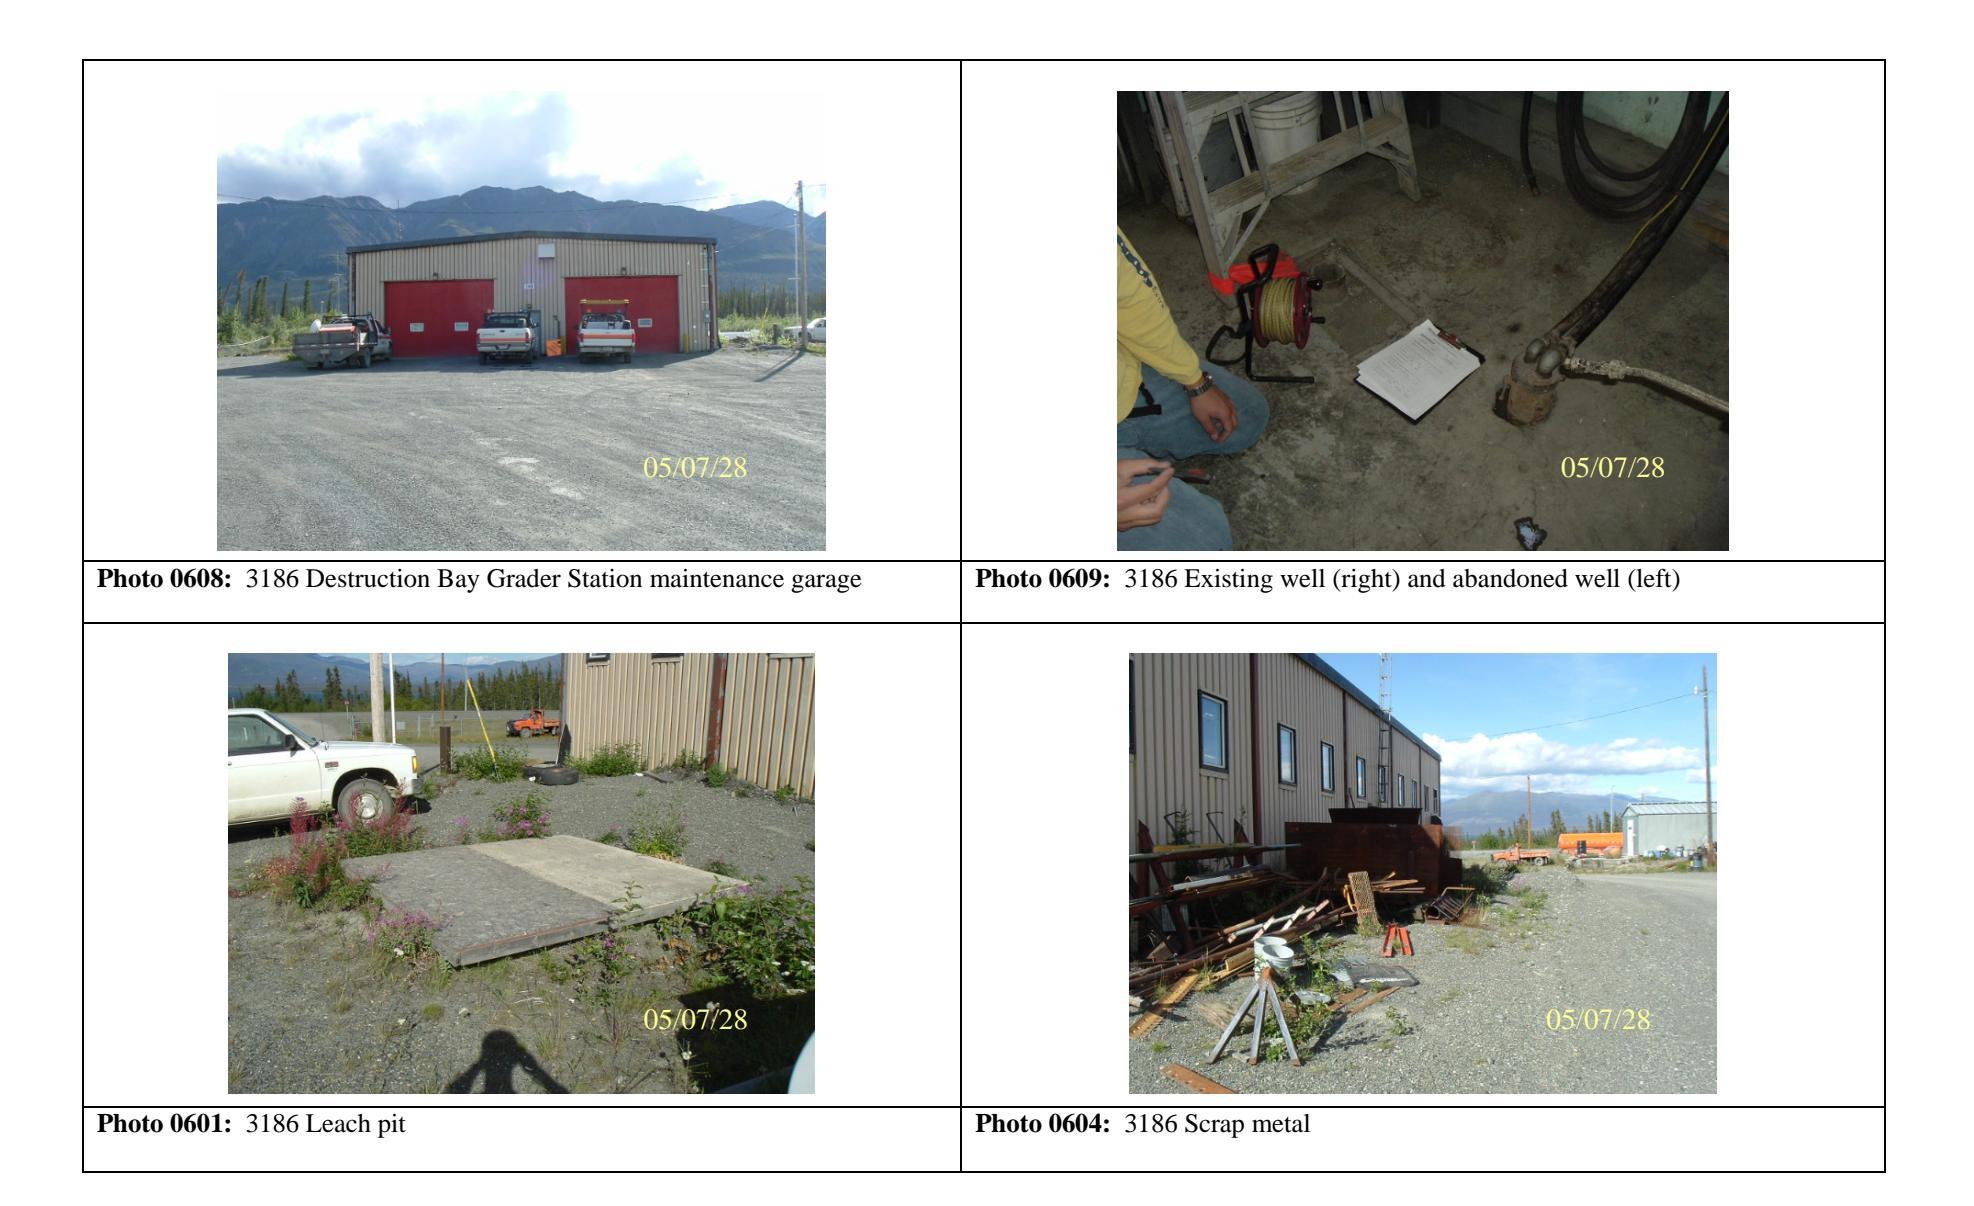
- A leach pit at approximately 13 m;
- Rock pit at 17 m;
- Underground fuel storage tank at less than 25 m;
- Used antifreeze drums at 7 m; and,
- An above ground used oil storage tank at 9 m.

- The well is located within 30 m of potential contaminant sources including an underground fuel storage tank, used antifreeze drums, a waste oil storage tank, and industrial activities;
