6.0 BUILDING M0131: BEAVER CREEK RCMP DETACHMENT6.1 Description of Existing Water Supply System

Western Region – R.C.M.P. Detachment Building # MO131

SMALL PUBLIC WATER SYSTEM ASSESSMENT

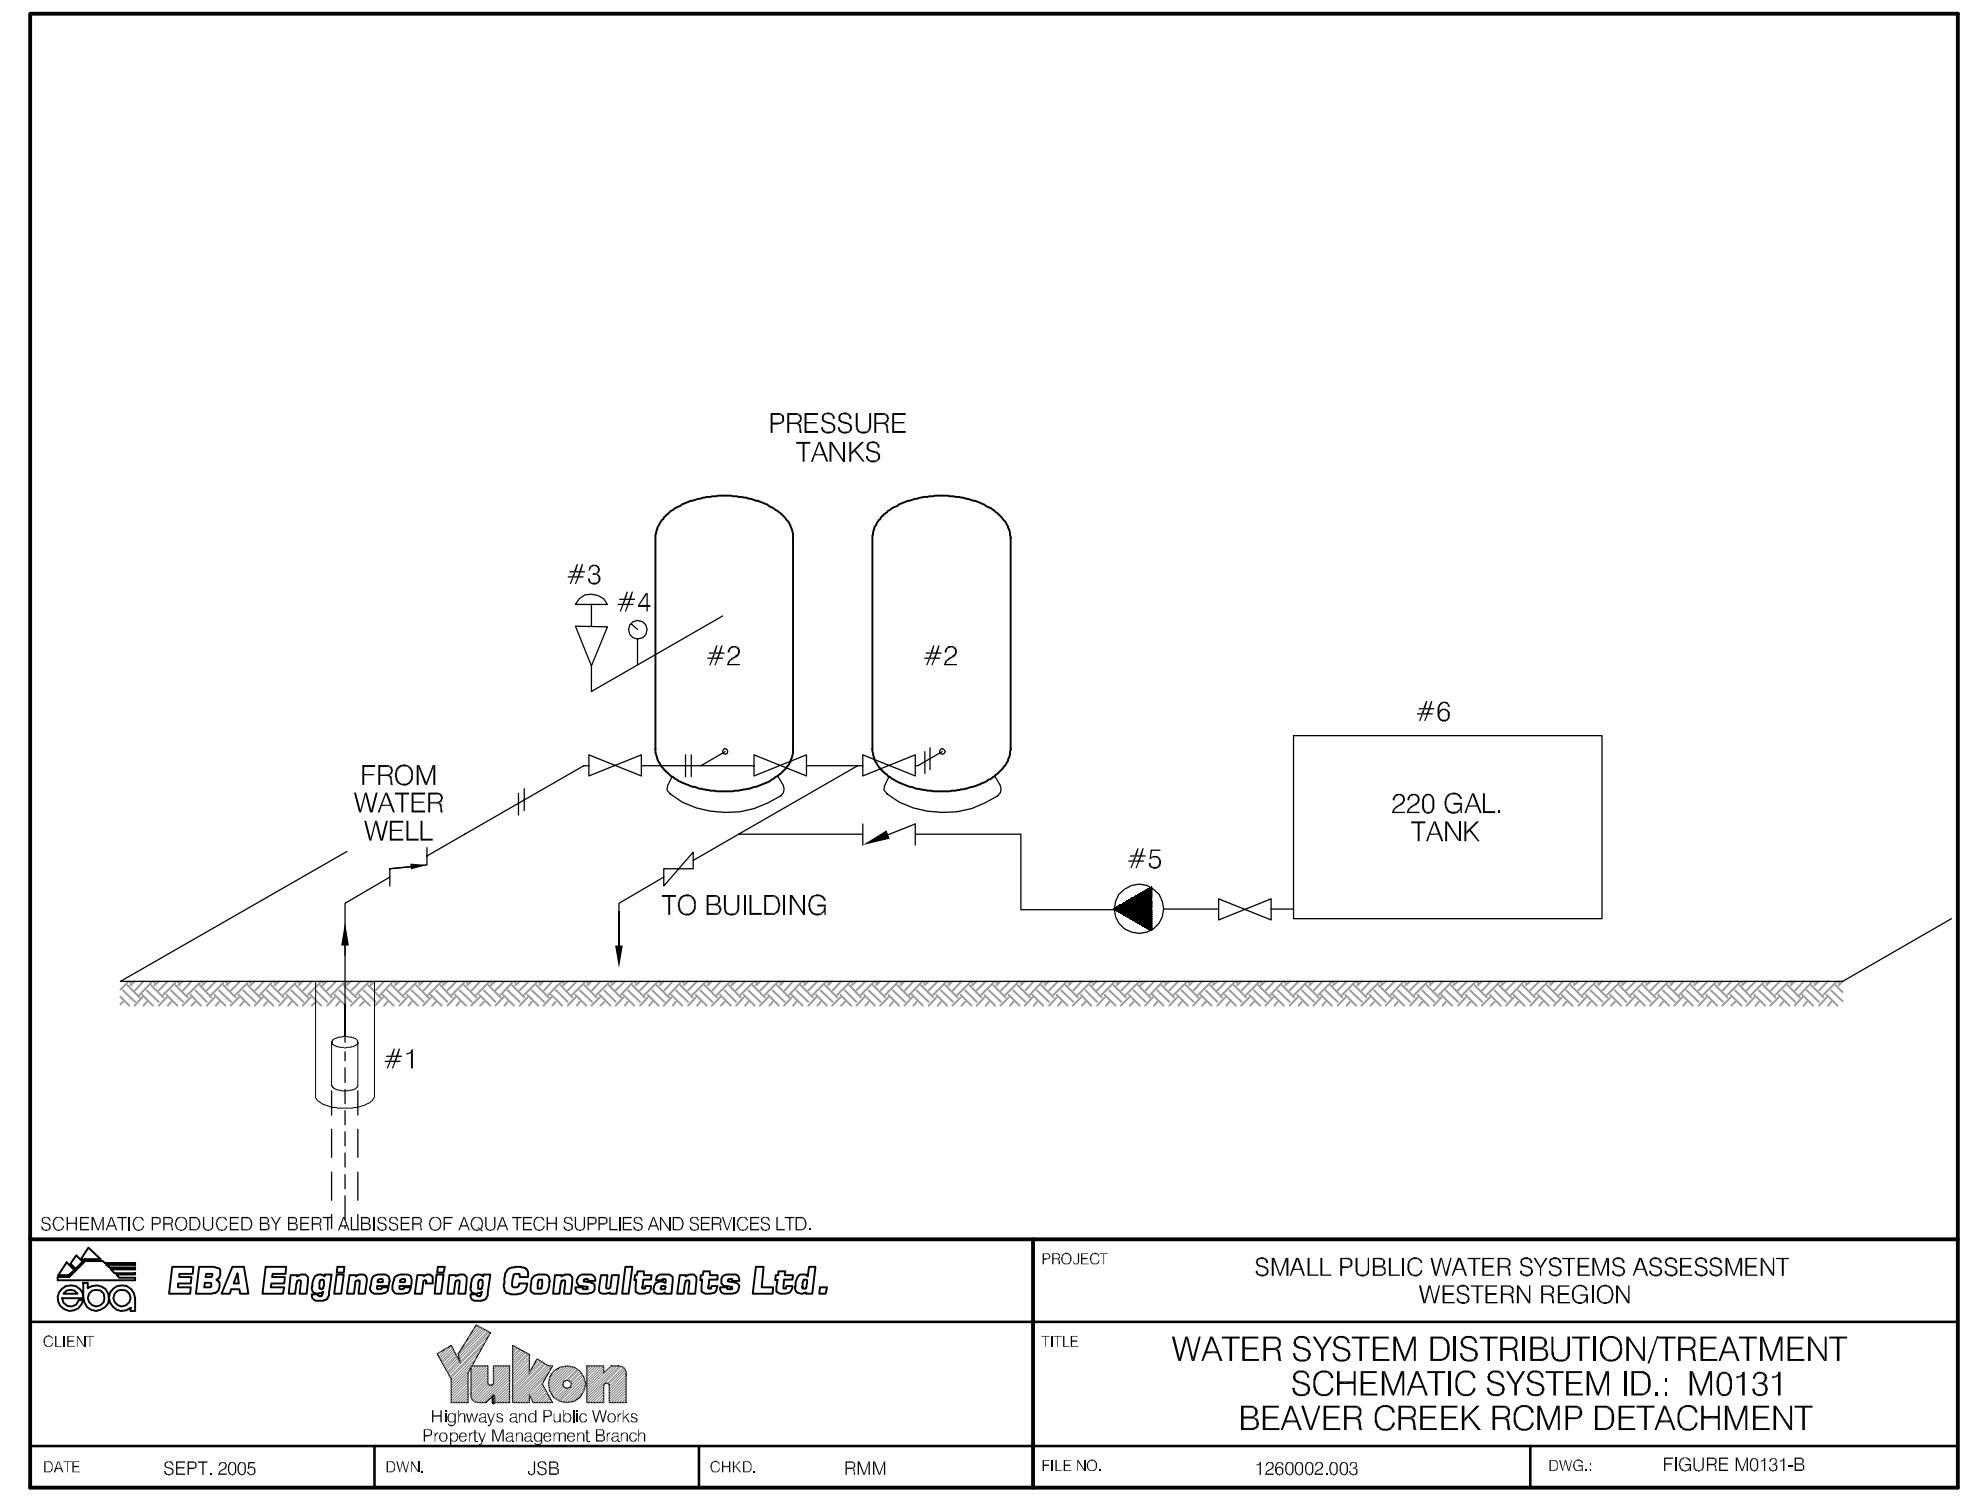
There is no treatment or disinfection system for the water supplying this system. There is a 900 L water storage tank located in a room in the rear of the detachment that was installed when a water line between the well and the building froze during a previous winter. A schematic detailing the water system is provided as Figure M0131-B in Appendix A6.

- The pressure tanks are constructed of galvanized steel and do not meet present plumbing code; and,
- There is no treatment or disinfection system.
- 6.6.2 Low Risk Deficiencies
 - Although the copper concentration was not in exceedence of the CDWQG MAC, copper was elevated with respect to general groundwater quality for the Beaver Creek area; and,
 - There has been a previous CDWQG MAC exceedence of turbidity, but the most recent sampling events reported turbidity less than the CDWQG MAC.

- Continue to monitor copper concentrations and turbidity; and
- Replace the galvanized pressure tanks with a bladder pressure tank that meets code.
