#### 10.0 BUILDING 4797: SWIFT RIVER UTILITY BUILDING 10.1 Description of Existing Water system

#### Eastern Region – Swift River Utility Building Building # 4797

#### SMALL PUBLIC WATER SYSTEM ASSESSMENT

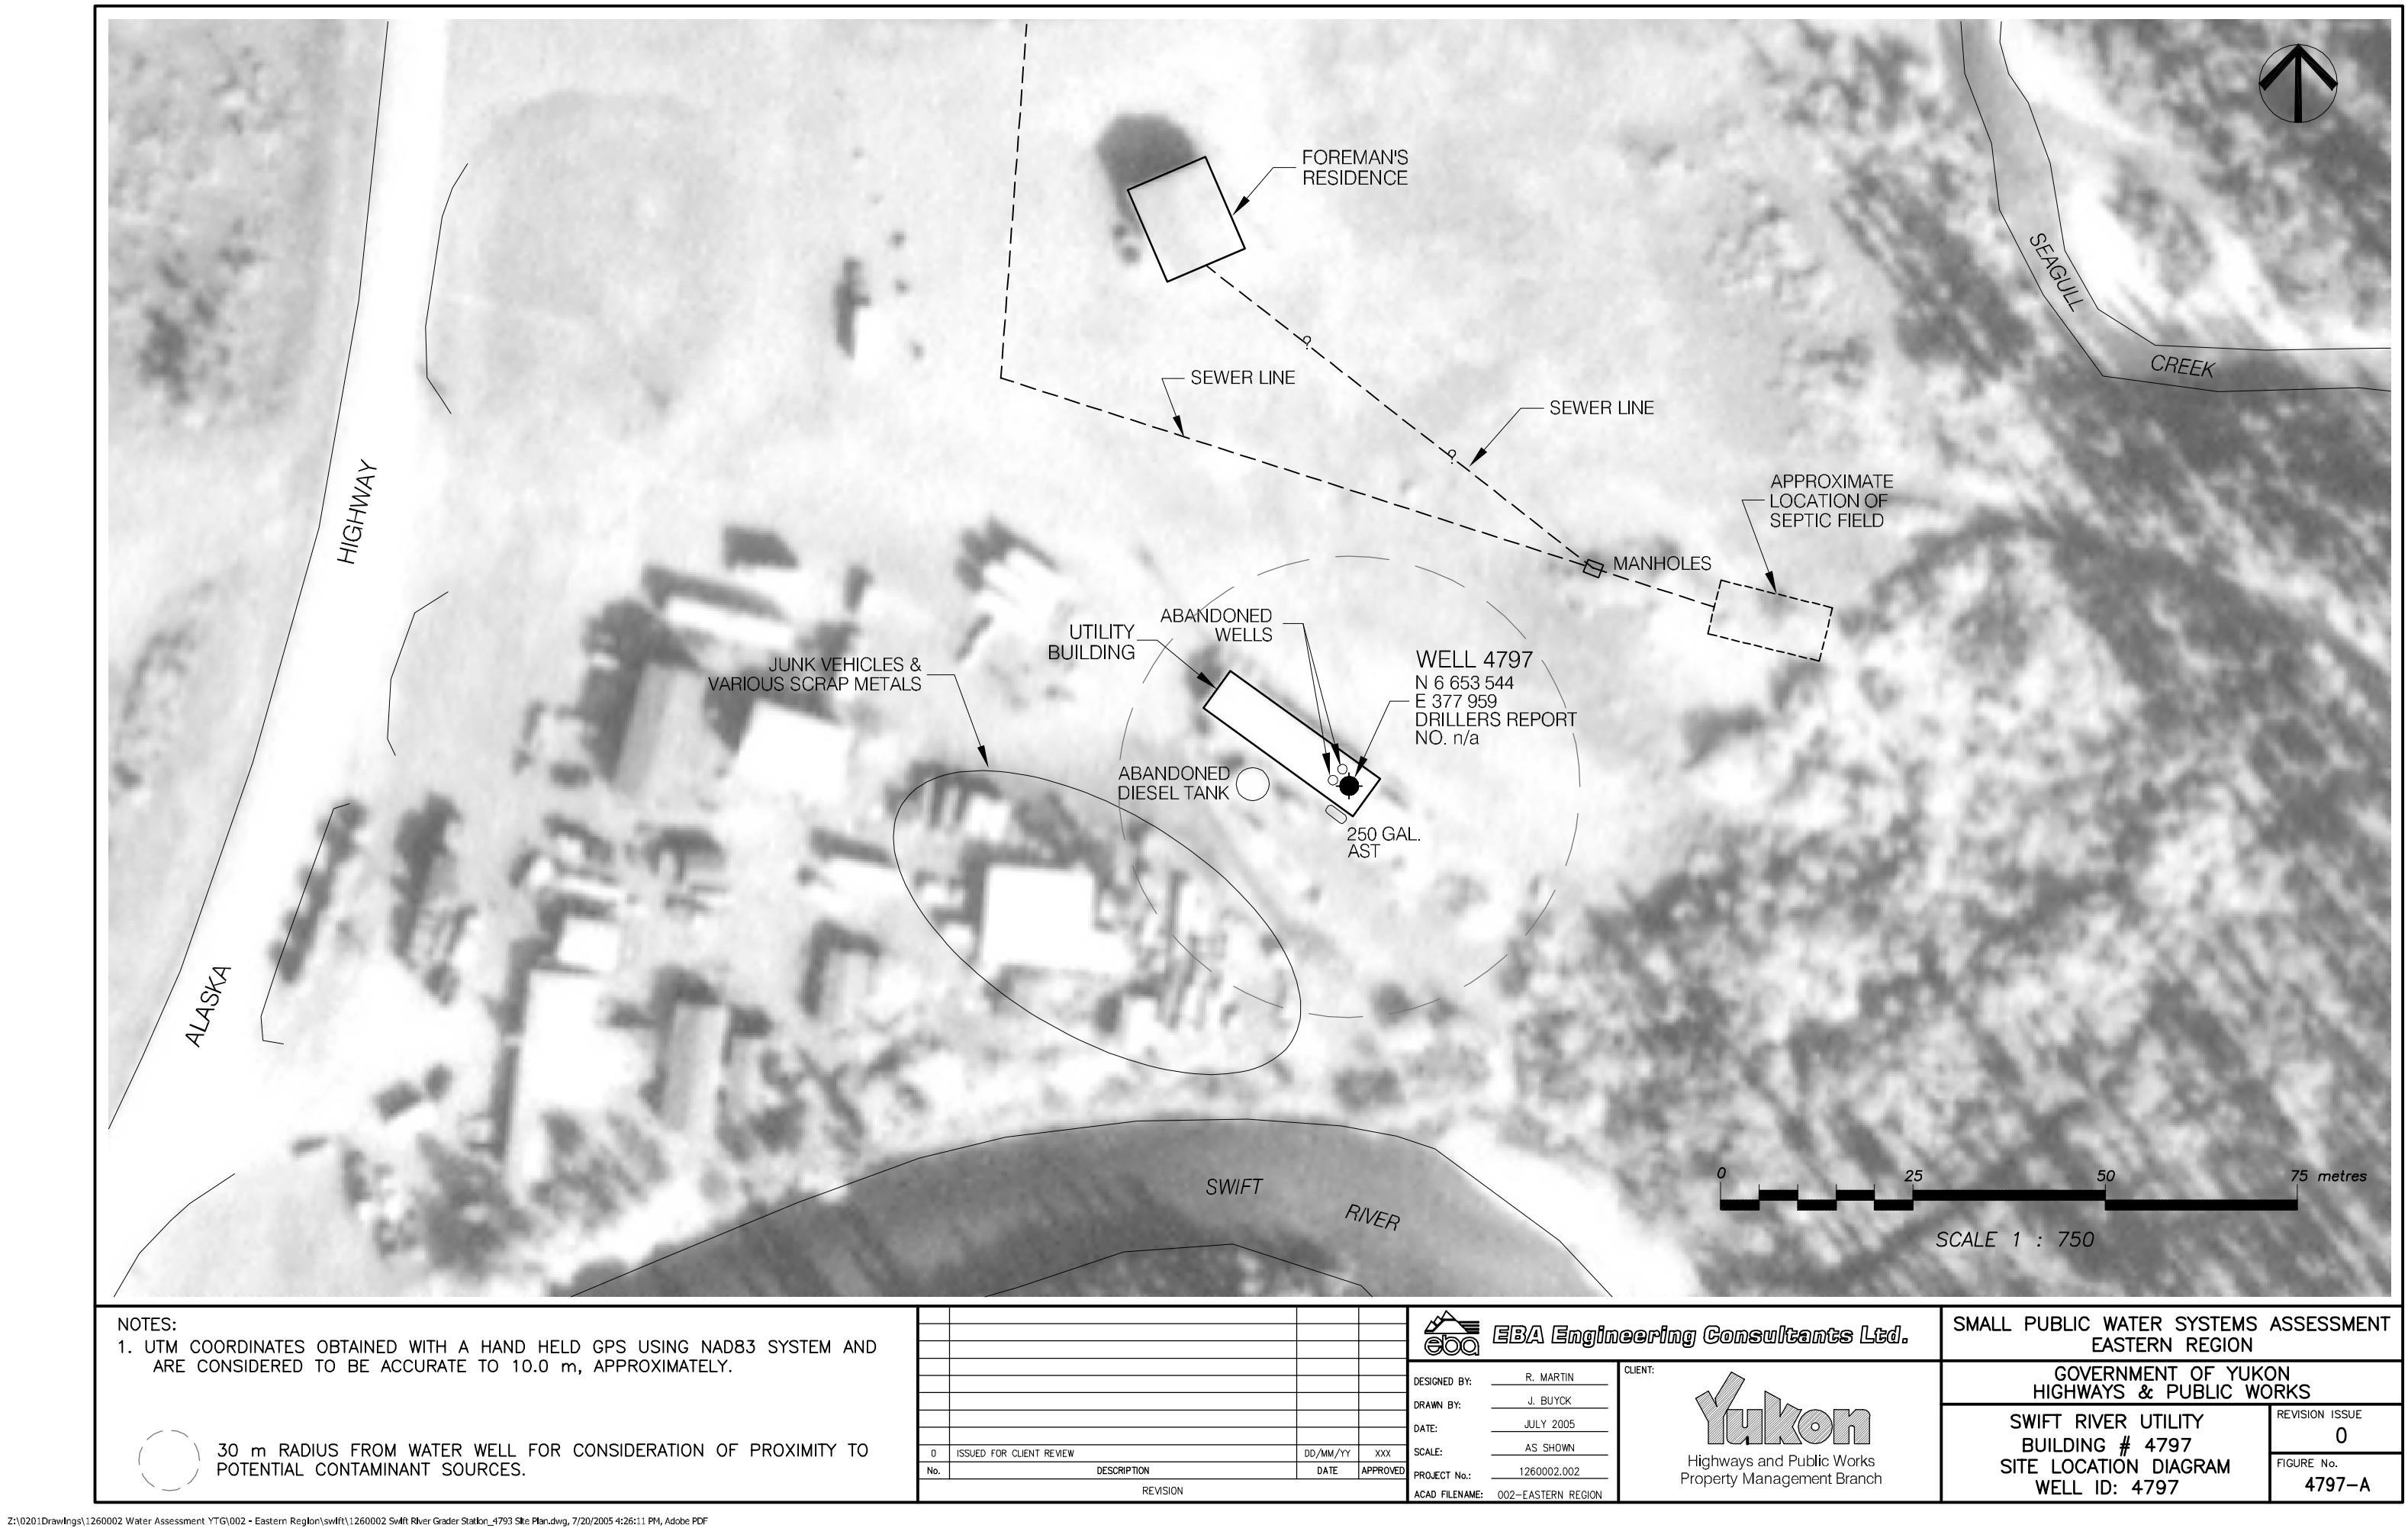
The water system for the Swift River Utility Building is supplied by a 23 m deep well located inside the pumphouse room of the utility building. The well location and other details about the surrounding area are provided in Figure 4797-A in Appendix A10. The coordinates of the wellhead were recorded as:

A septic field that serves both the Swift River Living Complex and the foreman's residence is located approximately 60 m to the northeast of the utility building. A site plan showing the location of the septic system is given by Figure 4797-A in Appendix A10.
