4.0 BUILDINGS M0107, M0108, AND M0109 – TESLIN RCMP DETACHMENT AND RESIDENCES

SMALL PUBLIC WATER SYSTEM ASSESSMENT

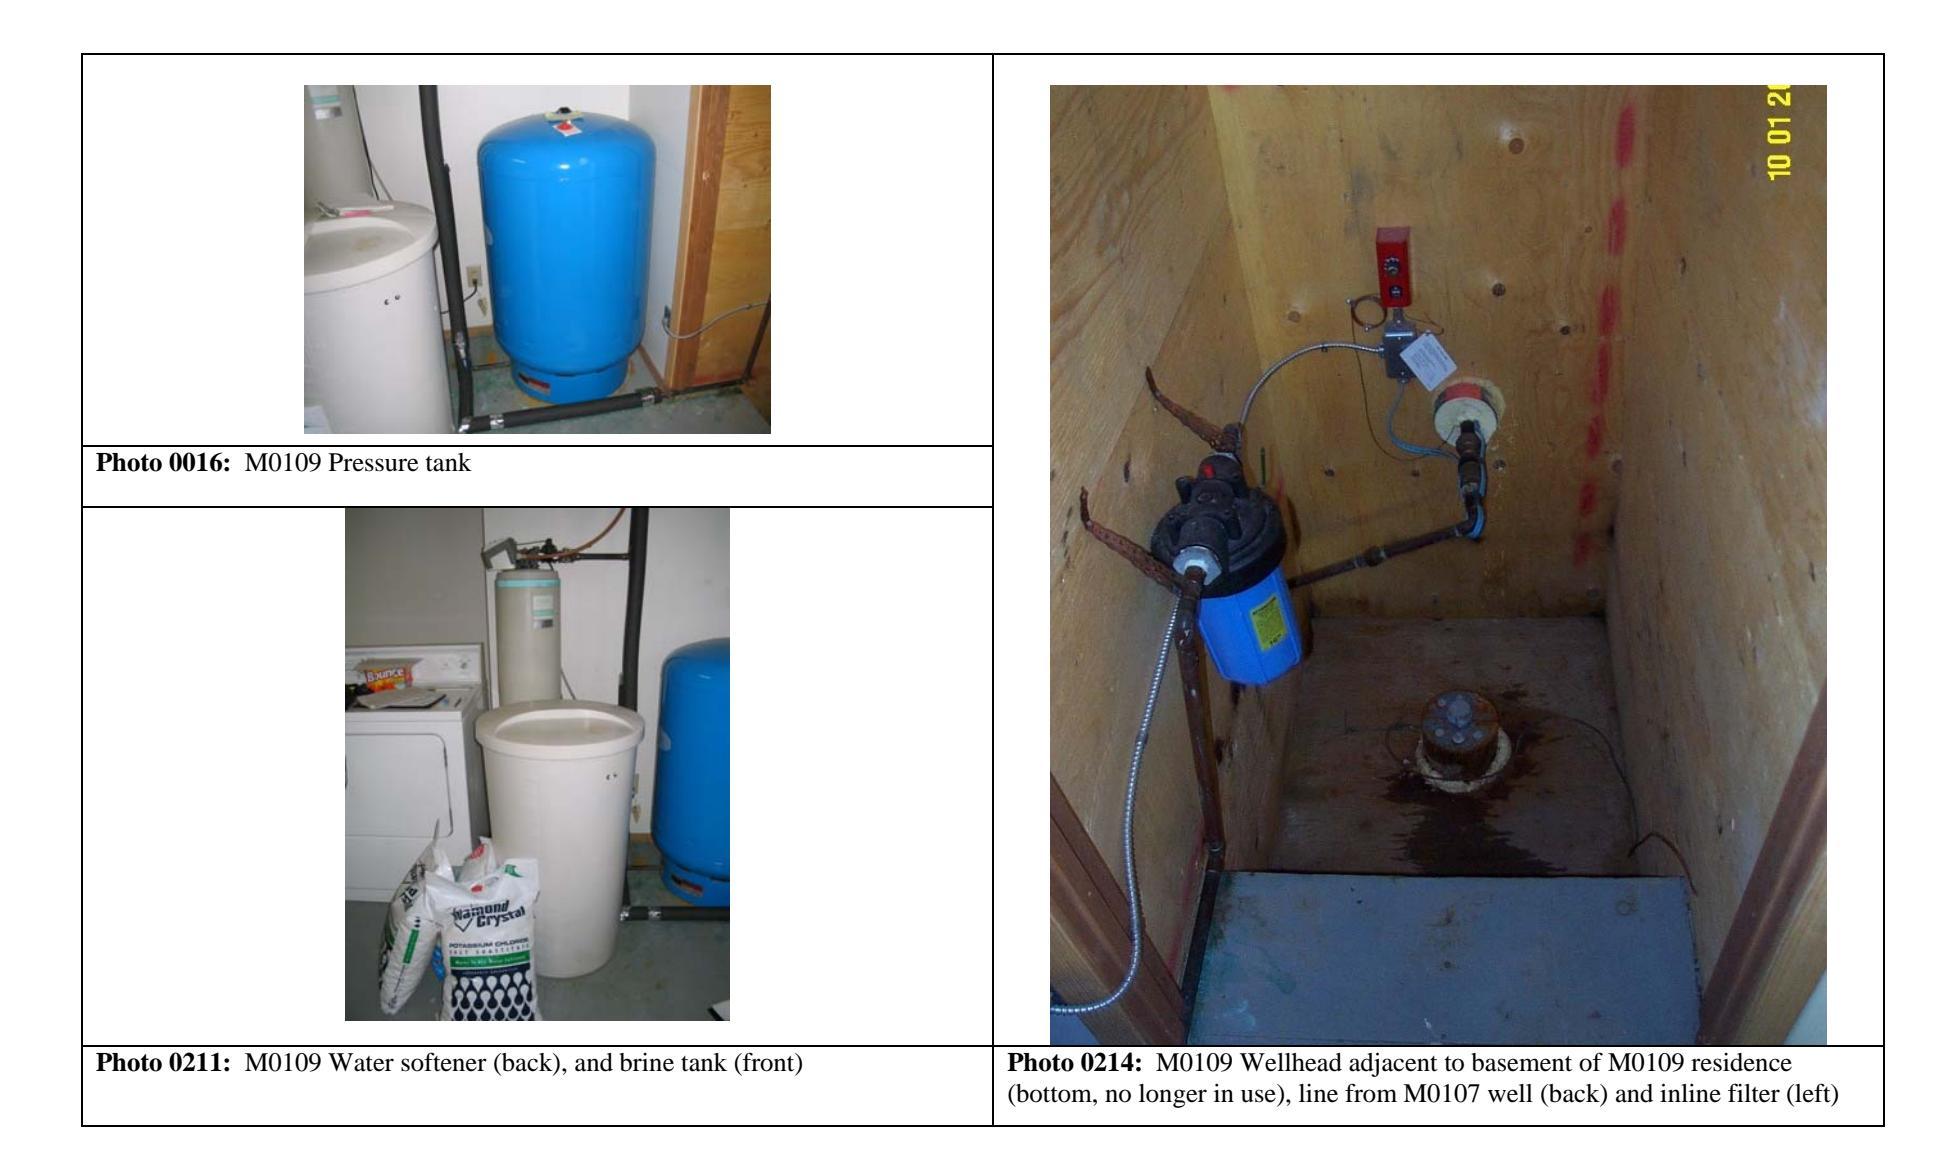
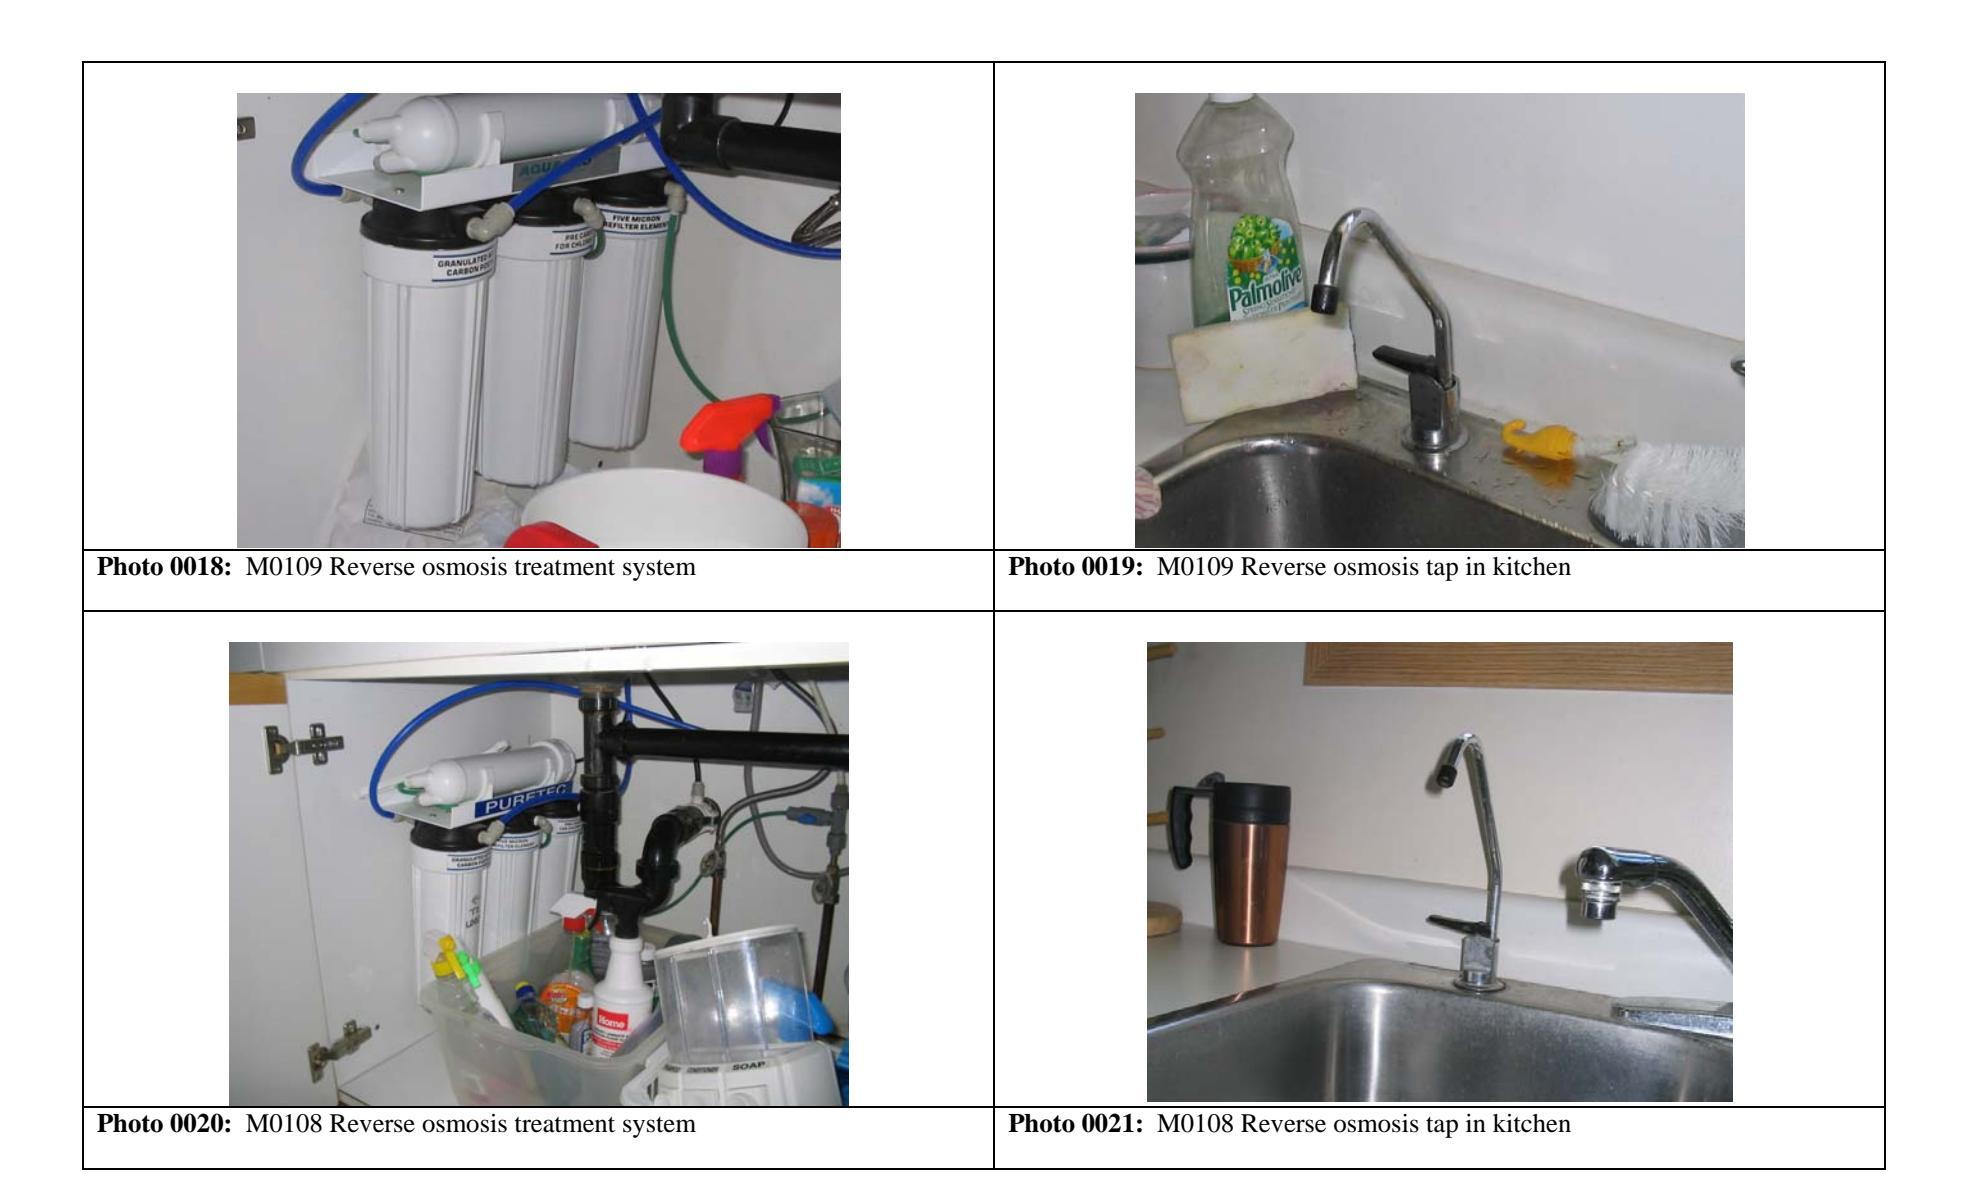
- 4.6.1 High and Medium-Risk Deficiencies;
 - Wellhead M0107 is below grade in a well pit.
 - From observations made during the field investigation, and given general well construction techniques employed at the time that this well was drilled, it is considered very unlikely that a surface sanitary seal was installed as required by the Canadian Groundwater Association Guidelines for Water Well Construction.
 - By definition of the Draft Yukon GUDI Assessment Guideline, the well is potentially under the direct influence of surface water because it is a vulnerable type (unconfined aquifer) and does not meet the requirements of the Guidelines for Water Well Construction.
 - Lack of disinfection for the water system from well M0107.
 - Non-functional water softening systems.
 - Proximity of well to three ASTs.
 - Abandoned well M0109 not properly decommissioned.

Photo 0212: M0107 Wellhead enclosure (front), Teslin RCMP Detachment building M0107 (back)	Photo 0213: M0107 Wellhead enclosure (front), Teslin RCMP Residences M0109 (right) and M0108 (behind), and above ground fuel storage tank in front of RCMP garage (back left)
Photo 0211: M0107 Wellhead in pit (pitless adapter)	Photo 0013: M0107 Water softener (centre), pressure tank (left), and brine tank (right)

- The wellhead at M0107 should be extended to a minimum of 500 mm above the surrounding grade, and the well pit should be backfilled with a low-permeability material to provide a surface seal around the well casing;
