Hydrogeological Assessment

Crestview Lagoon, Whitehorse, YT

19130631-001-R-Rev2

27 February 2020

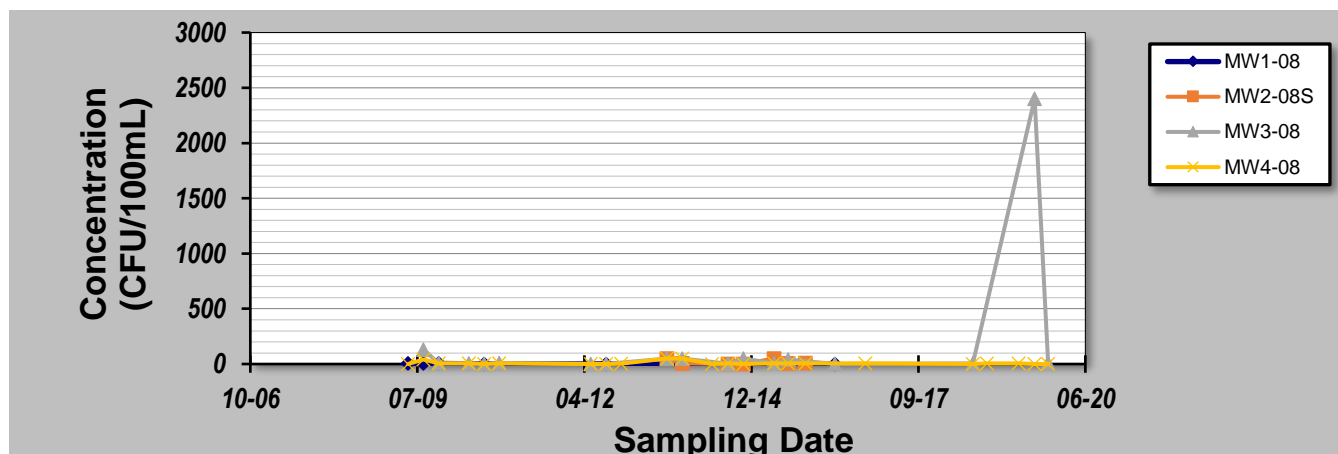
Figure 8: Fecal coliform concentrations at the Crestview Lagoon, 2008 - 2019.

The concentrations of Fecal Coliforms have ranged between less than the laboratory method detection limit (2 – 100 CFU/100mL) to 132 CFU/100mL in monitoring wells MW3-08 and MW4-08. A single incidence of 2,400 CFU/100mL was measured in MW3-08 in August 2019. A plot of fecal coliform over time is shown in Figure 8. There is some variability in the data; however, concentrations do not seem to have increased over time.

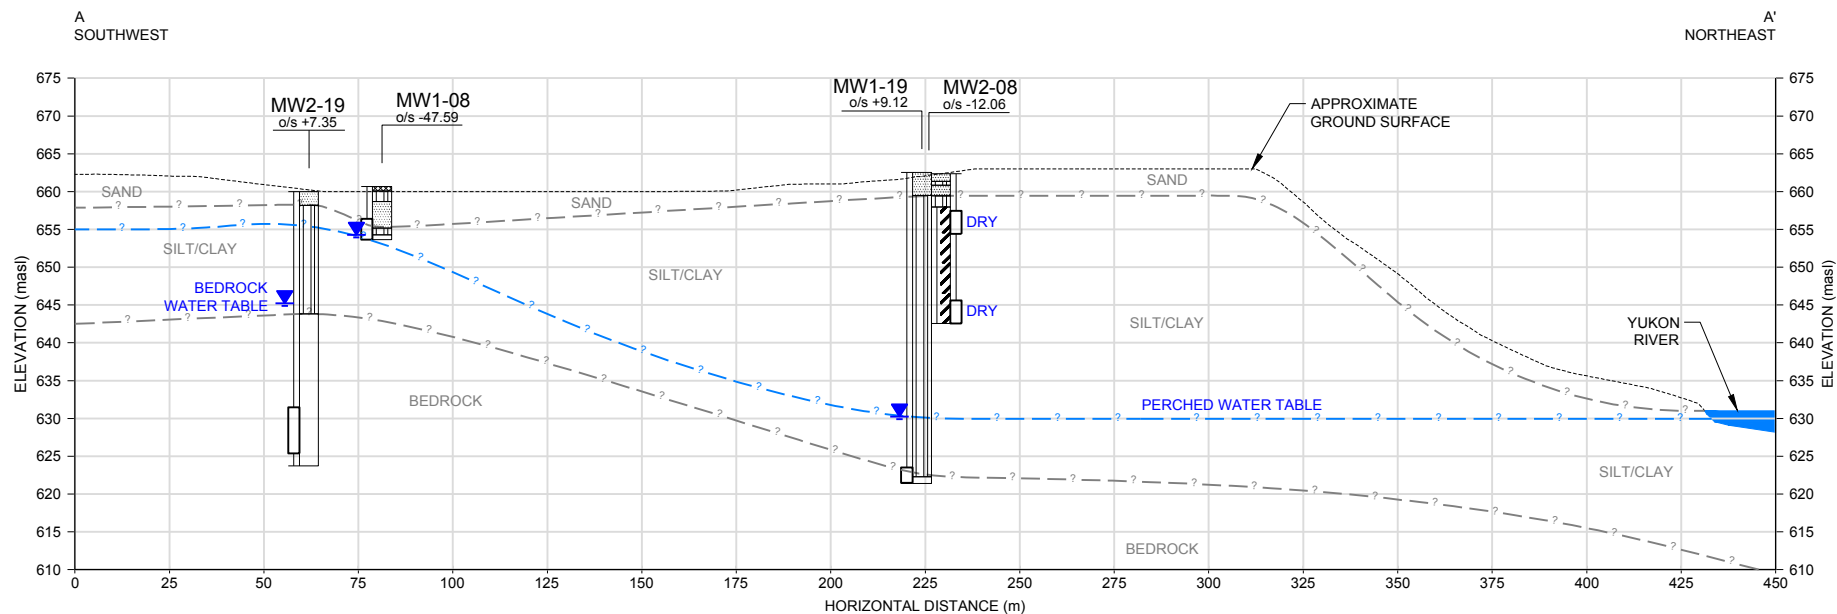
HORZ SCALE 1:2000
VERT SCALE 1:1000
A CROSS-SECTION A-A'
2

- Sand ranging in thickness between the two boreholes, from approximately 1.8 m at MW2-19 to 3.0 m at MW1-19.
- Silt or sandy silt ranging in thickness from approximately 14.4 m at MW2-19 to 37 m at MW1-19.
- Bedrock was encountered at both borehole locations and was noted at depths ranging from 16.2 m bgs at MW2-19 to 40.2 m bgs at MW1-19.

Groundwater was identified in the various stratigraphic units present at the Site including perched groundwater within the silt/clay unit, and a fractured bedrock aquifer. The monitoring wells were screened as follows:

- MW1-19 was screened within the silt/clay layer above bedrock in order to intersect the perched groundwater table located above bedrock, similar to MW1-08 and MW4-08.
- MW2-19 was installed approximately 12.3 m below the top of bedrock in order to capture the groundwater within fractured bedrock. MW2-19 is the first well on the Crestview Lagoon that is drilled into this aquifer.
- Additionally, as discussed by EBA (2009) a potential third groundwater unit may have been encountered at MW3-08. MW3-08 is screened in the upper sand unit and above the silt/clay layer. Water present in this monitoring well is suspected to be seepage and near surface groundwater discharge.

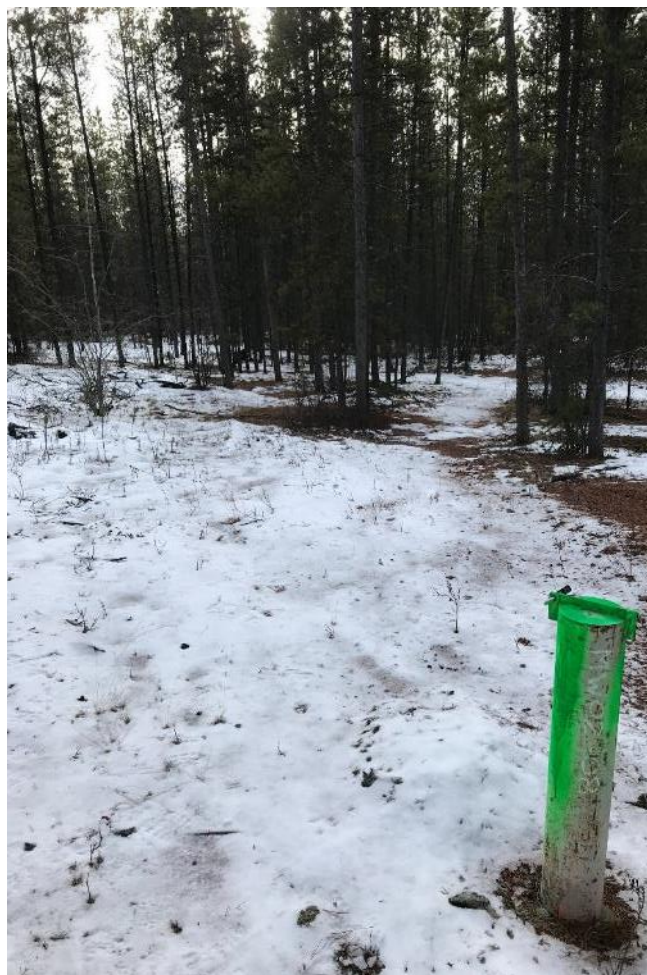
Photo 2: Initial survey site selection, proposed MW2-19 looking north, MW2-08 in foreground. (21 October 2019)

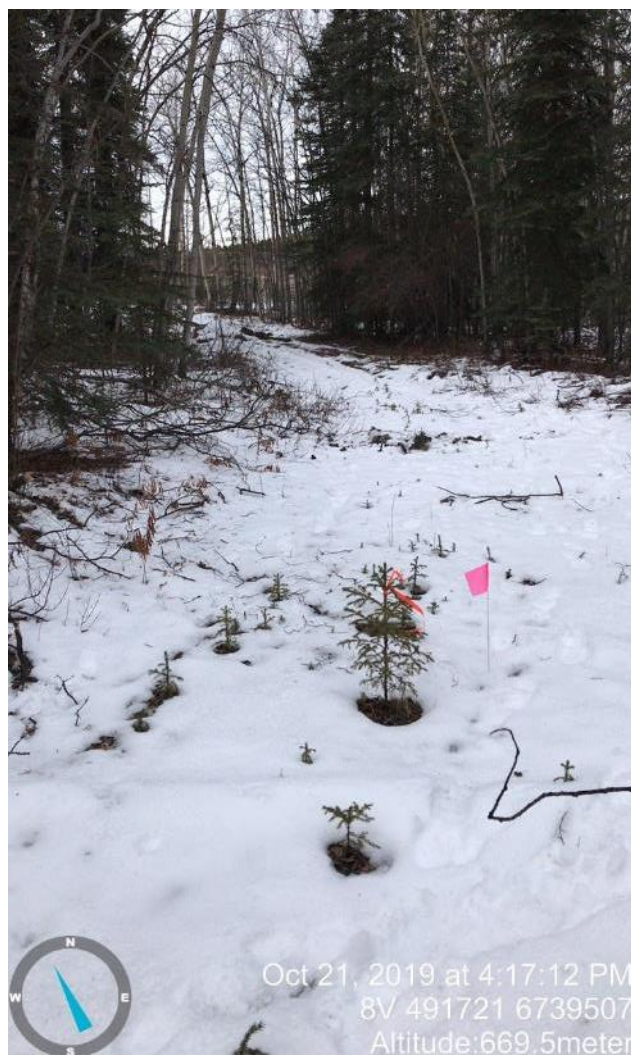
Photo 1: Initial survey site selection, proposed MW2-19 looking south. (21 October 2019)

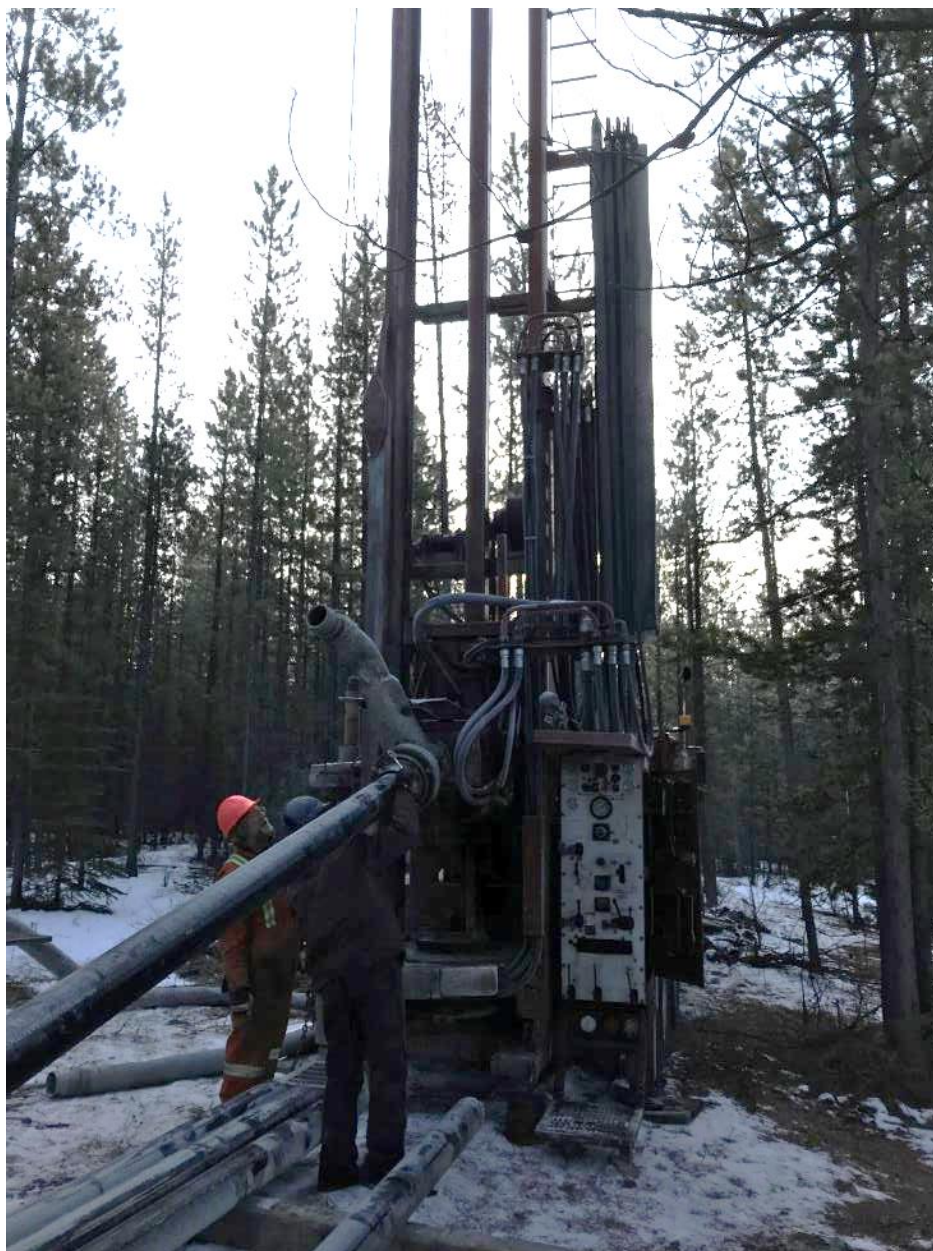
Photo 3: Air-rotary drill rig at MW1-19, Impact Well Drilling. (22 October 2019)

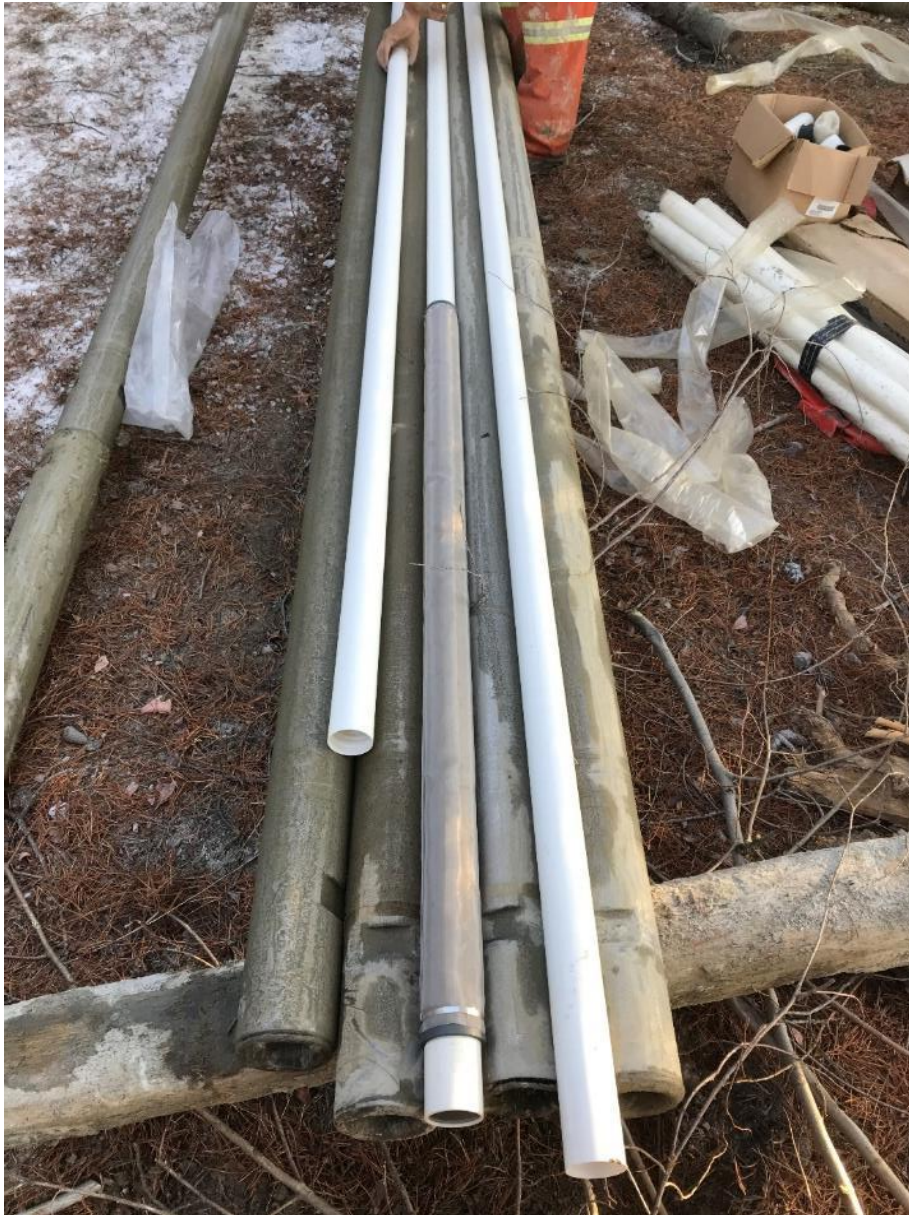
Photo 4: Monitoring well supplies, schedule 40 solid PVC and prepacked screened PVC. (22 October 2019)

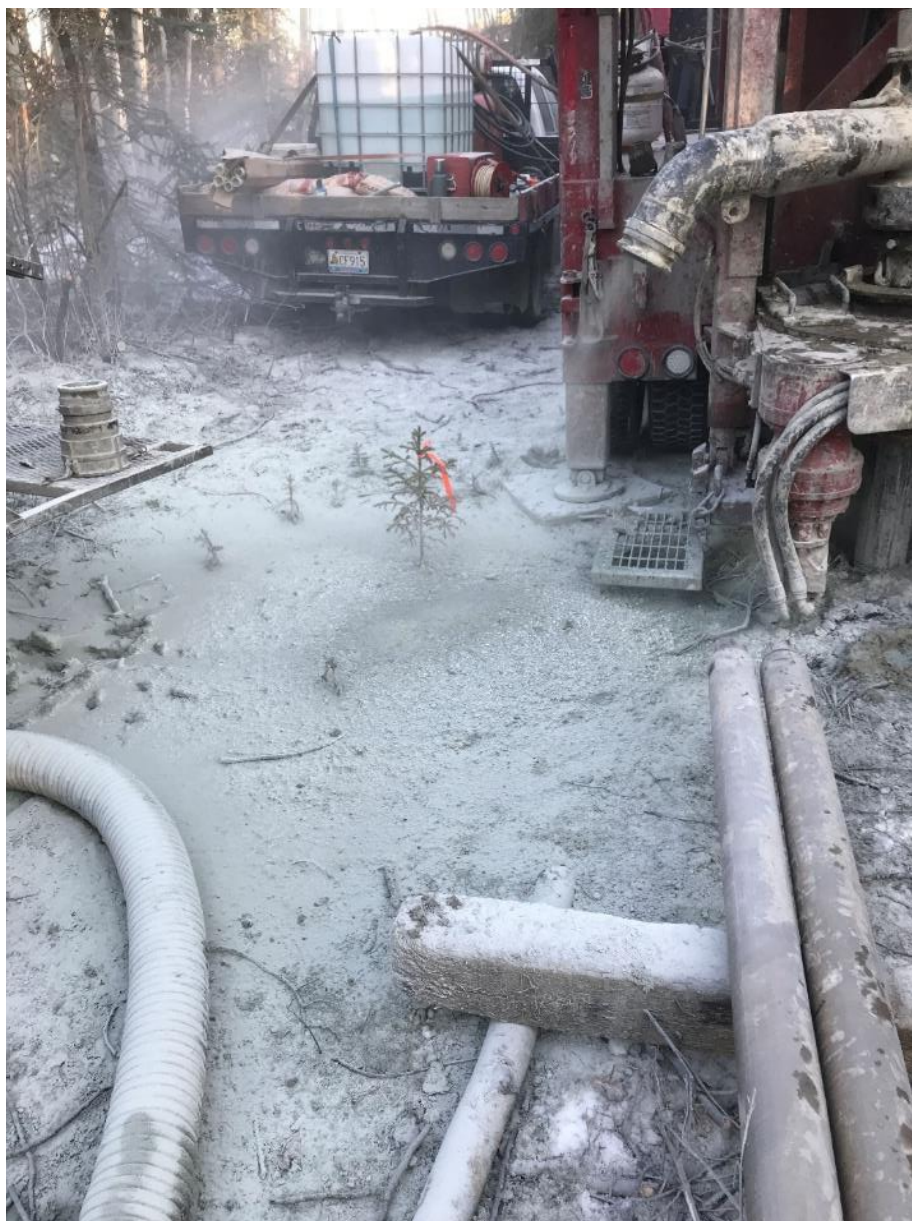
Photo 5: Drill cuttings from BH2-19 at sandy-silt/bedrock contact at 16.15 mbgs. (24 October 2019)

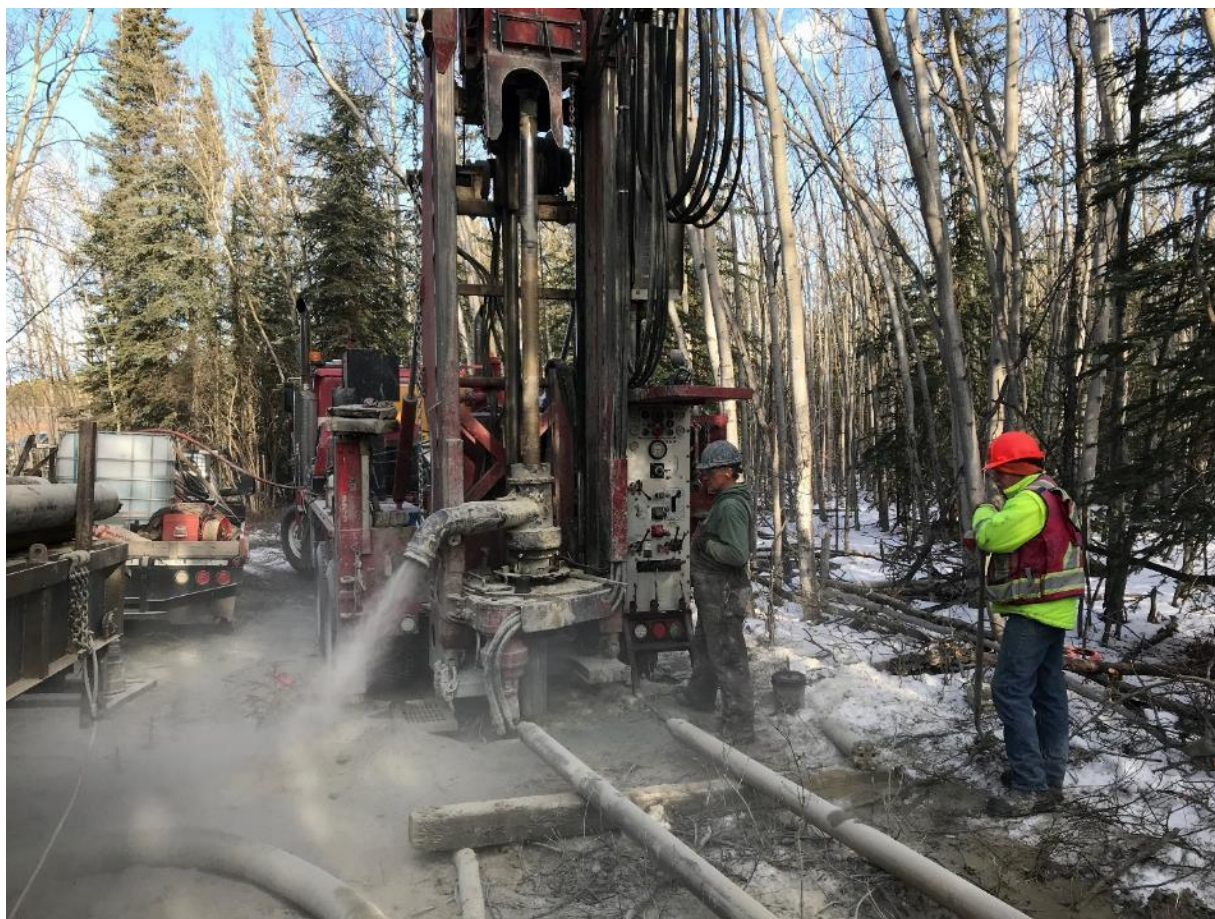
Photo 6: Drill cuttings from BH2-19 in bedrock at approximately 16.7 mbgs. (24 October 2019)

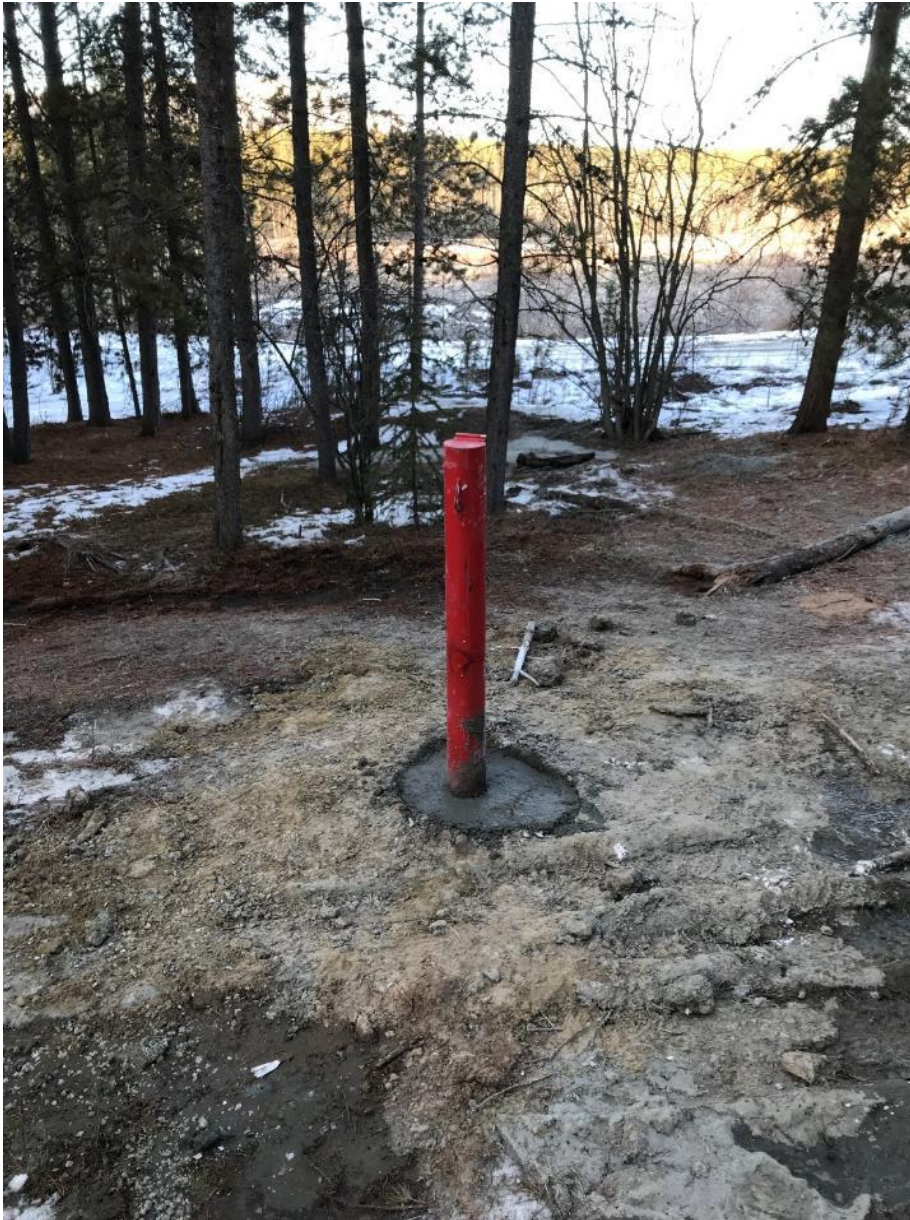
Photo 7: Completed Monitoring Well MW1-19. (25 October 2019)

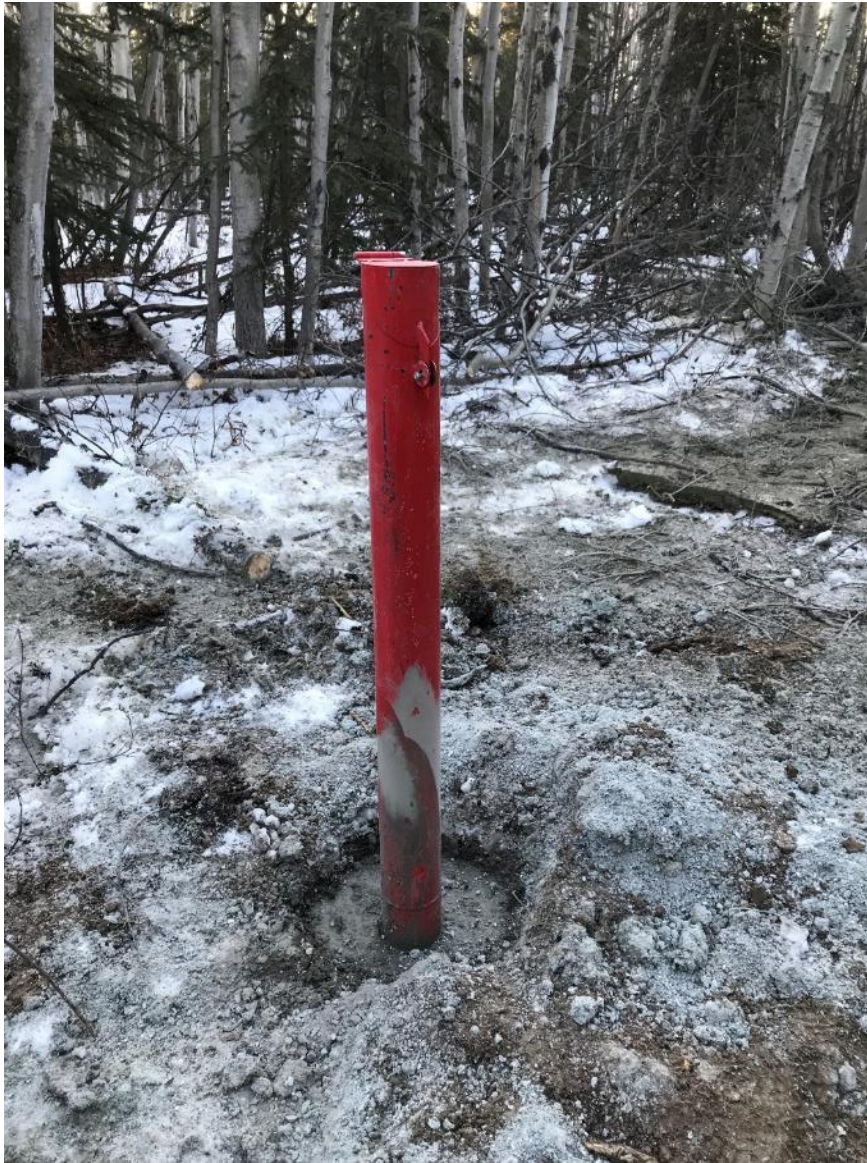
Photo 8: Completed Monitoring Well MW2-19. (25 October 2019)
