GOVERNMENT OF YUKON  
DEPARTMENT OF COMMUNITY SERVICES

# HYDROGEOLOGICAL ASSESSMENT HAINES JUNCTION WASTE DISPOSAL FACILITY

## REPORT

APRIL 2011  
ISSUED FOR USE  
EBA FILE: W23101317.007

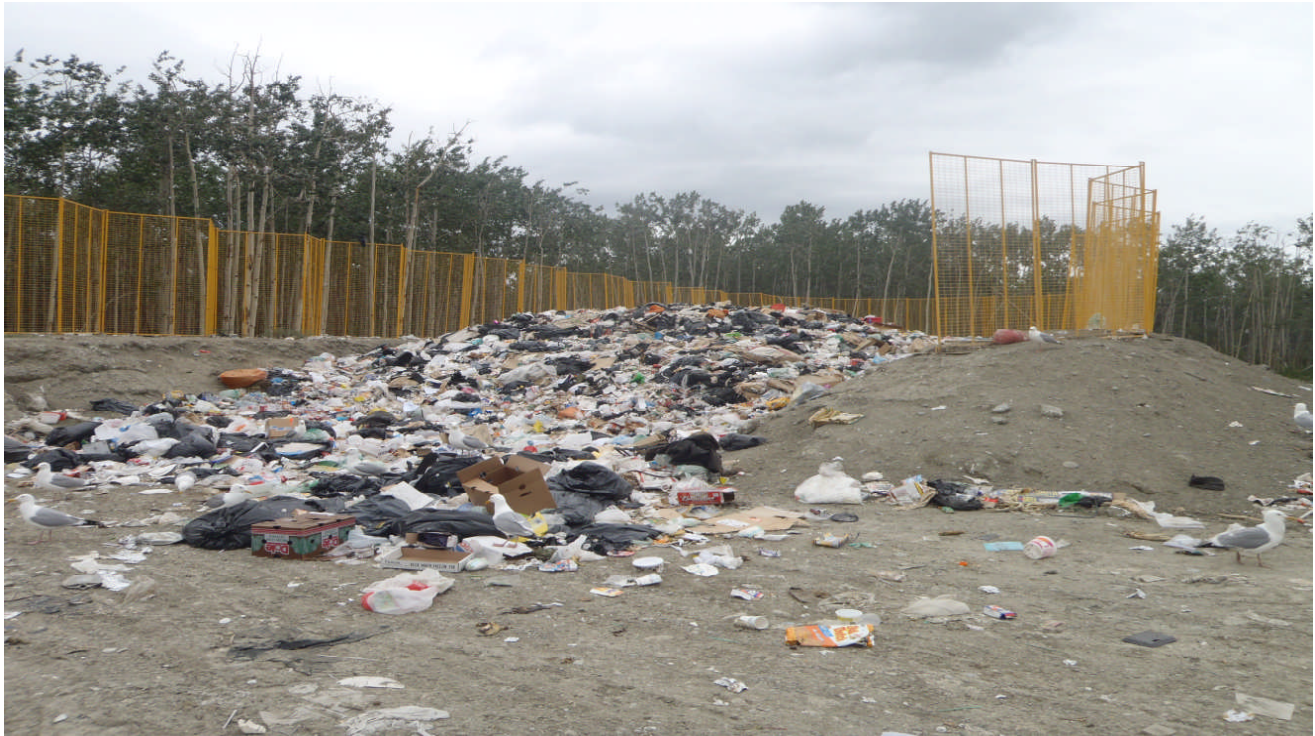
Photo 2: Haines Junction Domestic Waste Disposal, Area 1 – July 2010 (view east)

Domestic waste had historically been burned and buried in pits in the western and central portions of Area 1. Burning of domestic waste has been restricted since 1996, although some burning was reported to have continued due to public users lighting fires. Burning no longer occurs on site (Ken Gilbert, pers. comm.), which complies with the permit requirement to phase out burning by January 1, 2012. The eastern end of Area 1 has been excavated to approximately 4 m below ground level, with unburned domestic waste being placed in “cells” separated by soil berms and covered. Putrescible domestic waste is currently being disposed of in above ground bermed cells at the eastern end of Area 1, as shown in Photo 2. Batteries, oils and other hazardous wastes had been stored in a plastic lined area approximately halfway along the southern boundary of Area 1 prior to being moved to its current location, in a shed closer to the site entrance. When the former storage facility was removed, there was no evidence of leakage though the plastic lining (Martin Jones pers. comm.).

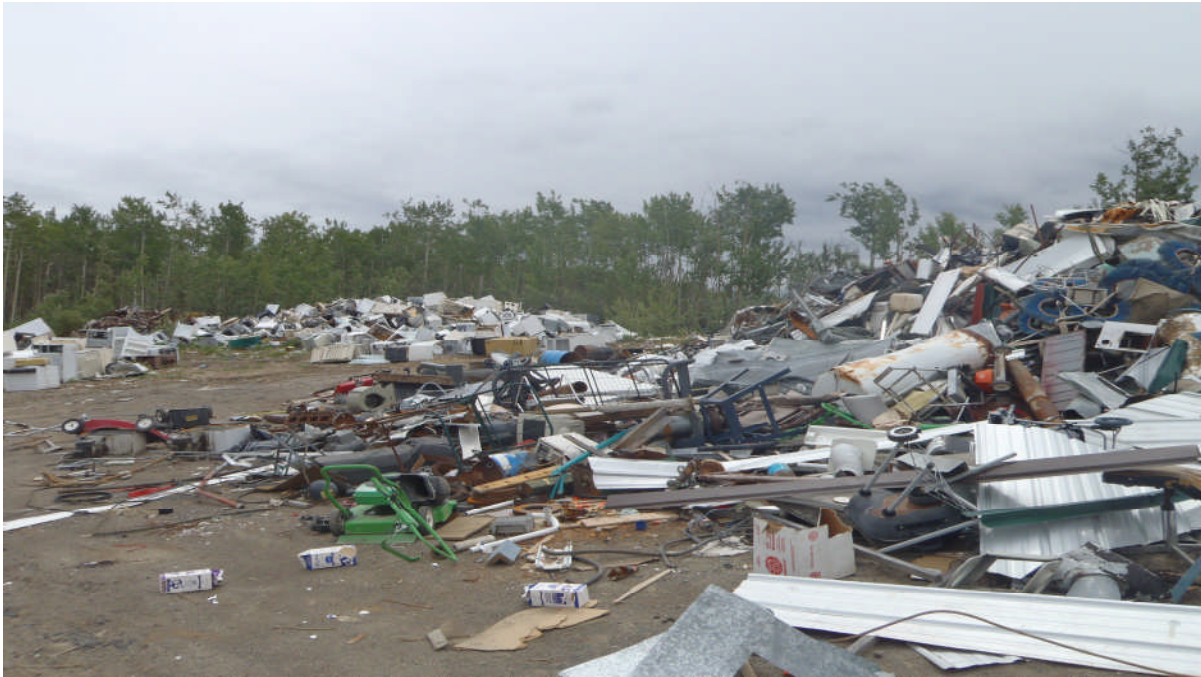
Photo 3: White Goods and Metal Stockpile, Area 3 – July 2010 (view east)

potentially resulting in oil being released into the pit prior to the pit being backfilled. Derelict cars are stockpiled at the eastern end of Area 3 and it is believed that there are cars buried beneath the stockpile (Martin Jones pers. comm.). White goods and miscellaneous metal is stockpiled up to 3 m high along the southern side of Area 3 (Photo 3).
