## HYDROGEOLOGICAL ASSESSMENT

## Johnson's Crossing Solid Waste Disposal Facility

er: 1114360073-509-R-Rev0-2100

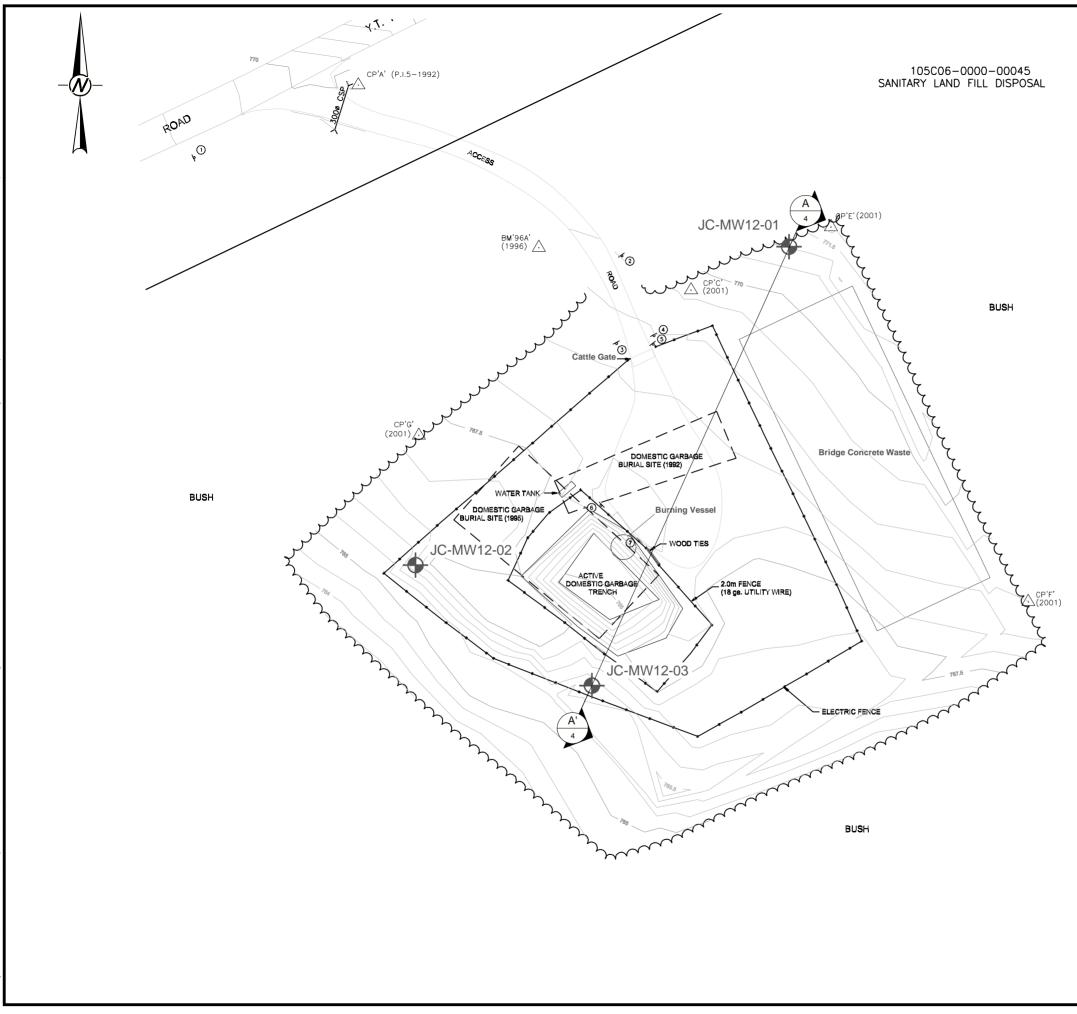
0073 PHASE No. 2100-2160 P12 SCALE AS SHOWN REV. -P12 FIGURE 2

Three (3) groundwater monitoring wells were proposed for installation at the Site to characterize groundwater conditions underlying the waste disposal Facility. A Site plan showing the monitoring well locations and key Site features is provided in Figure 2. JC-MW12-01 was intended to characterize upgradient groundwater conditions, while JC-MW12-02 and JC-MW12-03 were intended to assess groundwater conditions downgradient of the landfill. Locations of the monitoring wells were selected based on aerial photography, review of Site history, Site topography, suspected groundwater flow direction, and a Site inspection.

1. SITE PLAN IS NOT CONSISTENT WITH OBSERVED CONDITION DURING DRILLING, BUT IS INTENDED TO SHOW LOCATIONS OF NEWLY INSTALLED MONITORING WELLS IN RELATION TO BURIED STRUCTURES.

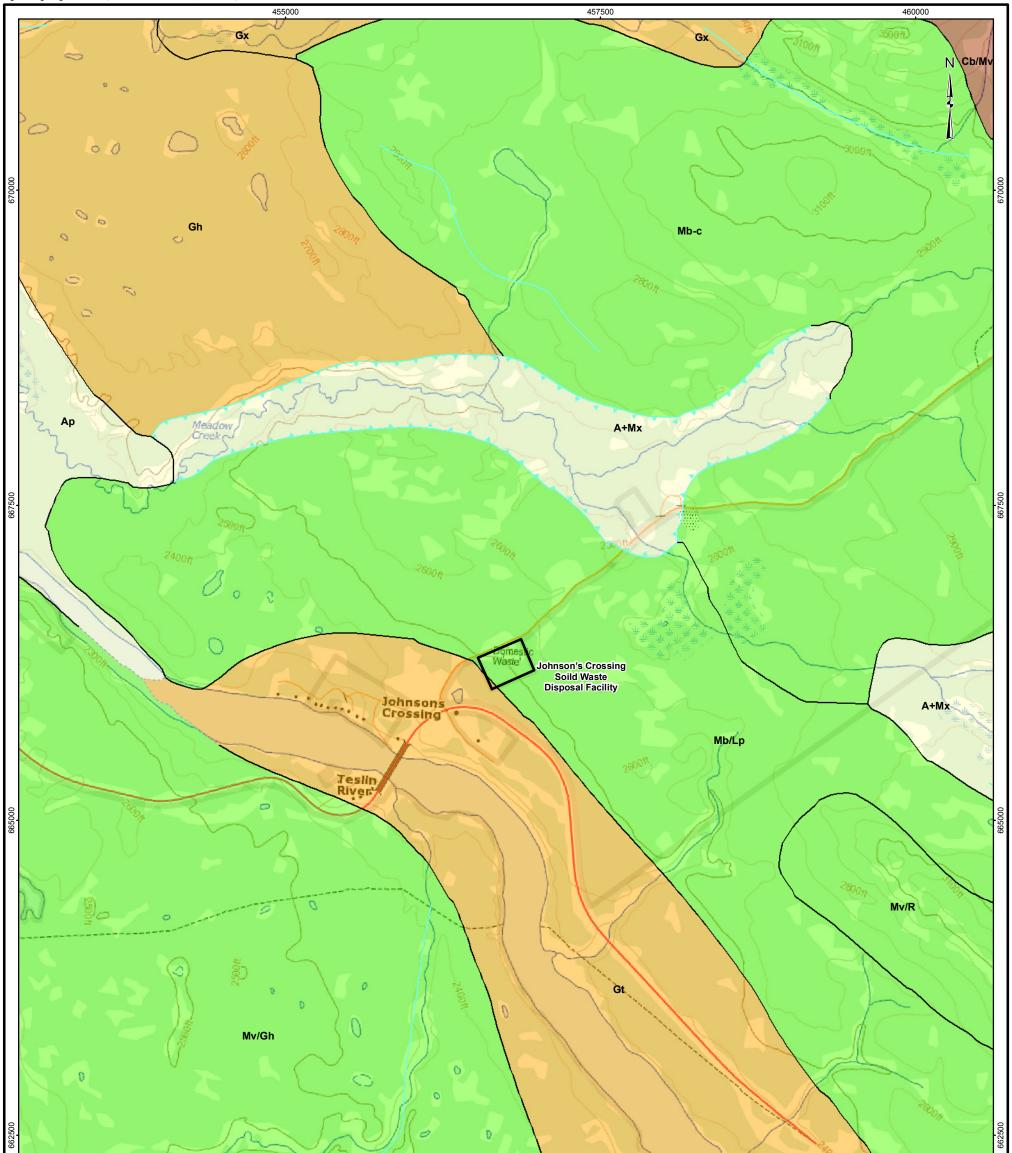
The Johnson's Crossing area is mapped as being underlain primarily by till, colluvium, and glaciofluvial outwash sediments of Quaternary origin, with modern lacustrine and fluvial sediments at lower elevations associated with the Teslin River and Teslin Lake. Ablation till, colluvial glacial debris, morainal deposits, and bedrock exposures are found at higher elevations in the mountains to the surrounding the Site.

LANDF	ORM OR LANDSCAPE	
		NATURE OF MATERIAL AND ESTIMATED THICKNESS	ORIGIN	TOPOGRAPHY	
	Gt	Gravel, sand and silt; 5 to 20 m thick	Alluvial Terraces	Gently irregular or nearly flat surfaces	
	Lp	Clay, silt, and sand; 5 to 10 m thick	Lacustrine deposits	Gently irregular or nearly flat surfaces with marked slope towards valley bottom	
	A+Mx	Gravel, sand, silt, and till; thickness variable	Valley Bottom pomplex of alluvial, colluvial, and glacial deposits	Nearly flat to strongly irregular terrain with relief to 30 m	
	Mb	Till; silty to sandy matrix; 1to 30 m thick	Lodgement and ablation till	Gently irregular to strongly irregular bedrock controlled topography blanketed by till.	
EGEND		455000	457500	460000	
	LITY DING OR ROAD			SCALE 1:30,000 KILOMETRES	
WATERCOURSE YUKON GOVERNMENT - COMMUNITY SERVIC SOLID WASTE DISPOSAL FACILITY				YUKON GOVERNMENT - COMMUNITY SERVICES	
REFERENCE MASEDATA OBTAINED FROM GEOGRATIS (NATURAL RESOURCES CANADA). SURFICIAL GEOLOGY DATA OBTAINED FROM THE YUKON OVERNMENT, ENERGY, MINES AND RESOUCES. MATUM: NAD83 PROJECTION: ALBERS			S AND RESOUCES.	Golder Greater Vancouver Office, B.C.

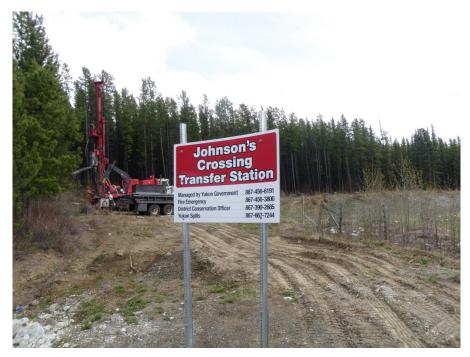
Photograph 1: A view of the north corner of the Site during installation of JC-MW12-01; taken from the access road.

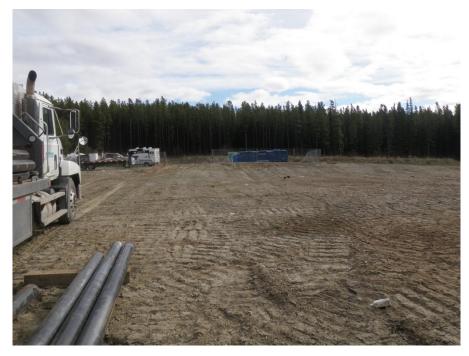
Photograph 2: A vew from the southwest edge of the Facility looking northeast, across the closed garbage trench and bridge concrete waste pit, at the present day waste transfer facility.

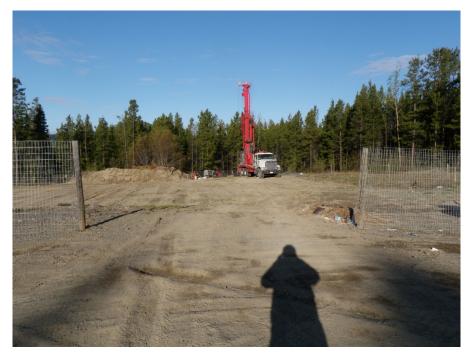
Photograph 3: A view of the west corner of the Site during the installation of JC-MW12-02; taken from the waste transfer facility in the center of the Site.

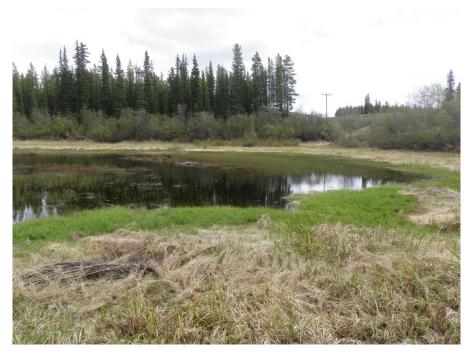
Photograph 4: Pond from which the downgradient water sample was taken.

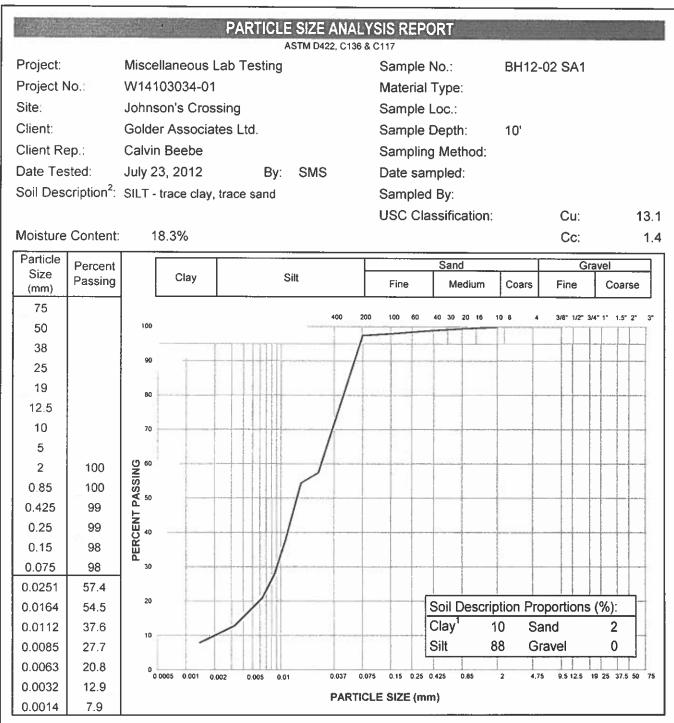
- Hydraulic conductivity of the surficial aquifer at the Site was calculated using a grain size analysis performed on cuttings taken during drilling to be between  $2 \times 10^{-4}$  and  $1 \times 10^{-3}$  (m/s);

Notes: <sup>1</sup> The upper clay size of 2 um, per the Canadian Foundation Engineering Manual <sup>2</sup> The description is visually based & subject to EBA description protocols
