20.0 BUILDING 3186: DESTRUCTION BAY GRADER STATION 20.1 Description of Existing Water Supply System

Western Region – Destruction Bay Grader Station Building # 3186

SMALL PUBLIC WATER SYSTEM ASSESSMENT

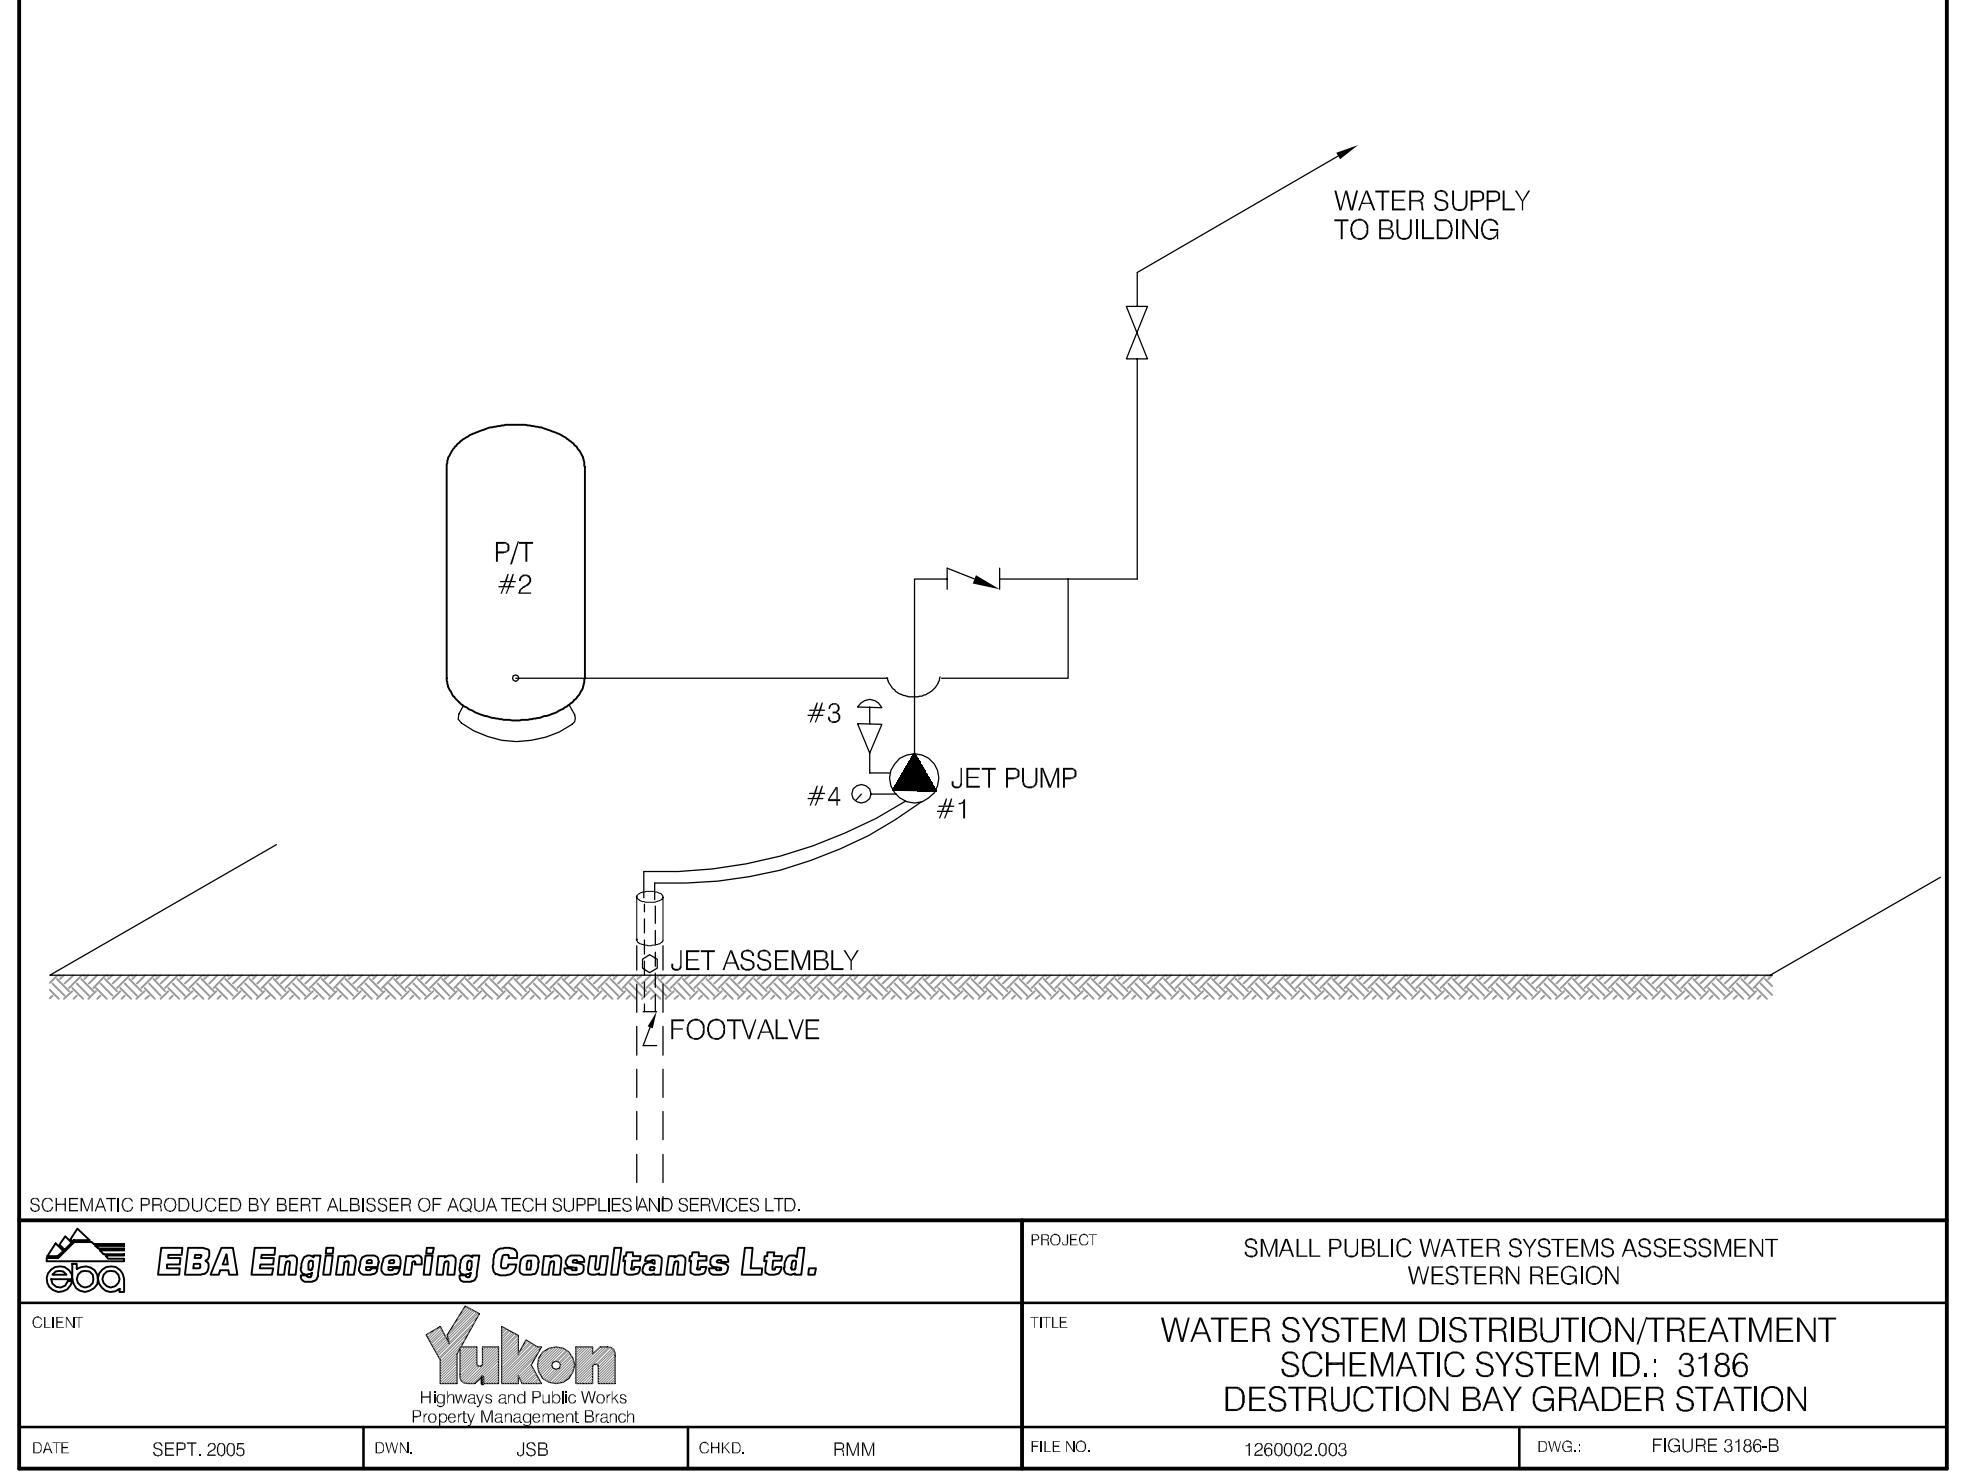
There is no treatment or disinfection system for the water supplying this system. There is a sign posted in the washroom stating "Contaminated Water, Do Not Consume" and it appeared that bottled water is provided. A schematic detailing the well supply system is provided as Figure 3186-B in Appendix A20.
