## **17.0 BUILDINGS M0064 AND M0094 CARMACKS RCMP HOUSING**

SMALL PUBLIC WATER SYSTEMS ASSESSMENT  
 WHITEHORSE REGION

## SMALL PUBLIC WATER SYSTEM ASSESSMENT

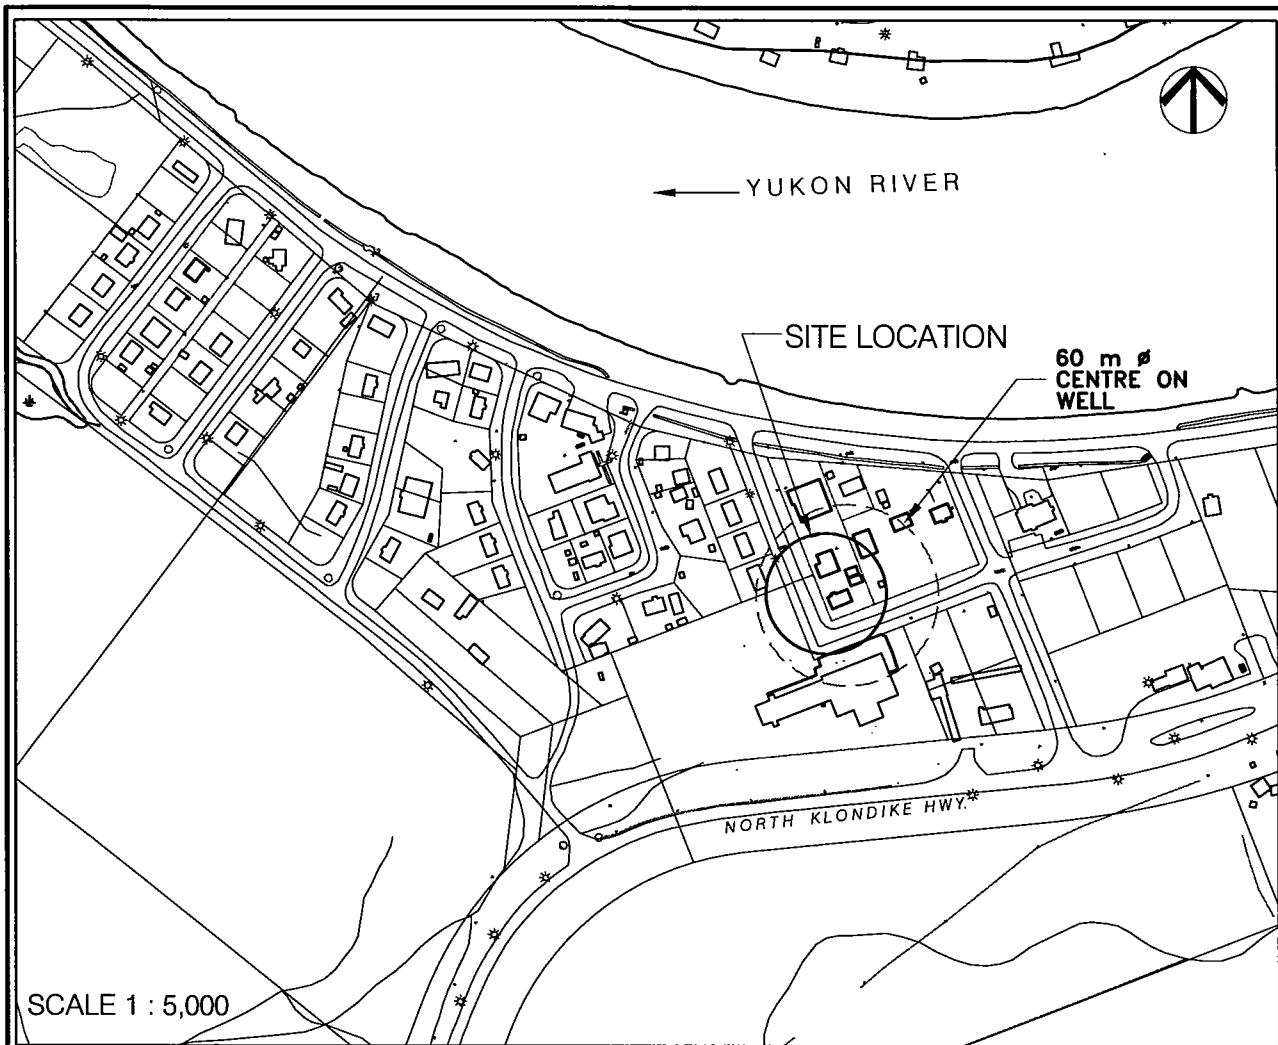
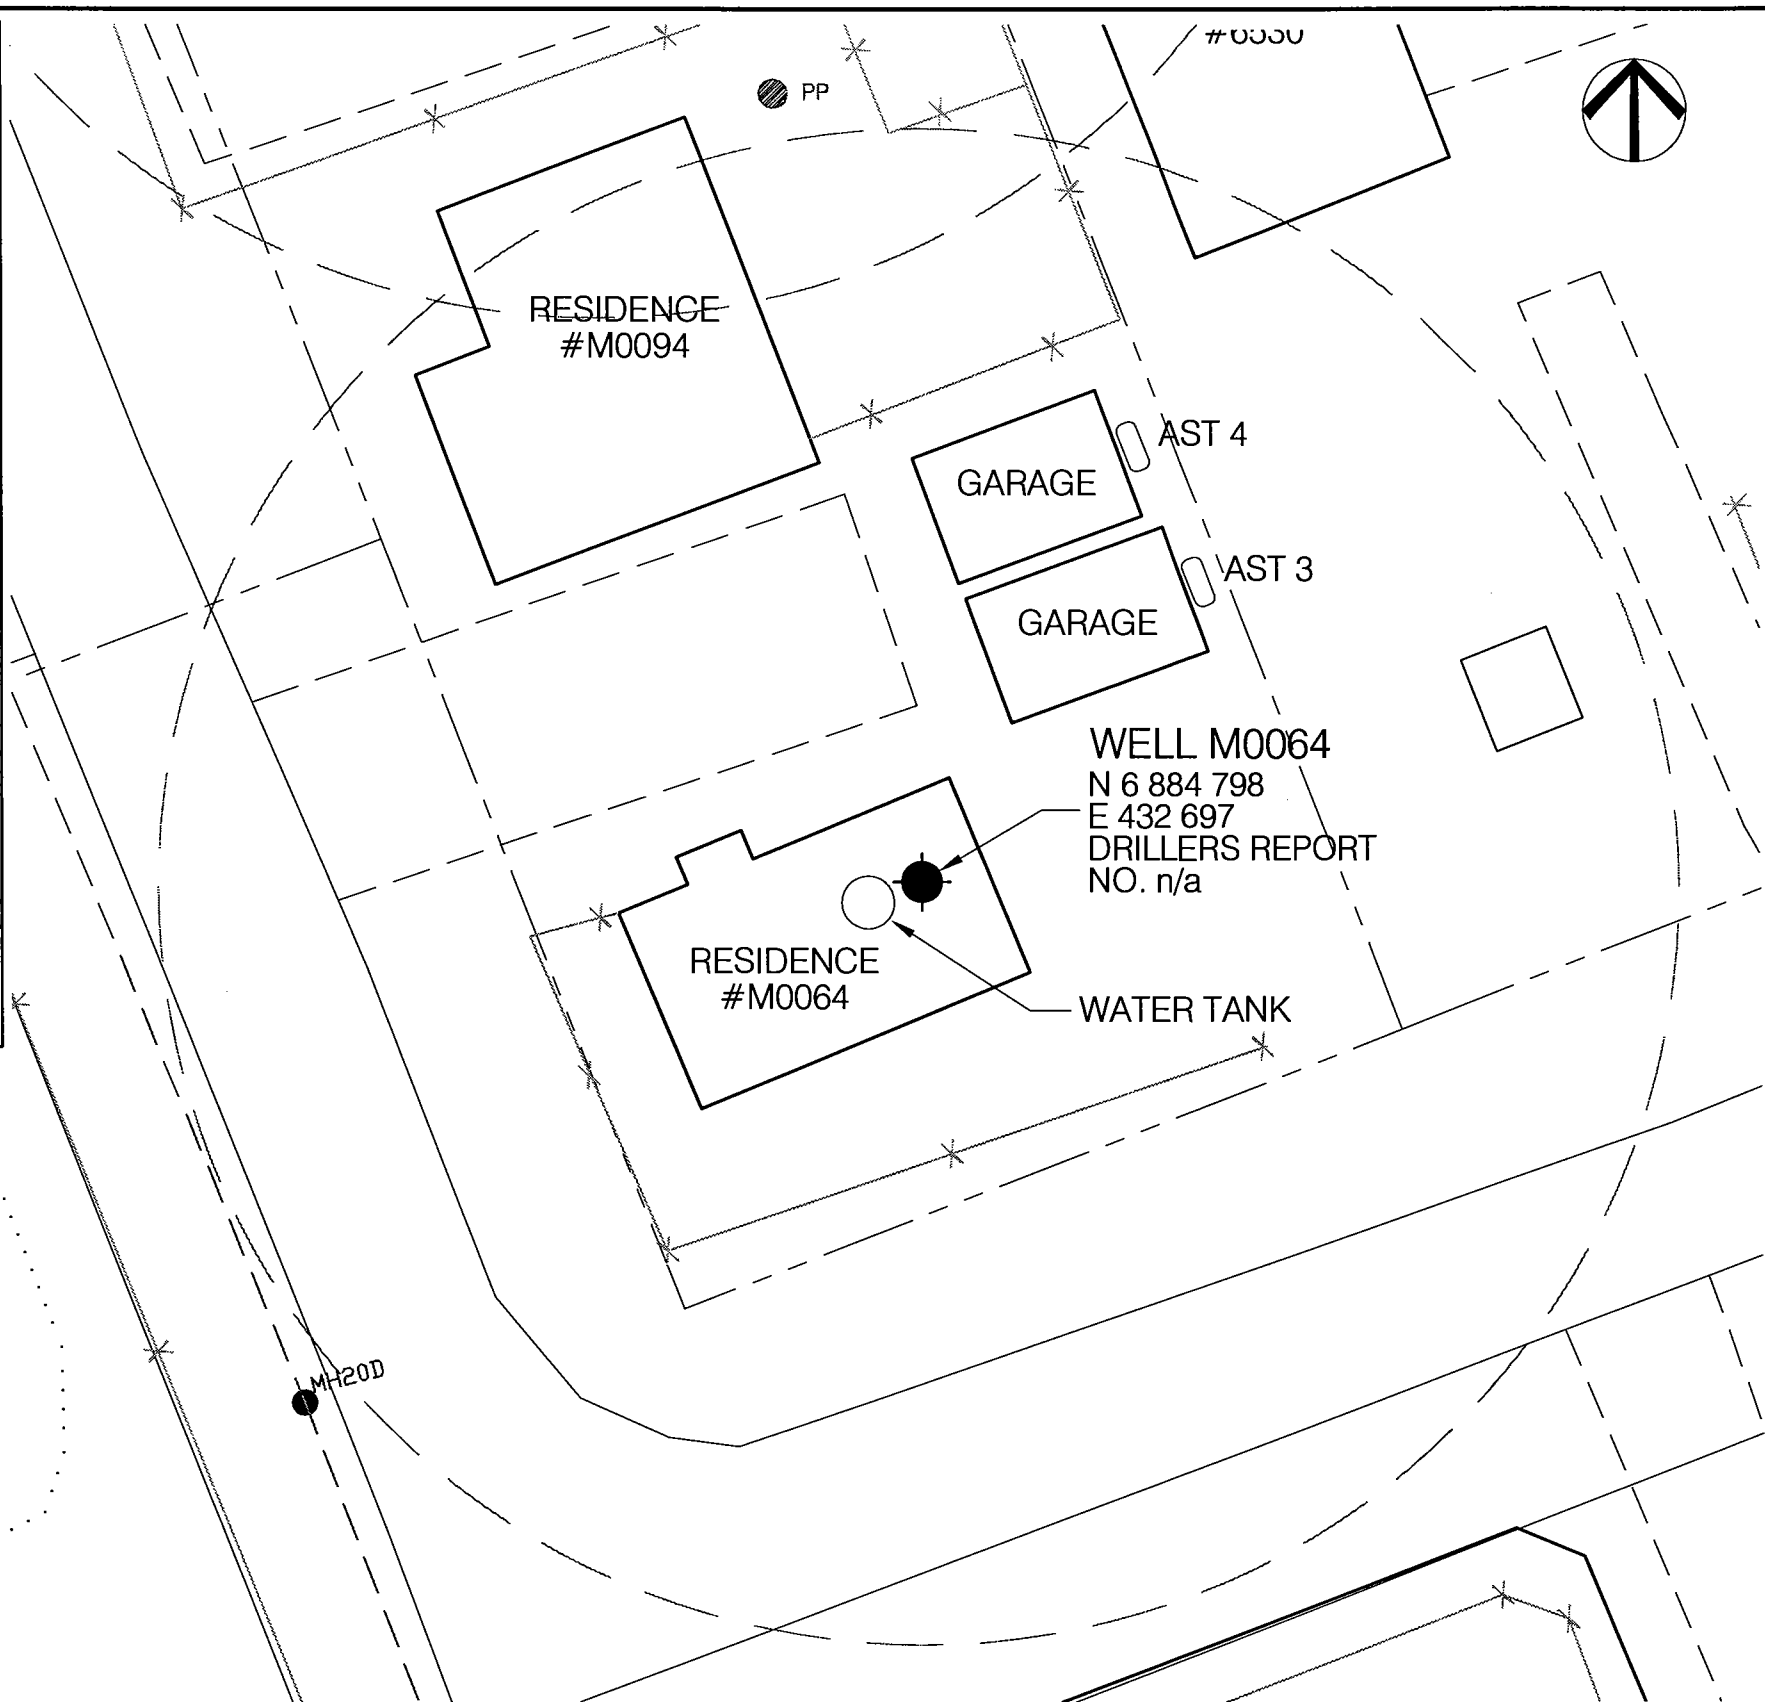
DRAWING No.  
 FIGURE M0064A

Both R.C.M.P. residences use a public sewage system provided by the Village of Carmacks. There is; however, a sewer service line that is located within 15 m of the wellhead. The sewage mains are located laterally and likely also upgradient from the well.

30 m RADIUS FROM WATER WELL FOR CONSIDERATION OF PROXIMITY TO POTENTIAL CONTAMINANT SOURCES.

- Secondary containment should be provided for the two above ground fuel storage tanks that are approximately 18 m from the well. Alternatively, they could be replaced with double walled fuel storage tanks to mitigate any potential contamination of the well;
