5.0 BUILDINGS M0156, M0226: PELLY CROSSING RCMP DETACHMENT AND RESIDENCE

PROJECT SMALL PUBLIC WATER SYSTEMS ASSESSMENT
WESTERN REGION

SMALL PUBLIC WATER SYSTEM ASSESSMENT

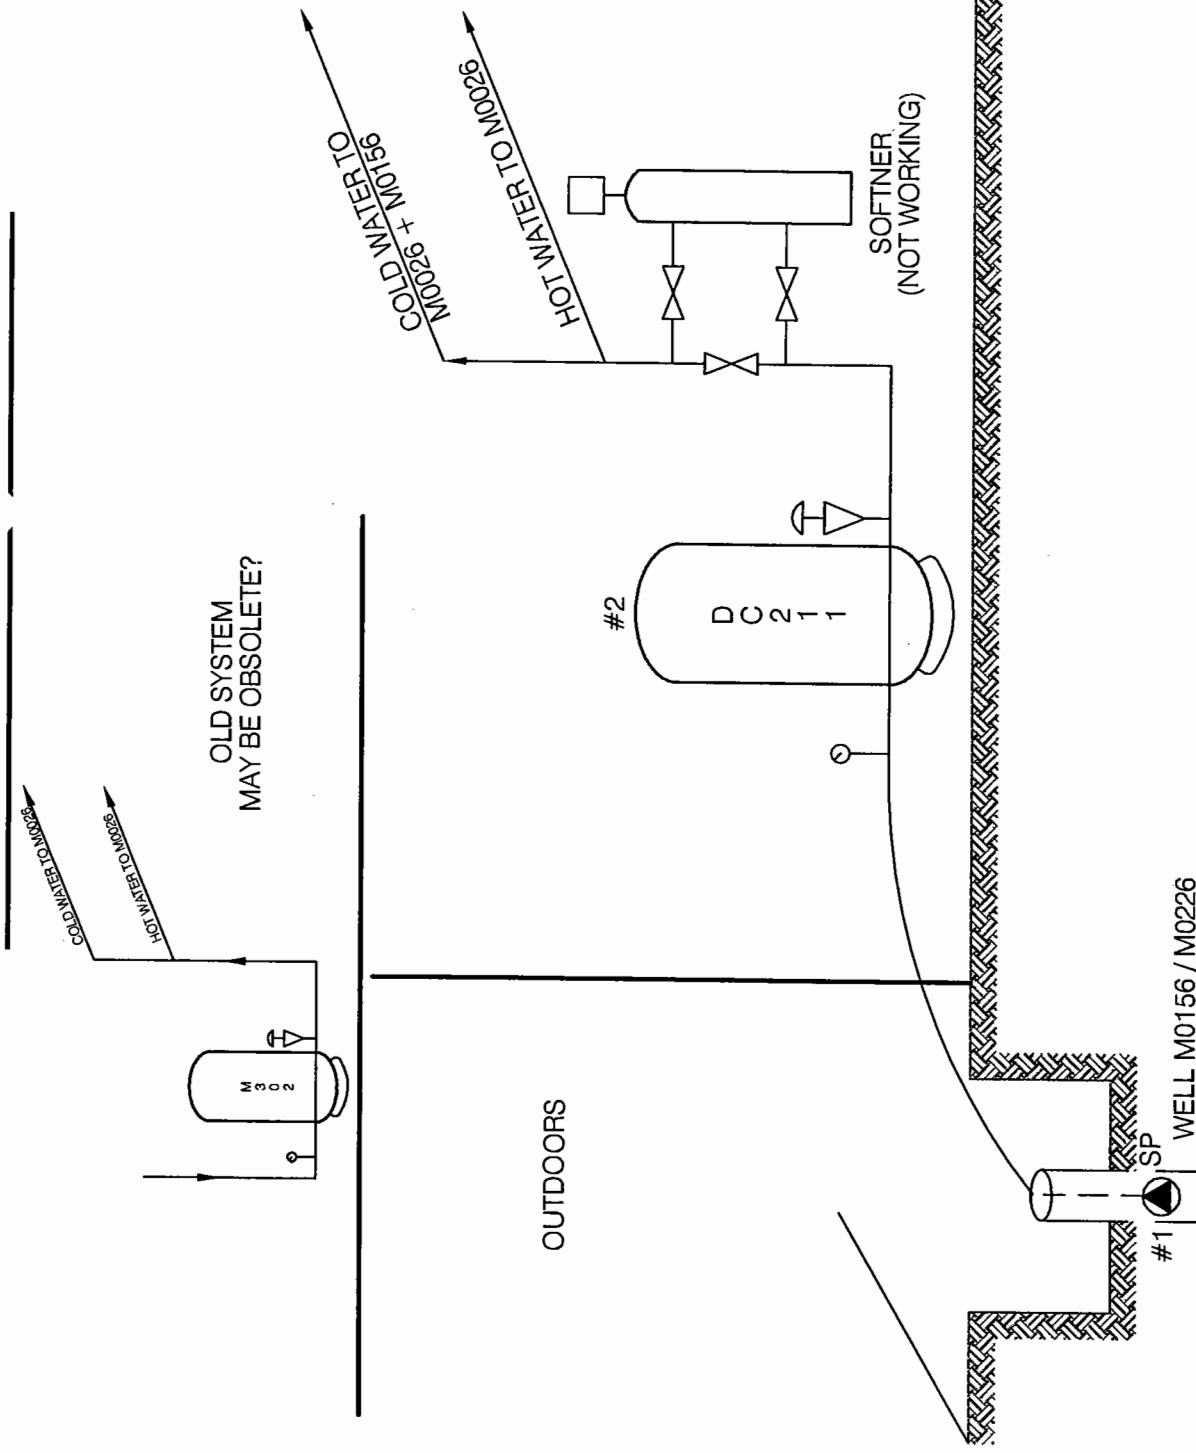
Water is piped from the well to residence M0226 and then it is piped underground to the detachment. The system is equipped with a water softener that was not functioning at the time of system assessment. A schematic detailing the water supply system is provided as Figure M0156/M0226-B in Appendix A5. Photos of the well and water system are also included at the back of this appendix.
