4.0 BUILDINGS M0026, M0227: PELLY CROSSING RCMP RESIDENCES

4.1 Description of Existing Water Supply System

SMALL PUBLIC WATER SYSTEMS ASSESSMENT
 NORTHERN REGION

PELLY RCMP
 BUILDING # M0227 & M0026
 SITE LOCATION DIAGRAM
 WELL ID: M0026/M0227

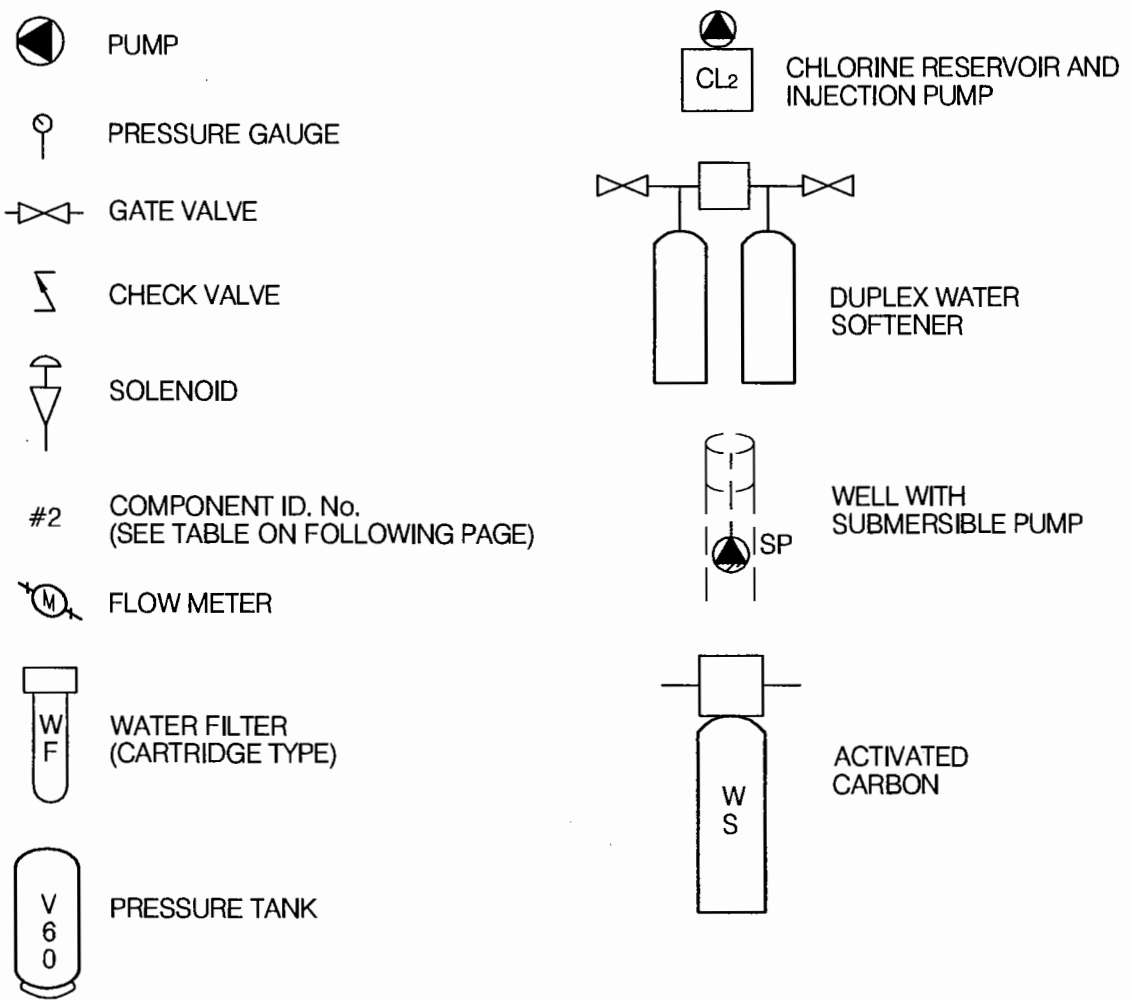
FIGURE No.
 FIGURE M0026
 /M0227-A

Water systems for Building M0026 and Building M0227, Pelly Crossing RCMP Residences are supplied by a central well located in a pit below grade approximately 4 m east of residence M0026. A site plan is provided as Figure M0026-A in Appendix A4. The coordinates of the wellhead, as measured by a handheld GPS device, were recorded as:

Each residence is served by in-ground septic disposal systems. As shown on Figure M0026-A, the septic system for residence M0227 is located greater than 30 m east of the building and likely crossgradient from the well. The septic system for residence M0026 is located on the west side of the building and septic effluent discharge likely begins approximately 25 m away and crossgradient from the well.
