9.0 BUILDING 3100: NELNAH BESSIE JOHN SCHOOL

SMALL PUBLIC WATER SYSTEMS ASSESSMENT
 WESTERN REGION

NELNAH BESSIE JOHN SCHOOL
 BUILDING # 3100
 SITE LOCATION DIAGRAM
 WELL ID: 3100A

SMALL PUBLIC WATER SYSTEM ASSESSMENT

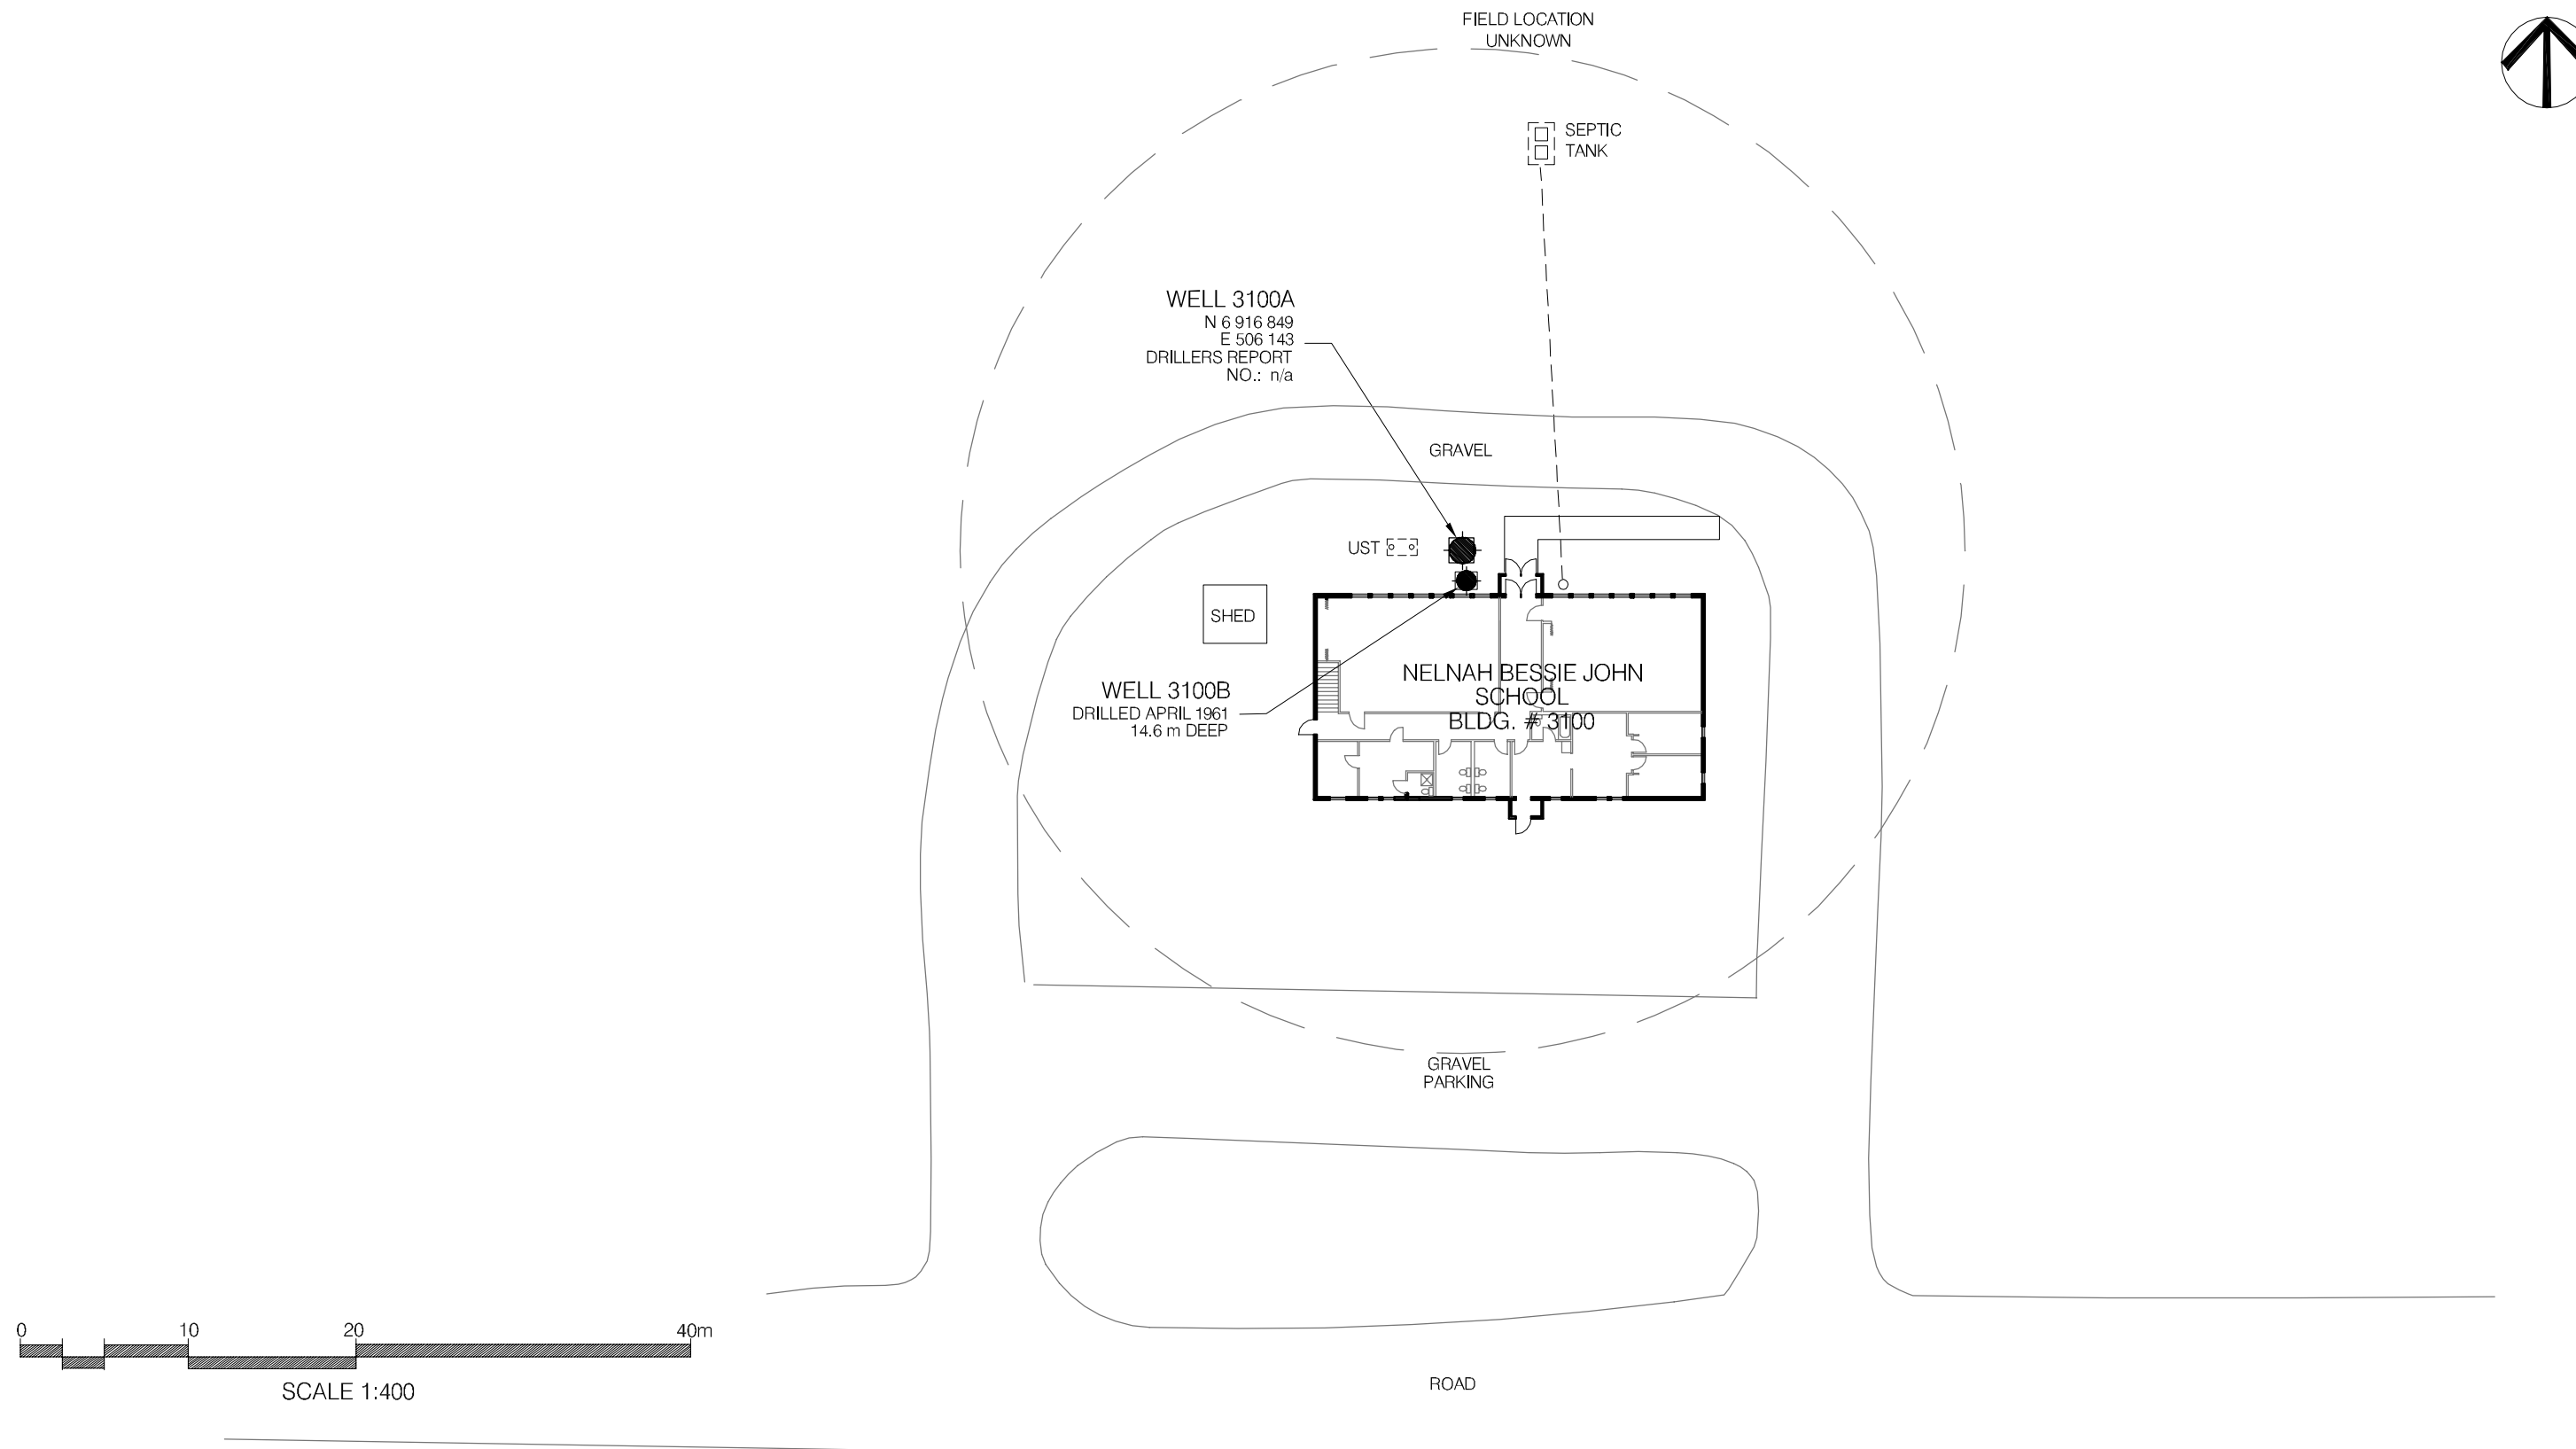
FIGURE No.
 FIGURE 3100-A

The school's septic tank is located approximately 22 m north of the well on the north side of the school as indicated in Figure 3440-A. The location of the septic effluent discharge field is unknown but it is likely located north of the tank. The location of the septic disposal system should be confirmed prior to making final decisions regarding water supply system upgrades.

- There is an open, abandoned well located approximately 1 m from the current well;
- The septic tank is located approximately 22 m from the well, and although the exact location of the septic field is unknown, it may be within 30 m;
- There is no well log available to review well construction and/or lithology;
- The pellet chlorination system on the wellhead has not been properly installed. It was observed that a large number of the chlorine pellets do not drop into the well but fall into well pit instead;
- Field chemistry reported that the residual chlorine concentration was 0.07 mg/L, below the required minimum of 0.2 mg/L; and,
- The configuration of the treatment system does not meet current standards.

Priority 2 recommended upgrades include the removal of the UST located adjacent to the well. The UST should be replaced with a double walled above ground storage tank (AST) located at a safe distance from the well. Observations should be made and confirmatory sampling completed to confirm whether the existence of the UST has impacted soils in the vicinity of the tank, which could ultimately impact on the groundwater and water quality.

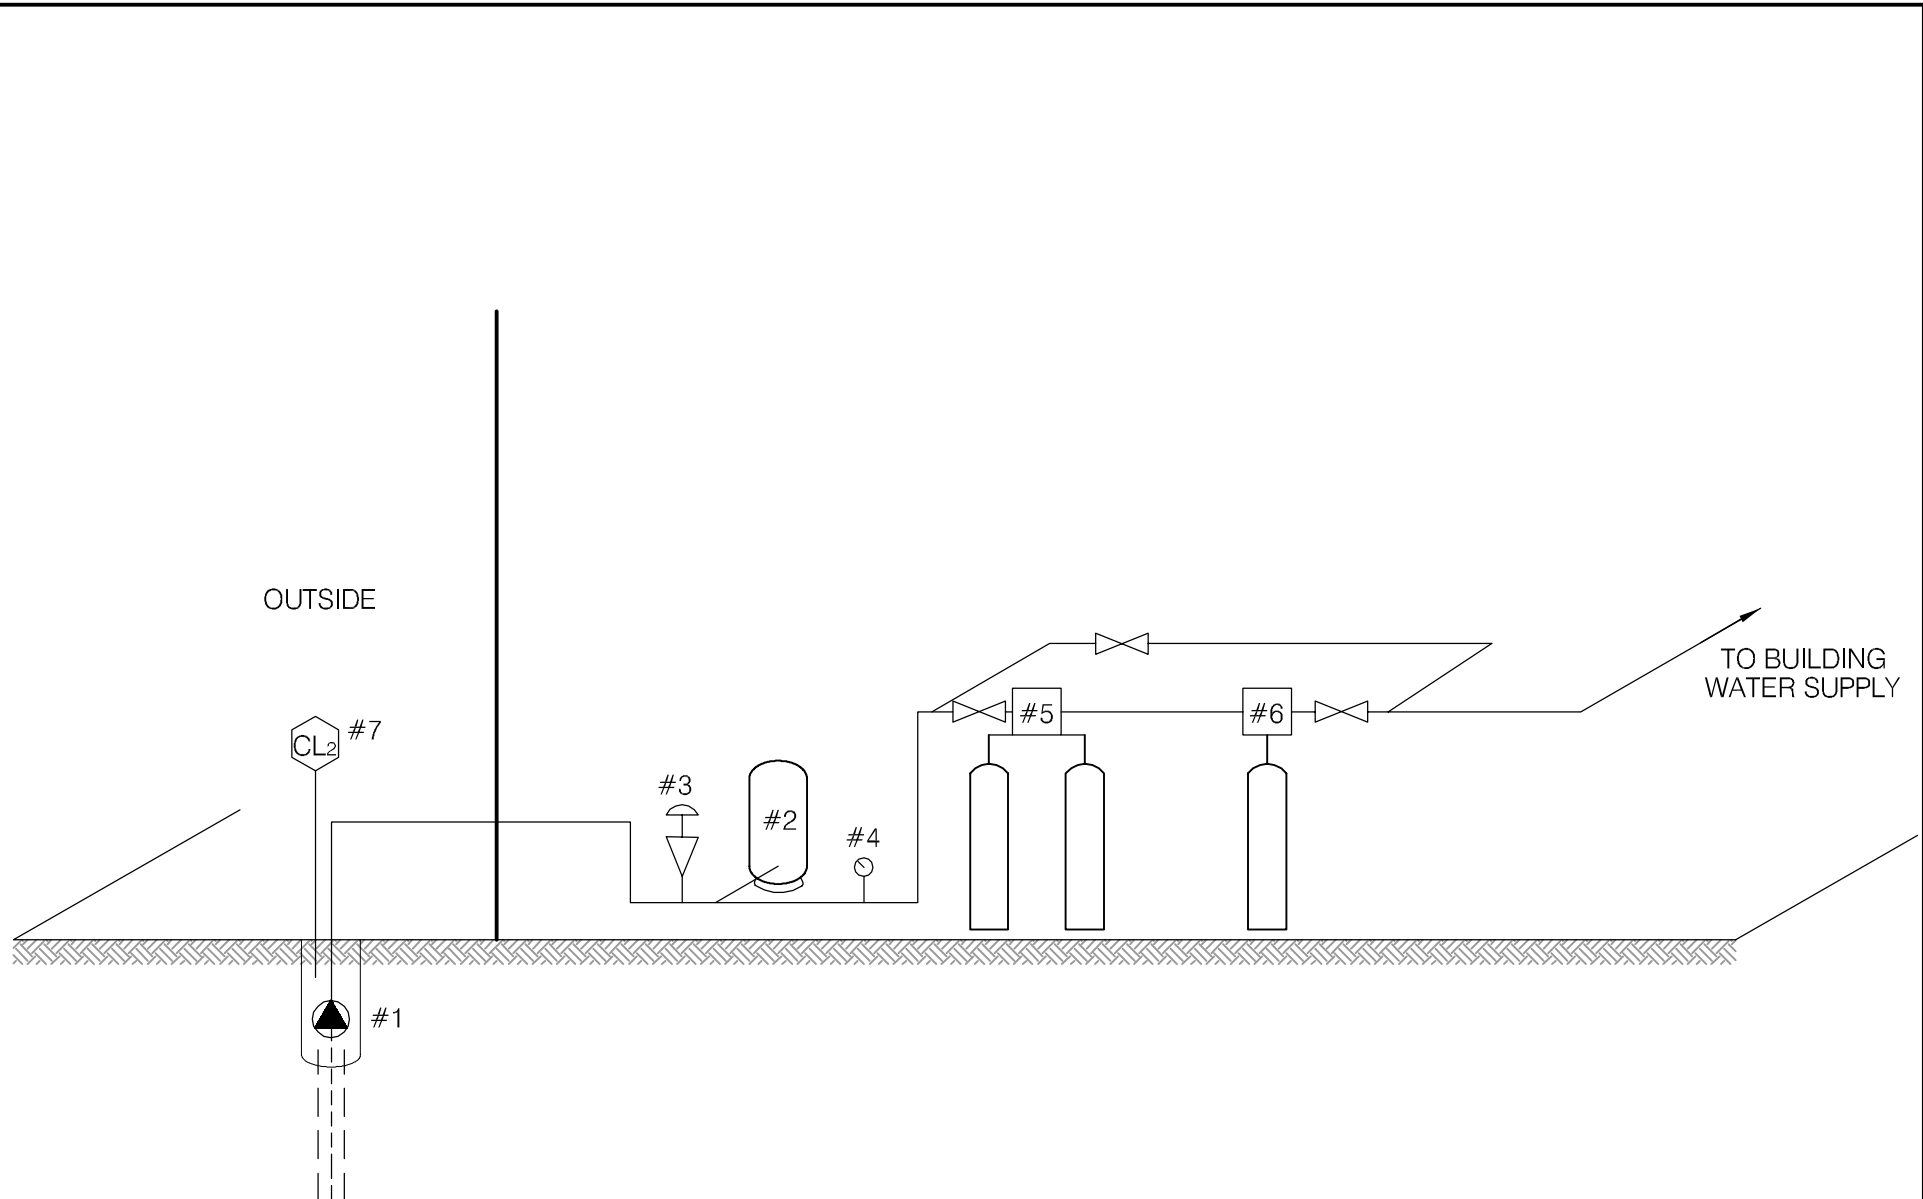
Yukon Highways and Public Works Property Management Branch		TITLE WATER SYSTEM DISTRIBUTION/TREATMENT SCHEMATIC SYSTEM ID.: 3100 BESSIE JOHN SCHOOL - BEAVER CREEK							
DATE	SEPT. 2005	DWN.	JSB	CHKD.	FMM	FILE NO.	1260002.003	DWG.:	FIGURE 3100-B

The water system is equipped with a pellet chlorinator that is installed on the wellhead, however, at the time of the assessment, it was not functioning properly as it was discharging some pellets into the wellhead enclosure (some appeared to be discharging into the well as designed). This water system is also equipped with a water softener and an activated carbon filter for treatment. Field chemistry completed during the water system assessment indicated that the residual chlorine concentration was approximately 0.07 mg/L.

There is an abandoned well located approximately 1 m from the current well. The abandoned well did not have a proper cap.
