7.0 BUILDING M0133: BEAVER CREEK RCMP RESIDENCE

SMALL PUBLIC WATER SYSTEMS ASSESSMENT
WESTERN REGION

BEAVER CREEK RCMP
RESIDENCE BUILDING # M0133
SITE LOCATION DIAGRAM
WELL ID: M0133

SMALL PUBLIC WATER SYSTEM ASSESSMENT

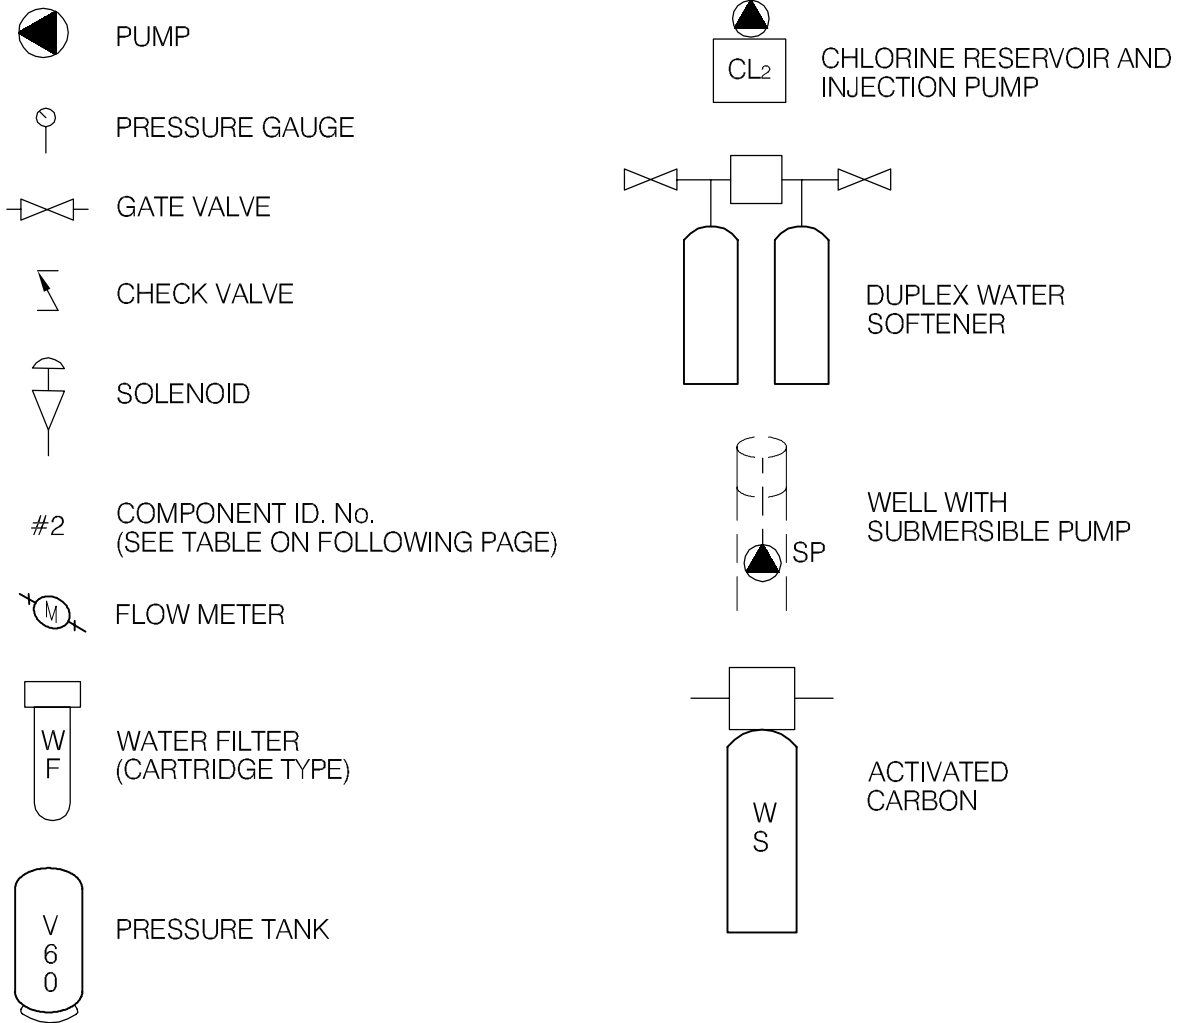
FIGURE No.
FIGURE M0133-A

The septic tank that serves the residence is located approximately 20 m west of the well, and the septic effluent discharge field is located approximately 40 m down slope from the well. Although the effluent field is downslope from the well, conceptual hydrogeology (outlined in a following section) indicates that it may be hydraulically upgradient. A site plan showing the septic system is given by Figure M0133-A in Appendix A7.
