### **13.0 BUILDING 3123: BEAVER CREEK GRADER STATION**

SMALL PUBLIC WATER SYSTEMS ASSESSMENT  
WESTERN REGION

## SMALL PUBLIC WATER SYSTEM ASSESSMENT

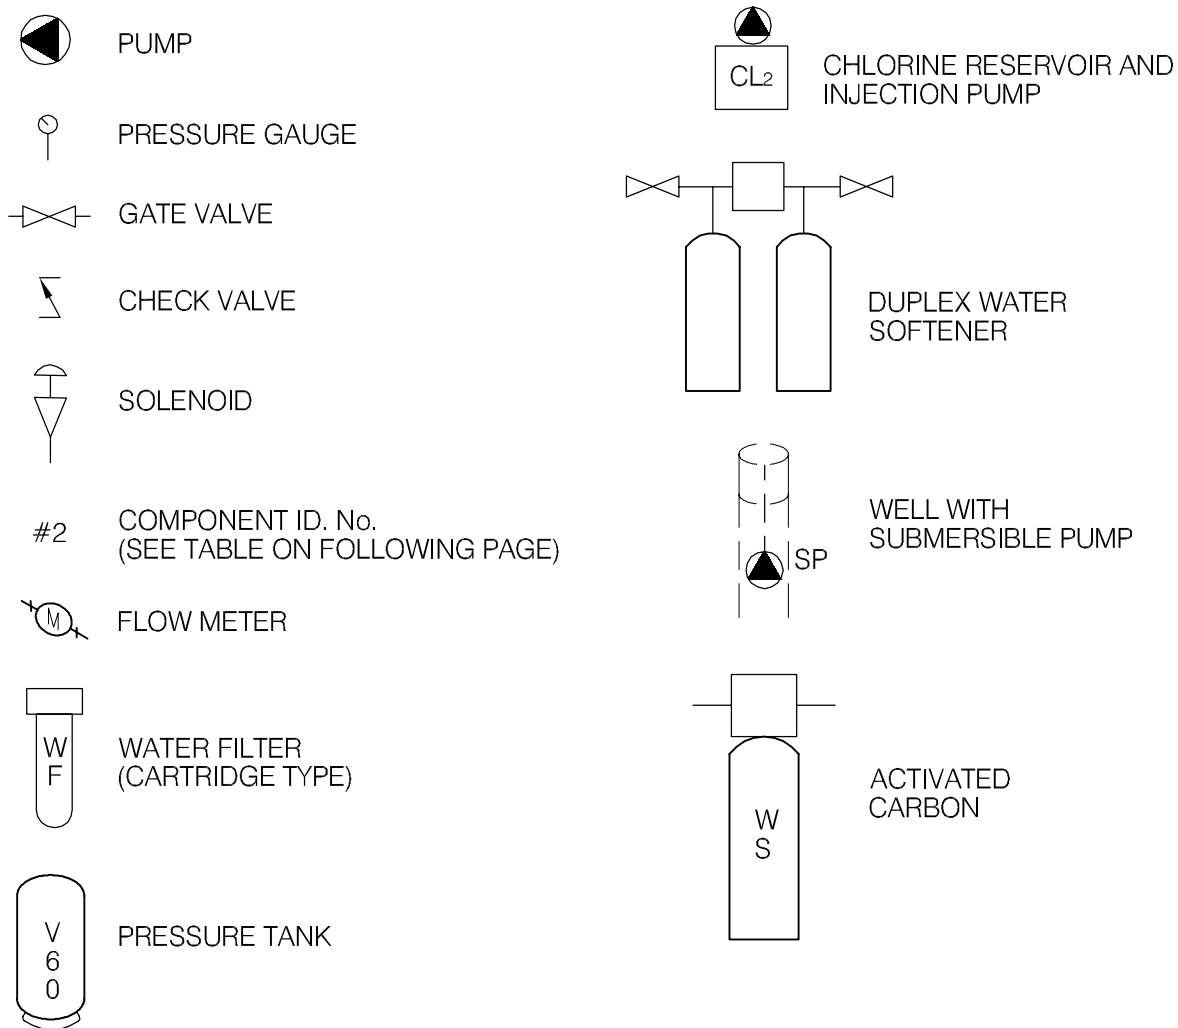
REVISION ISSUE  
0  
FIGURE No.  
FIGURE 3123-A

There is a septic tank present at the southeast corner of the building approximately 20 m from the well. Septic effluent is discharged to an in ground disposal field south of the tank approximately 34 m from the well and potentially upgradient of the well. There is a rock pit that is used to drain the garage sumps located approximately 34 m south that is also potentially up gradient from the well. There is also an old abandoned septic tank and field approximately 22 m north and likely downgradient from the well. A site plan showing the septic system is provided as Figure 3123-A in Appendix A13.
