19.0 BUILDING 4842: CASSIAR WEIGH SCALES

SMALL PUBLIC WATER SYSTEMS ASSESSMENT
EASTERN REGION

CASSIAR WEIGH SCALE
BUILDING # 4842
SITE LOCATION DIAGRAM
WELL ID: 4842-A

SMALL PUBLIC WATER SYSTEM ASSESSMENT

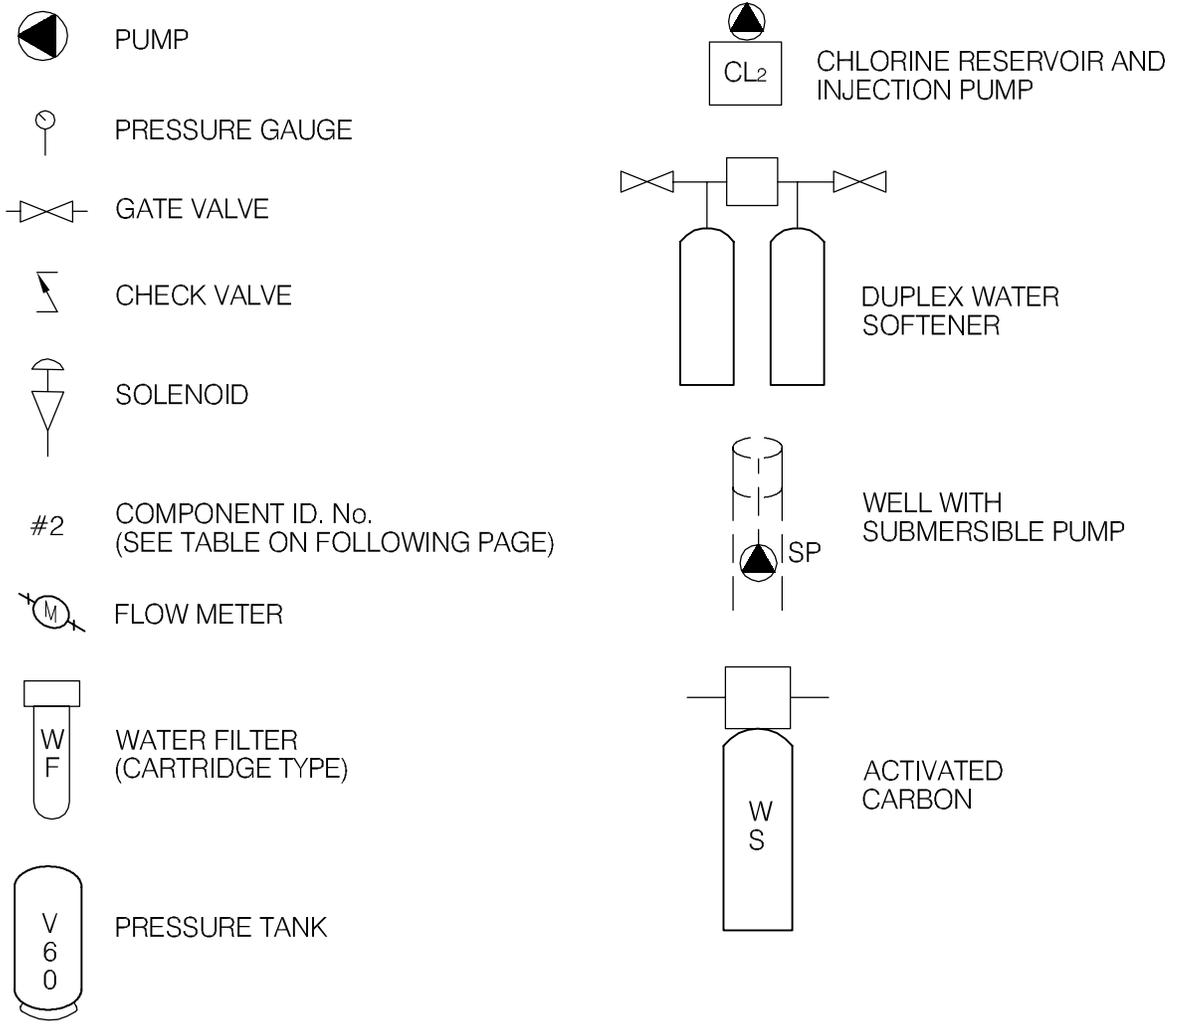
FIGURE No.
4842-A

The septic tank for the Cassiar Weigh Scales is located south of the weigh scales office on the opposite side of the well approximately 13 m away. Whether the septic tank is routinely pumped out, or discharges effluent to an inground sewage disposal field is unknown at this time. A site plan showing the septic system is given by Figure 4842-A in Appendix A19.

-
- Septic tank 13 m from the well (effluent field potentially within 30 m, however, this requires verification);
 - Above ground fuel storage tank 1 m from the well, and;
 - A drainage feature runs within 1 m of the well during wet periods, which may result in surface water infiltration to the well.

It should be noted that it was unclear whether there was a septic field at this site, or whether it was only a holding tank. An investigation should be carried out in order to determine if there is an actual effluent disposal field on the property and its proximity with respect to the well.
