20.0 BUILDING 4840: WATSON LAKE ENVIRONMENTAL OFFICE

SMALL PUBLIC WATER SYSTEMS ASSESSMENT
 EASTERN REGION

WATSON LAKE ENVIRONMENTAL
 BUILDING # 4840
 SITE LOCATION DIAGRAM
 WELL ID: 4840-A

TITLE WATER SYSTEM DISTRIBUTION/TREATMENT SCHEMATIC SYSTEM ID.: 4840 WATSON LAKE ENVIRONMENTAL OFFICE	
DATE	JULY 2005	DWN.	JSB
CHKD.	FMM	FILE NO.	1260002.002
		DWG.:	FIGURE 4840-B

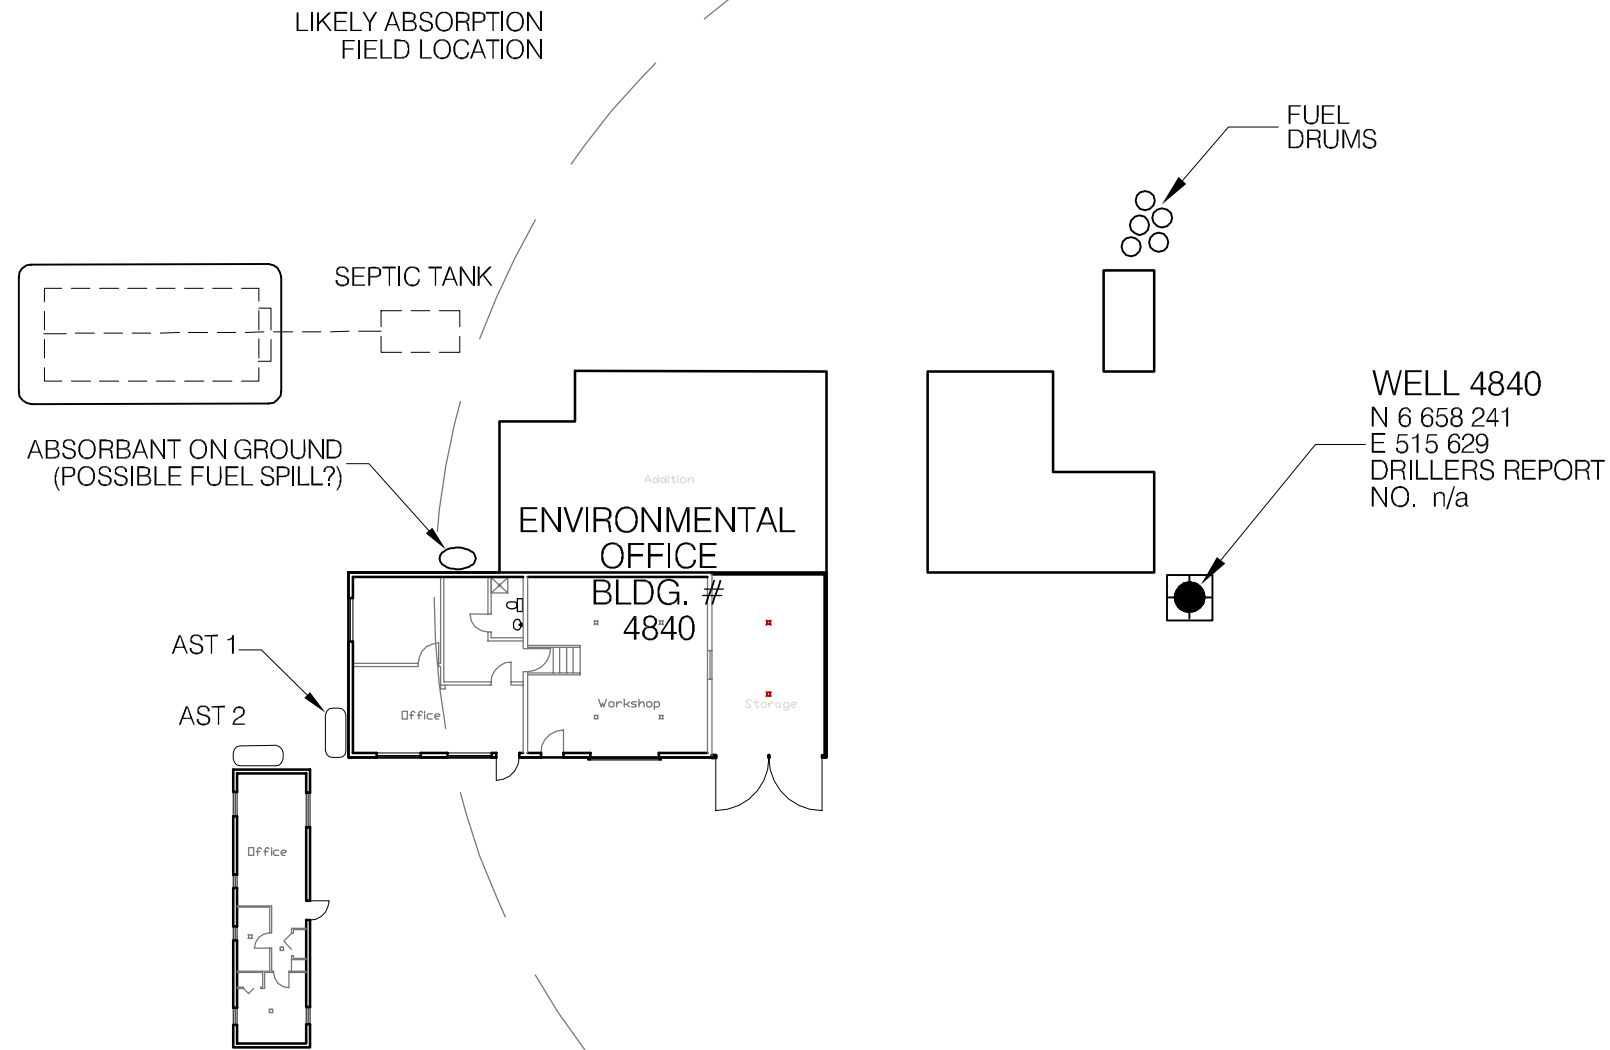
30 m RADIUS FROM WATER WELL FOR CONSIDERATION OF PROXIMITY TO POTENTIAL CONTAMINANT SOURCES.

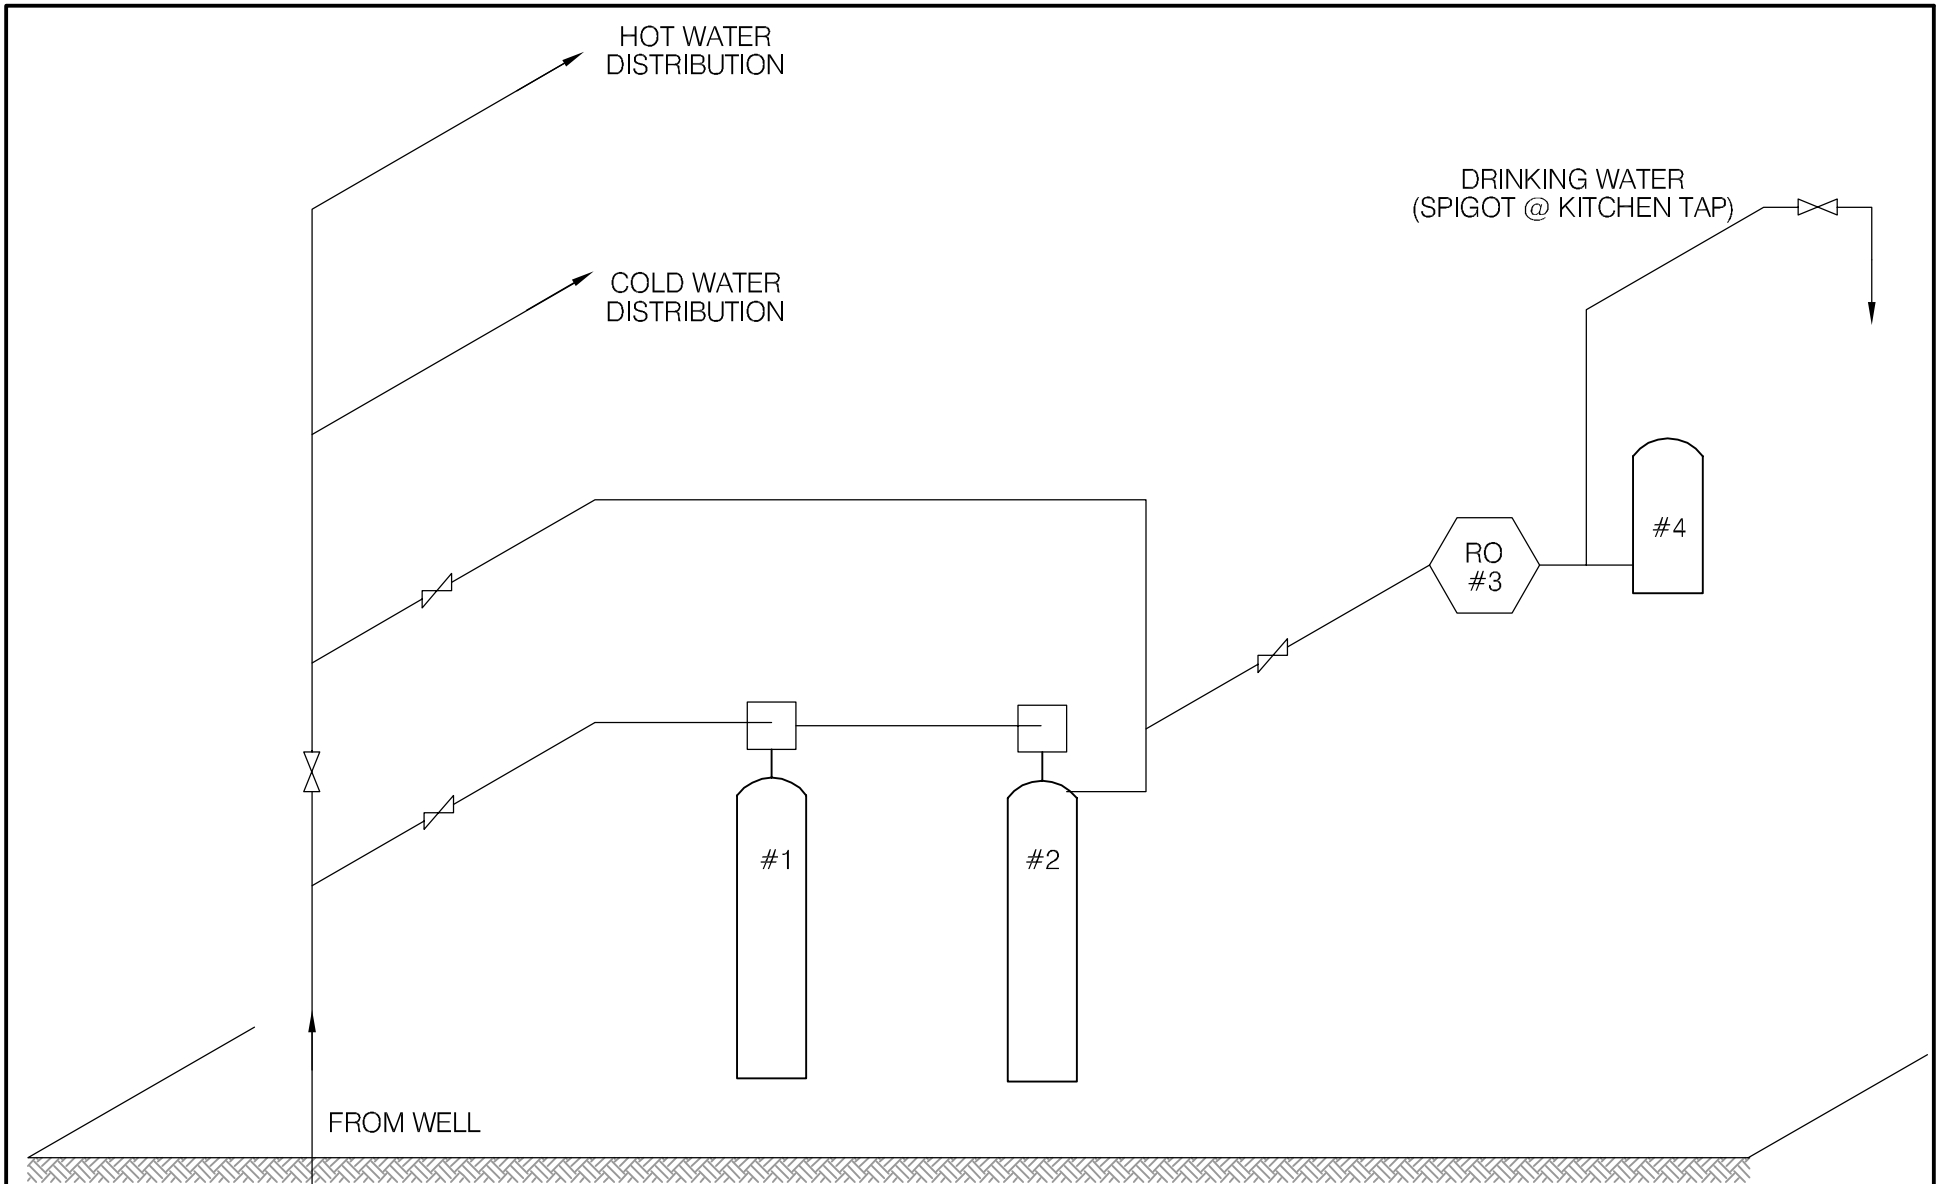
The water system is equipped with a sediment filter and a water softener, and there is also a reverse osmosis treatment system that supplies water to one tap in the office kitchen. A schematic detailing the well water system is available as Figure 4840-B in Appendix A20.
