## **22.0 BUILDING 4873: TUCHITUA PUMPHOUSE**

SMALL PUBLIC WATER SYSTEMS ASSESSMENT  
EASTERN REGION

TUCHITUA PUMPHOUSE  
BUILDING # 4873  
SITE LOCATION DIAGRAM  
WELL ID: 4873-A

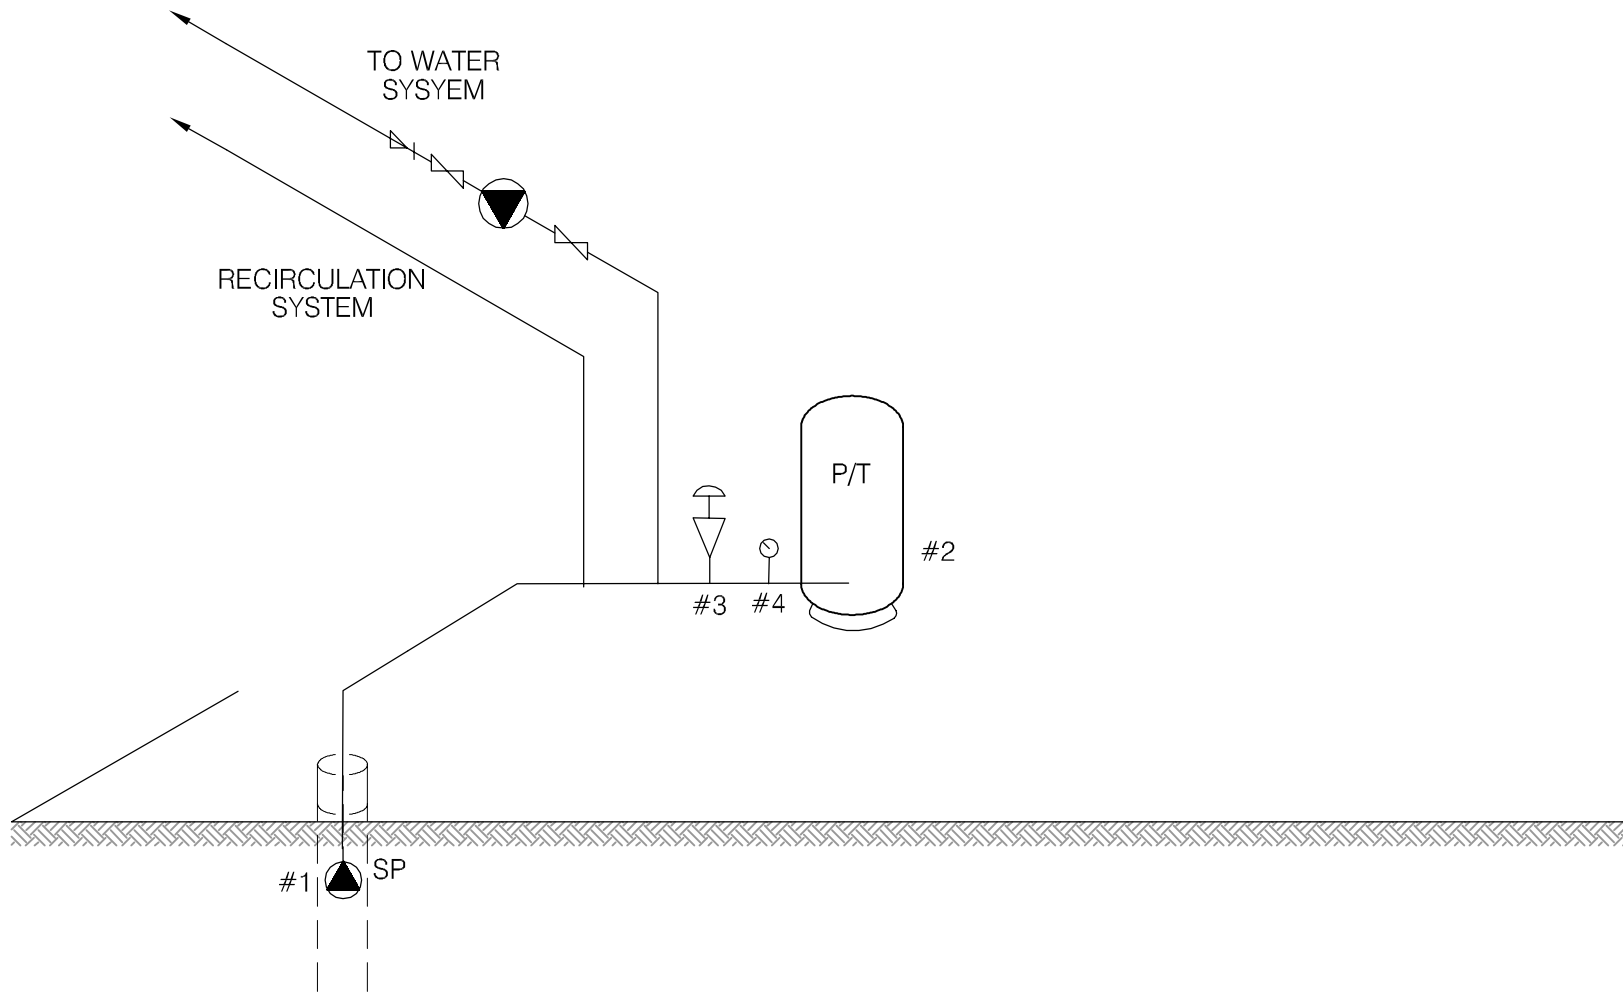
- The plumbing from the well was found during the site inspection to be in disrepair. The pressure tank is very old, and it as well as much of the piping was leaking.

SCHEMATIC PRODUCED BY BERT ALBISSER OF AQUA TECH SUPPLIES & SERVICES LTD.
