## **9.0 BUILDING 4793: SWIFT RIVER GRADER STATION**

SMALL PUBLIC WATER SYSTEMS ASSESSMENT  
 EASTERN REGION

## SMALL PUBLIC WATER SYSTEM ASSESSMENT

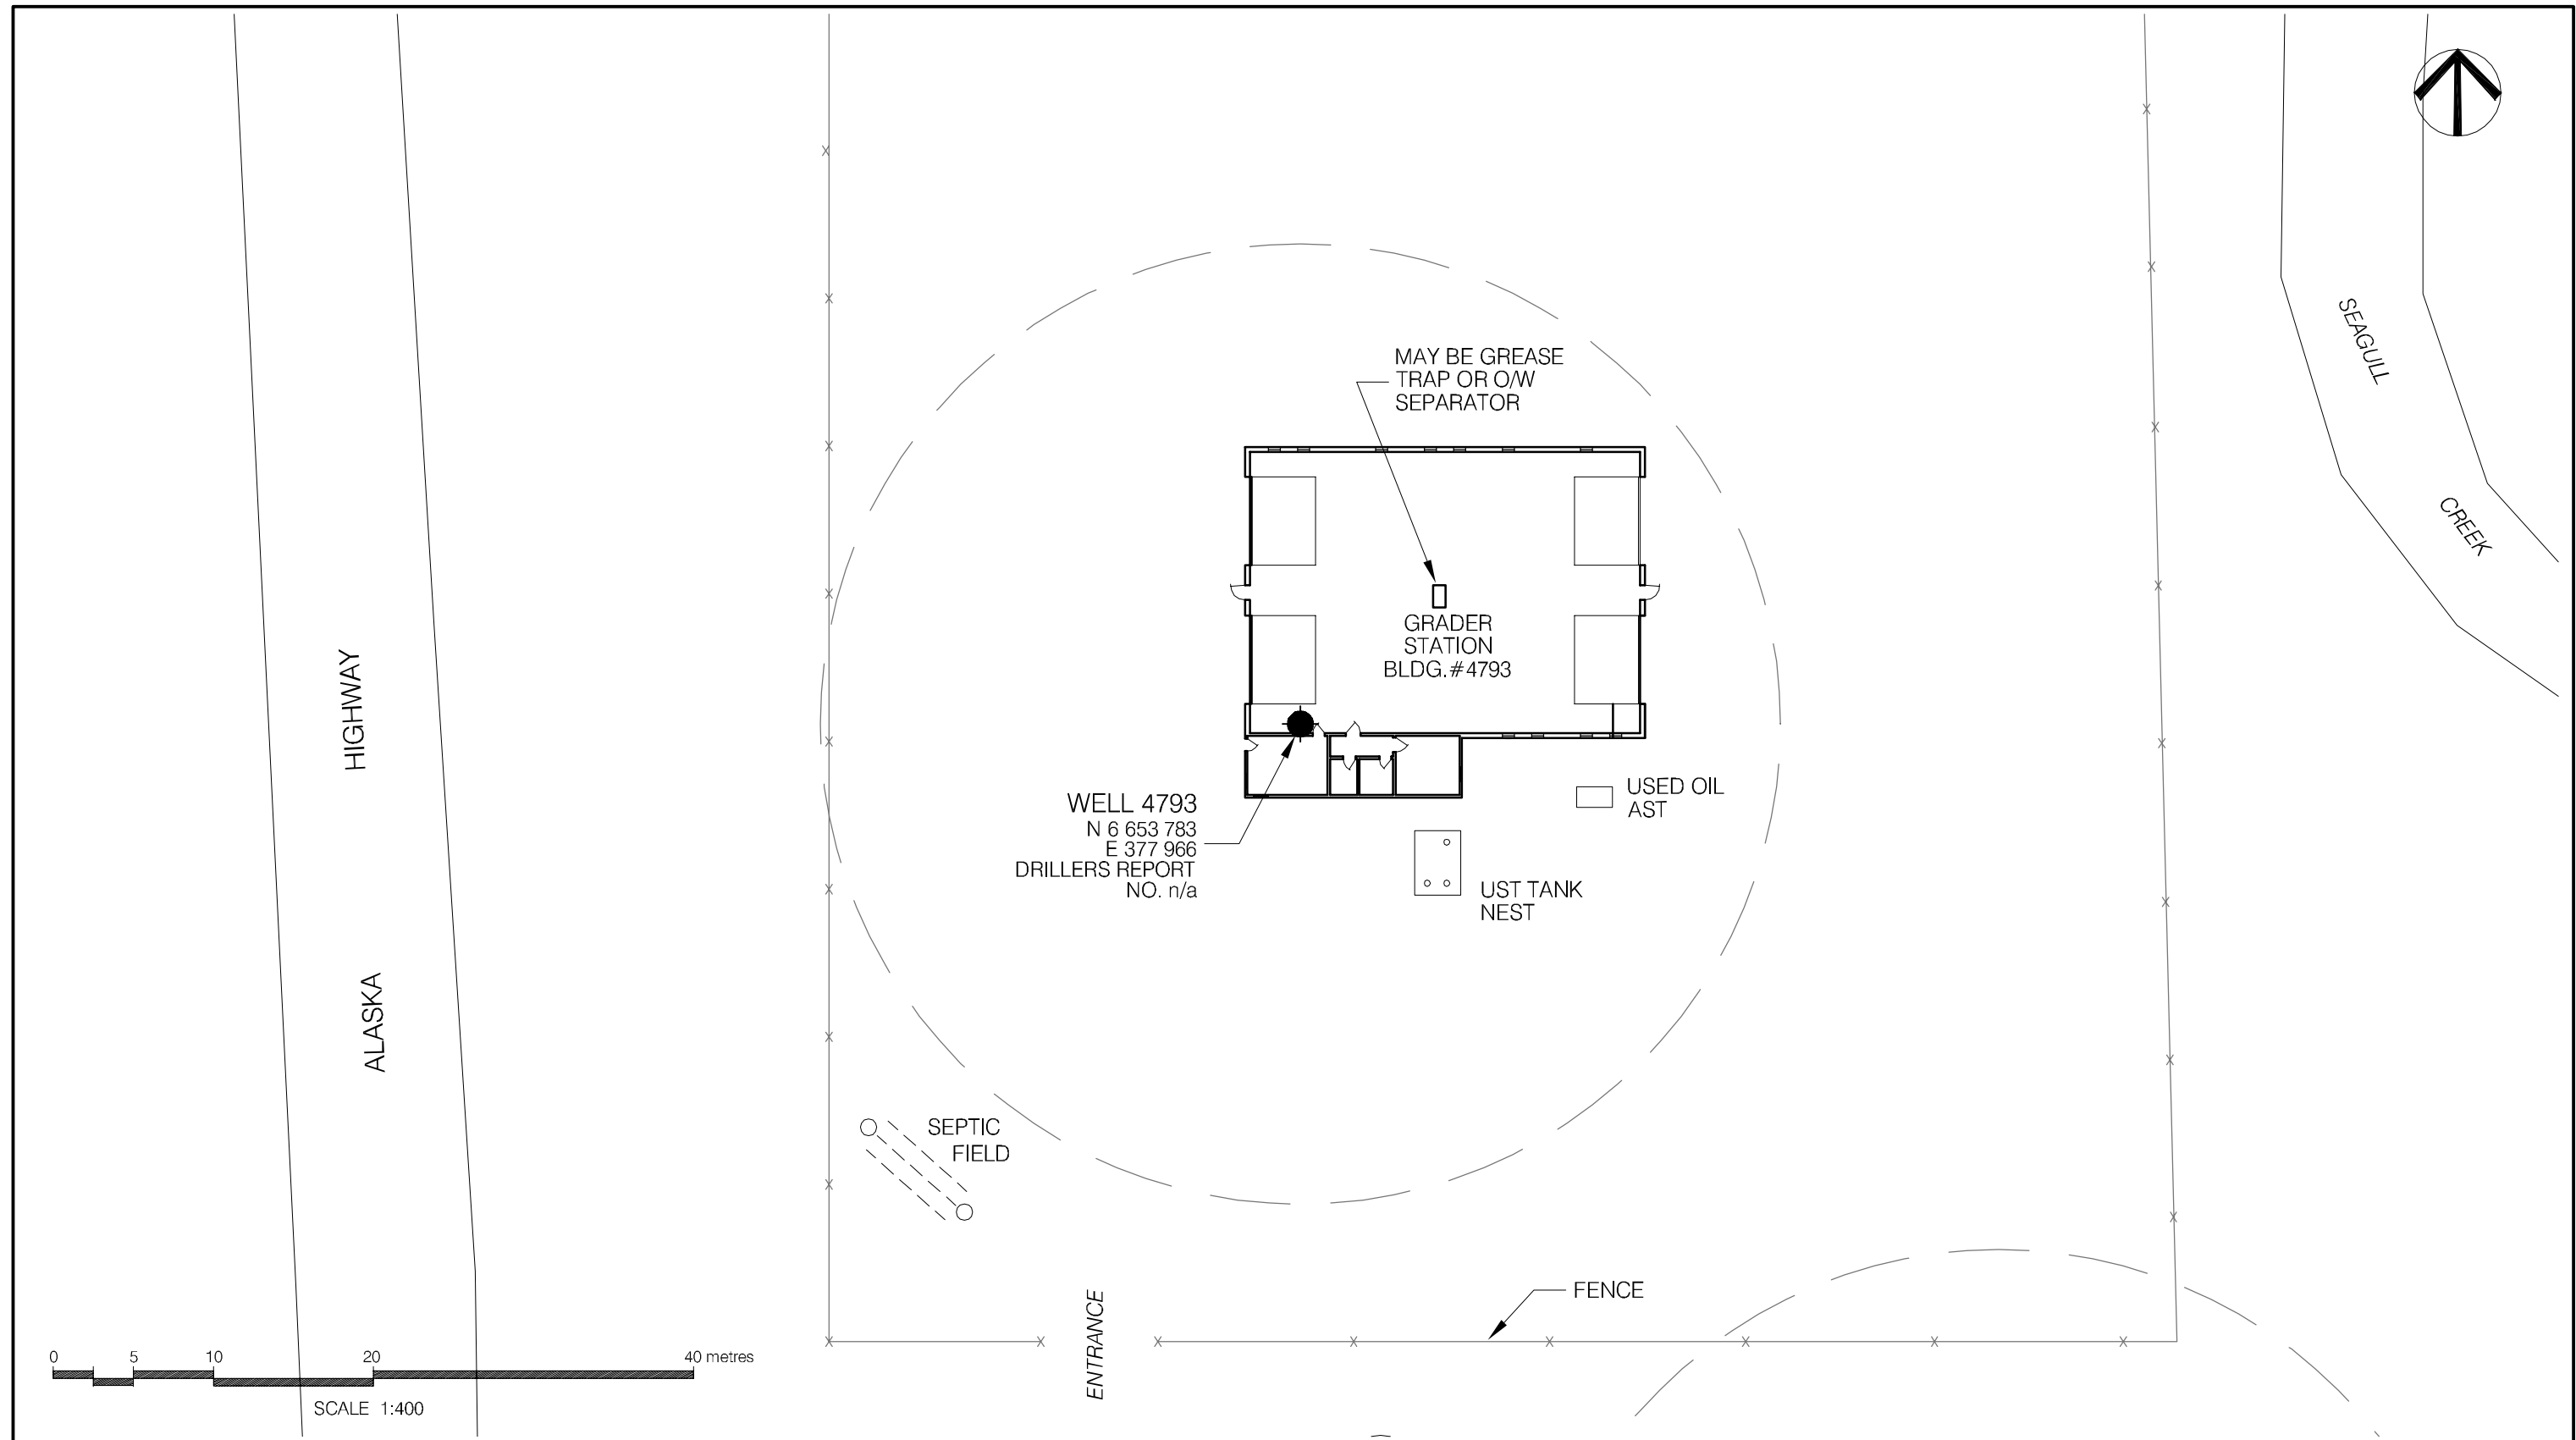
The septic field for the Swift River Grader Station is located on the southwest corner of the property approximately 38 m from the well. A site plan showing the location of the septic system is given by Figure 4793-A in Appendix A9.

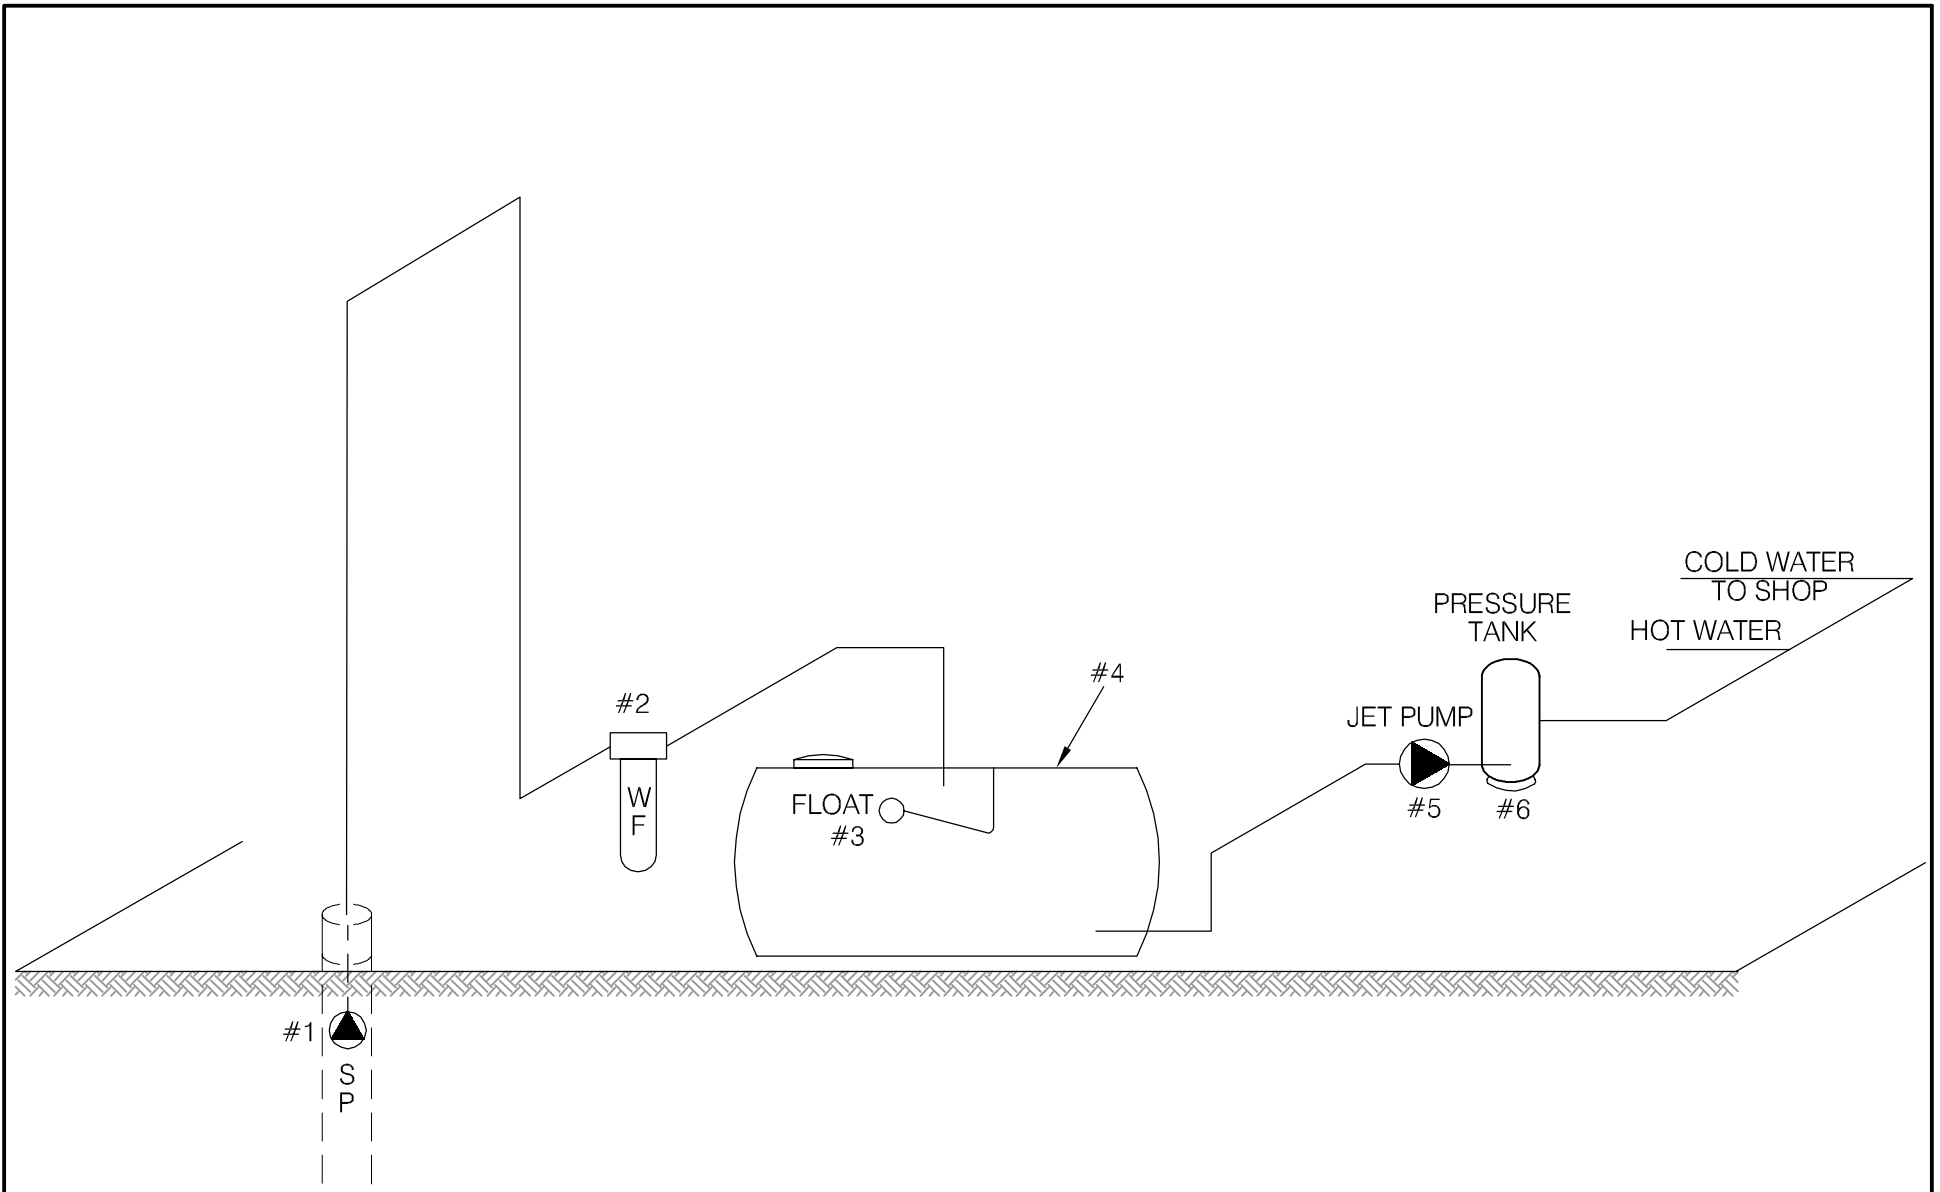
Water passes through a sediment filter and then is stored in a 1000 L water storage tank prior to entering the domestic plumbing system. A schematic detailing the water system is provided as Figure 4793-B in Appendix A9. There is a sign posted in the grader station kitchen stating that the water is not for human consumption. Bottled water is provided for drinking.
