26.0 BUILDING 1131 – CARCROSS SEARCH AND RESCUE OFFICE

SMALL PUBLIC WATER SYSTEMS ASSESSMENT
 WHITEHORSE REGION

PART A: EBA Site Inspection

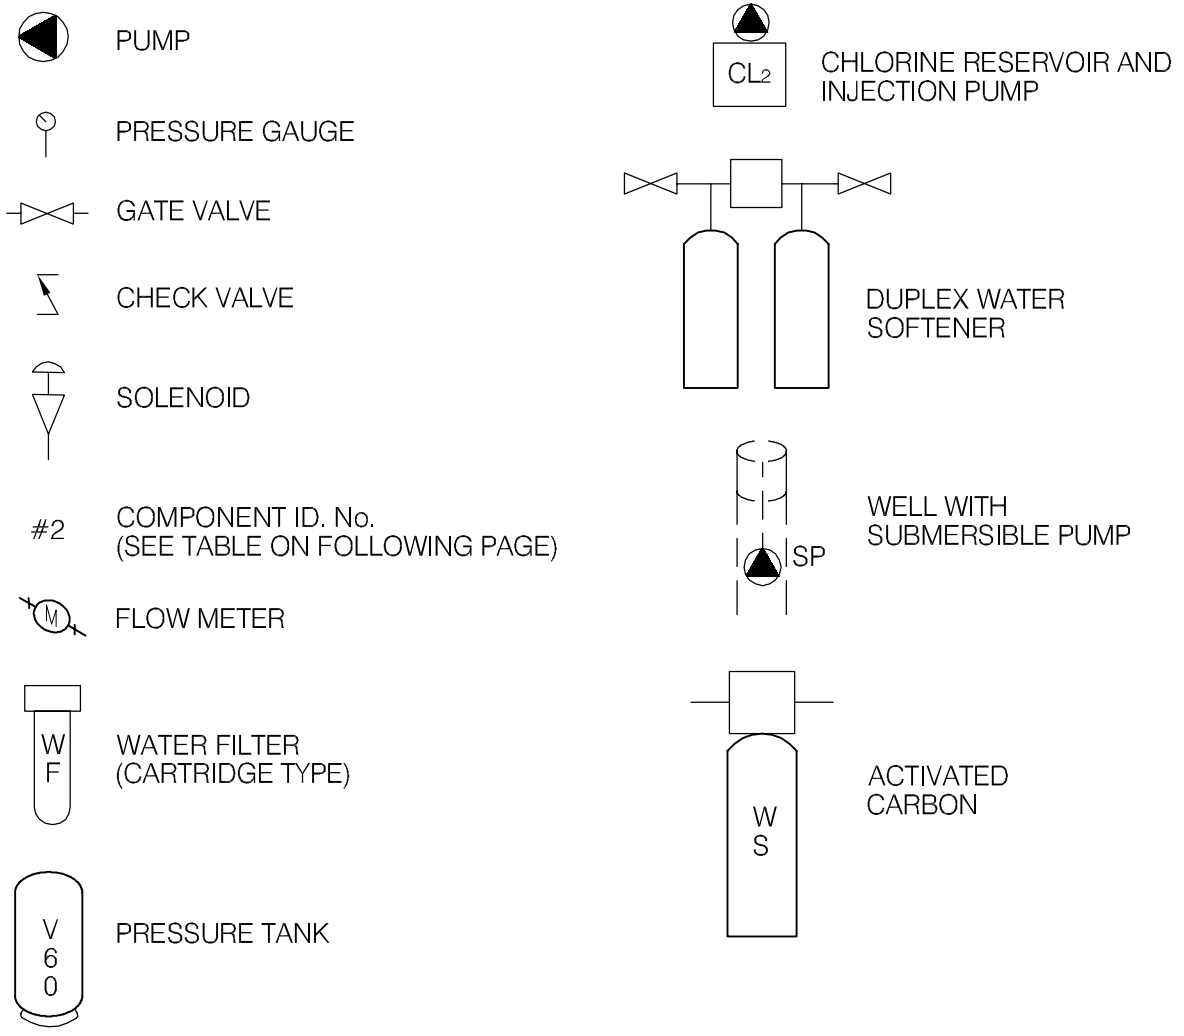
TITLE WATER SYSTEM DISTRIBUTION/TREATMENT SCHEMATIC SYSTEM ID.: 1131 CARCROSS SEARCH & RESCUE BUILDING			
DATE APRIL 2006	DWN. JSB	CHKD. RMM	FILE NO. 1260002.005	DWG.: FIGURE 1131-B

- FAC at the point of use was 0.01 mg/L, below the required 0.2 mg/L, and there is no routine monitoring of residual chlorine concentrations;
- The vent/overflow does not have a vermin proof screen; and,
- The water tank is not easily accessible for routine inspection and cleaning. It may be difficult to install a watertight access hatch in a polyethylene tank. If it is not possible to clean this tank in its current state, a replacement tank with suitable access should be installed.

- Install secondary disinfection consisting of a NSF/ANSI 55 certified UV system with filtration pretreatment (15 micron). We understand that the source water is filtered to 1 micron at source. The sample collected at the time of the assessment had a UV Transmittance % that is below the level recommended for UV treatment. Other samples from the same source (Bennett Lake) were found to be suitable to UV disinfection. It is considered likely that the sample was anomalous and that ANSI/NSF 55 certified UV treatment would be adequate. This is, however, only a conceptual design recommendation based on the information available for planning and budgeting purposes. Engineering input will be required for final system specifications;
- Install a vermin proof screen on the overflow/vent;
