4.0 BUILDING 1134-CARCROSS SCHOOL

SMALL PUBLIC WATER SYSTEMS ASSESSMENT
 WHITEHORSE REGION

CARCROSS SCHOOL
 BUILDING 1134
 SITE LOCATION DIAGRAM
 WELL ID: 1134A & 1134B

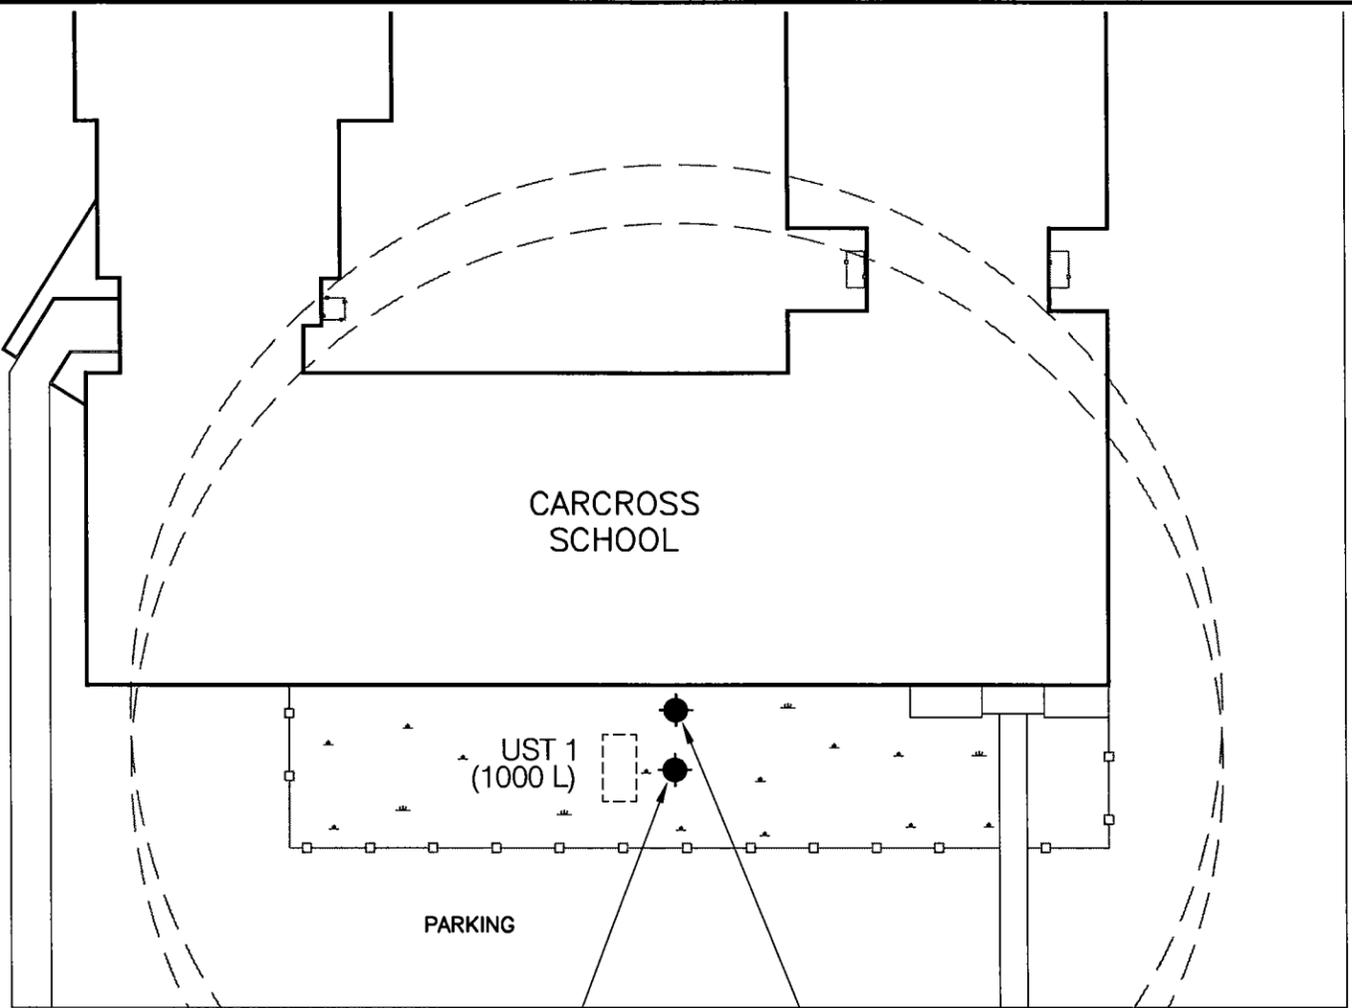
WELL 1134B
N 6 670 157
E 516 083
DRILLERS REPORT
NO. n/a

WELL 1134A
N 6 670 157
E 516 083
DRILLERS REPORT
NO. 204020022
