16.0 YUKON WILDLIFE PRESERVE

16.1 Description of Existing Water Supply System

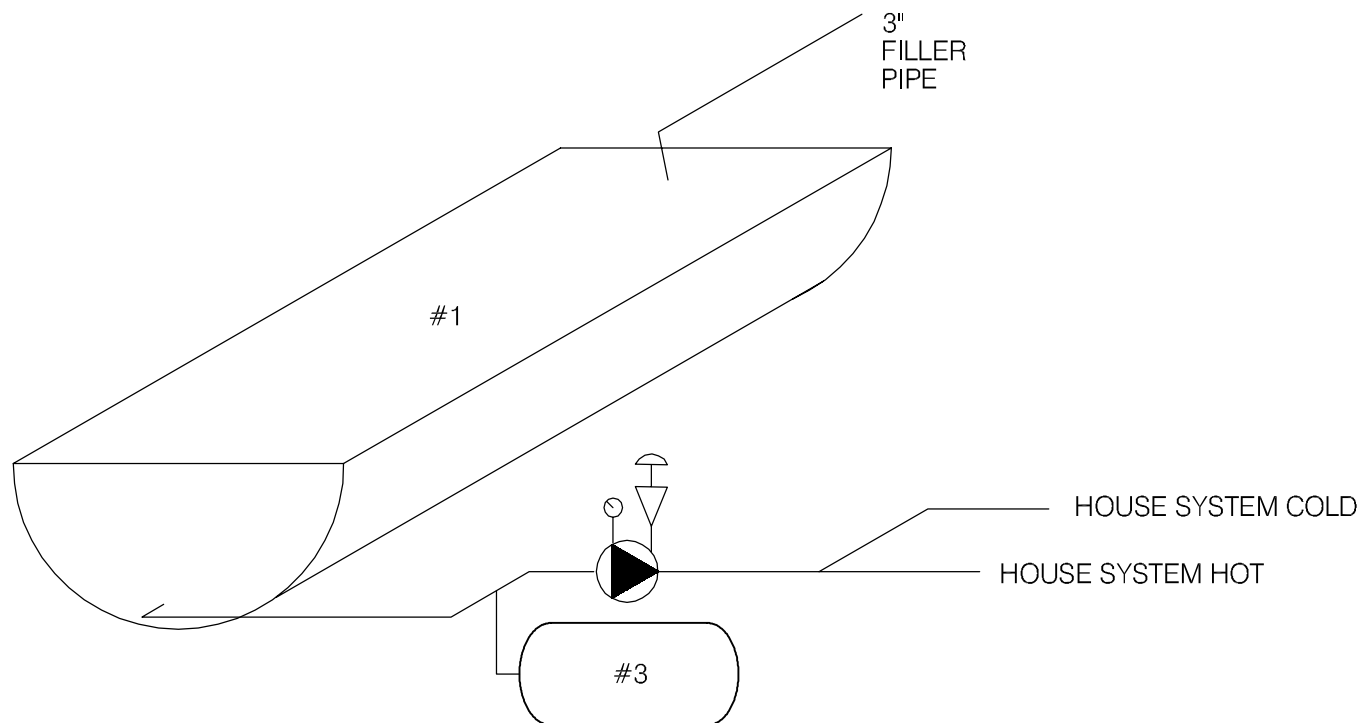
DWG.: FIGURE YWP-B

The Yukon Wildlife Preserve Kestrel Cottage (YWP-B) is currently serviced by a water delivery system. Water from a 3000 L water storage tank supplies potable water to the building. A system schematic is provided as Figure YWP-B in Appendix A16. There is no treatment or disinfection system, but the delivered water is chlorinated at the source. Field chemistry with a Hach Colorimeter at the site taken at the time of water sampling indicated that the residual chlorine was at 0.38 mg/L, which is considered adequate according to the proposed regulations.
