Village of Haines Junction Aquifer and Wellhead Protection Plan

PRESENTED TO
Government of Yukon, Community Services

FEBRUARY 7, 2017
ISSUED FOR USE
FILE: WTR.GWTR03067-01

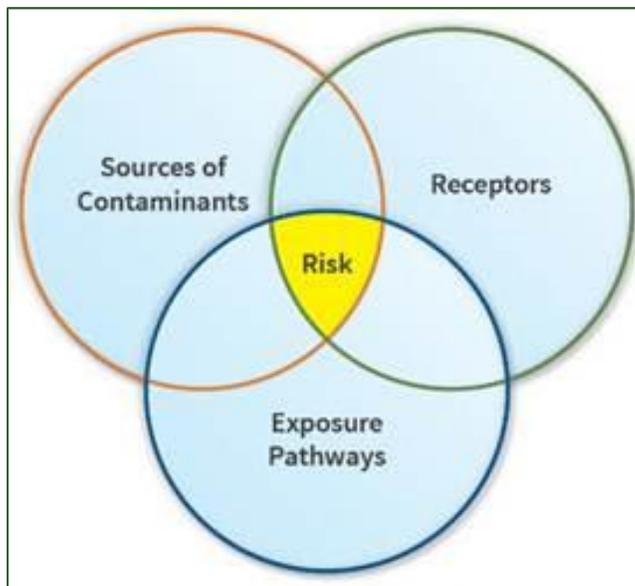
pathways for exposure can remove or reduce the chance that an exposure will occur and reduce or eliminate risk. Figure 6-1 illustrates this concept.

Figure 6-1: Fundamental Concepts of Risk and Risk Management

Risk is generally defined as the likelihood that a receptor will be exposed to a particular hazard multiplied by the consequence of that exposure. Hazard and receptor must meet to result in exposure, so exposure risk can be defined as occurring where hazard and receptor meet due to an exposure pathway. Eliminating or blocking the

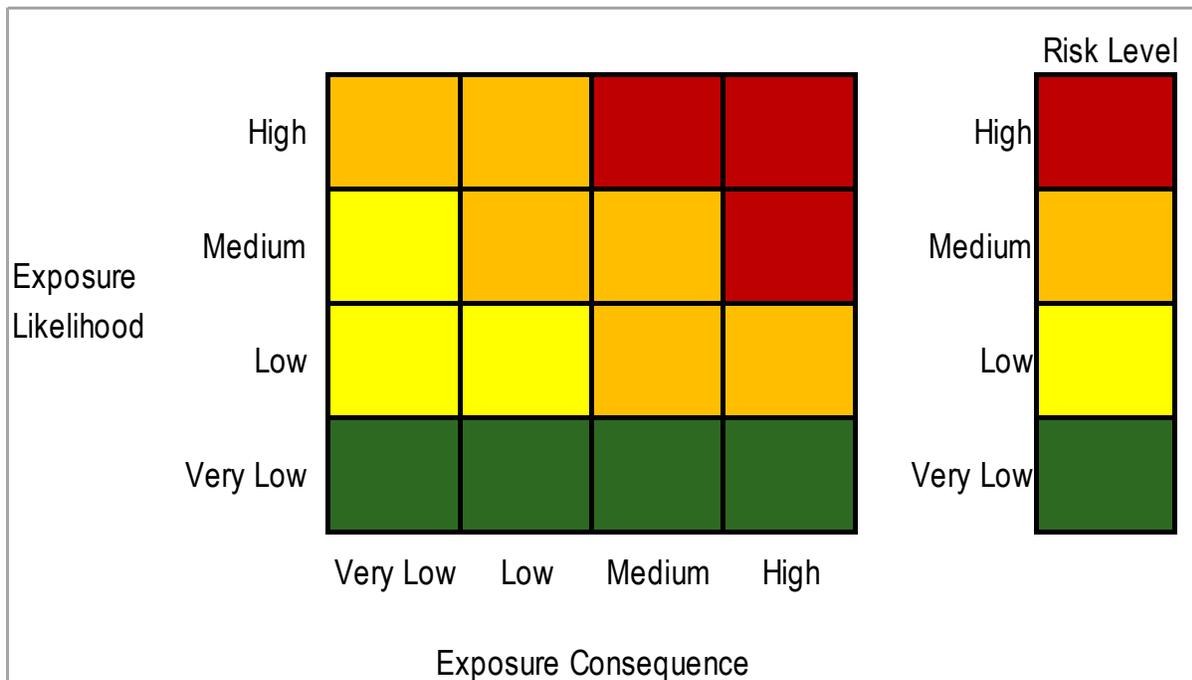
The risk matrix provides the potential risk posed by each of the hazards identified within the well capture zones. An overall risk of “Very Low”, “Low”, “Medium” and “High” was assigned to each potential contaminant of concern (hazard) identified within the well capture zones. The risk levels were based on the combined exposure likelihood and consequence for the potential contaminant source. Colour coding the identified risks provides a straight forward and intuitive basis for managing risks identified on a colour coded Risk Map.

Figure 6-2: Risk Assessment Matrix

Risk to the well users was evaluated for each of the hazards identified using the Risk Matrix shown in Figure 6-2. The following factors were used to define the categories of exposure likelihood and hazard consequence:

Table 6-3 summarizes the rationale used for assigning “Very Low”, “Low”, “Medium” and “High” risk values to each identified exposure likelihood and exposure consequence within the well capture zones.

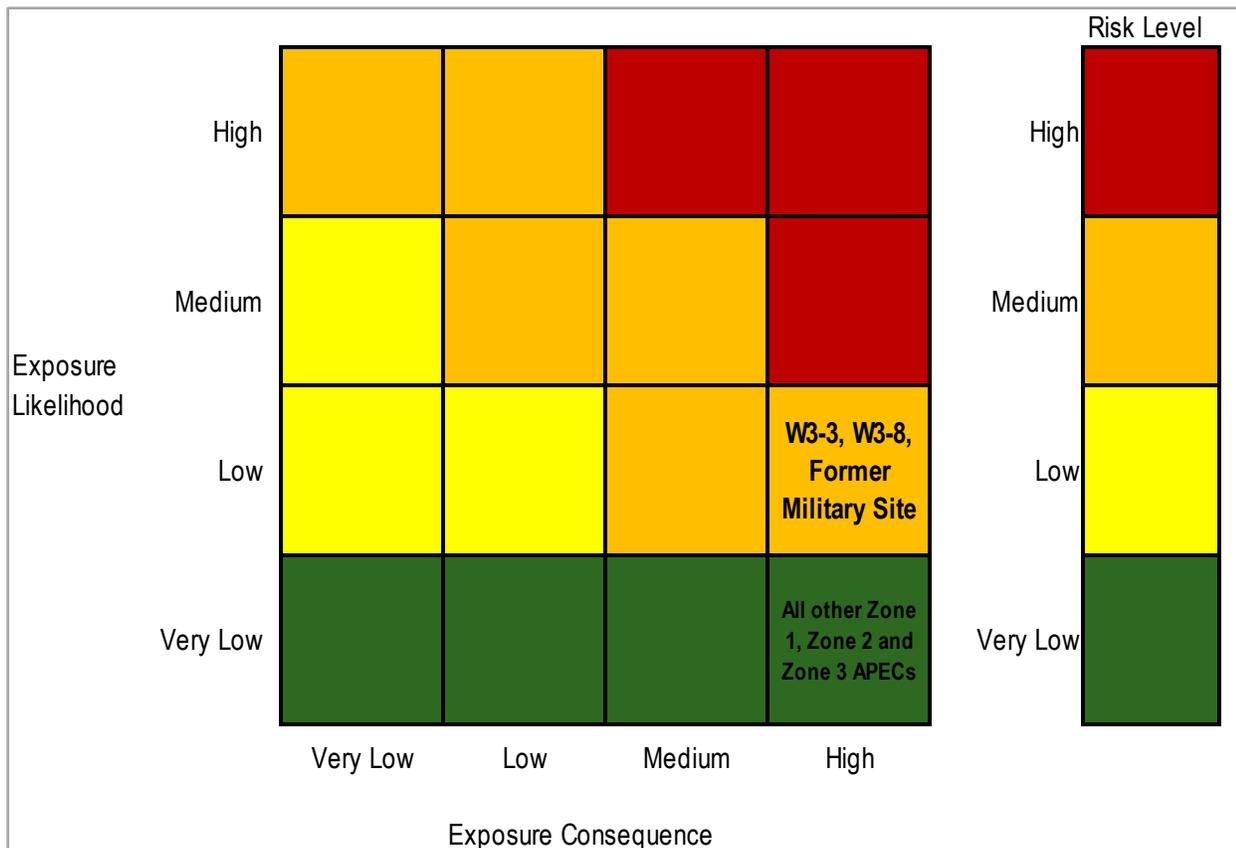
The resulting risk ranking for each hazard is shown in the risk matrix corresponding to the community well that would be impacted (Figure 6-3 and Figure 6-4), and are colour coded to represent the estimated level of risk the hazard presents to the community water users.

Figure 6-3: Risk Ranking for Potential Contaminant Sources identified in the vicinity of Well No.3

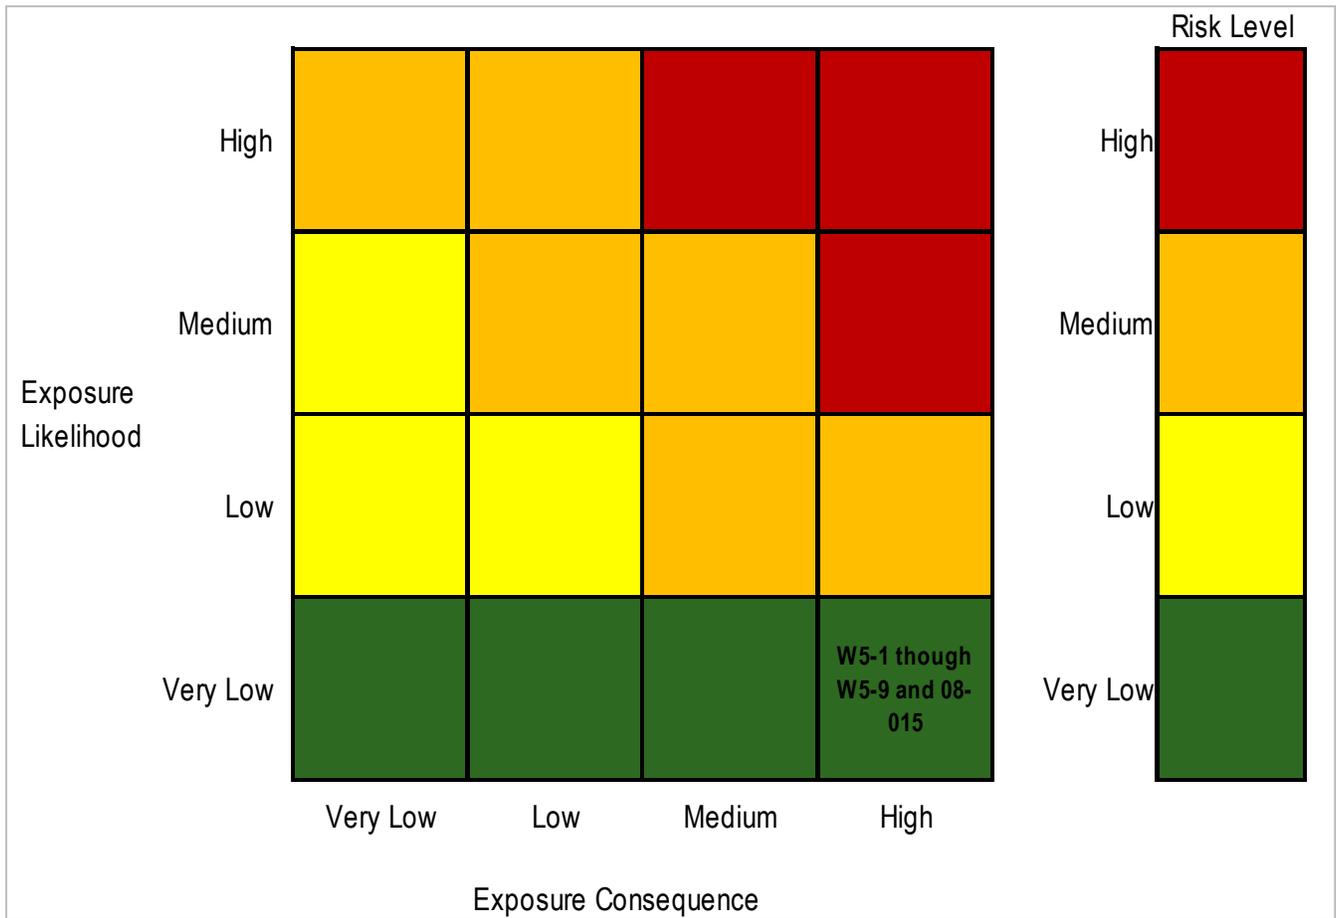
Figure 6-4: Risk Ranking for Potential Contaminant Sources identified in the vicinity of Well No.5

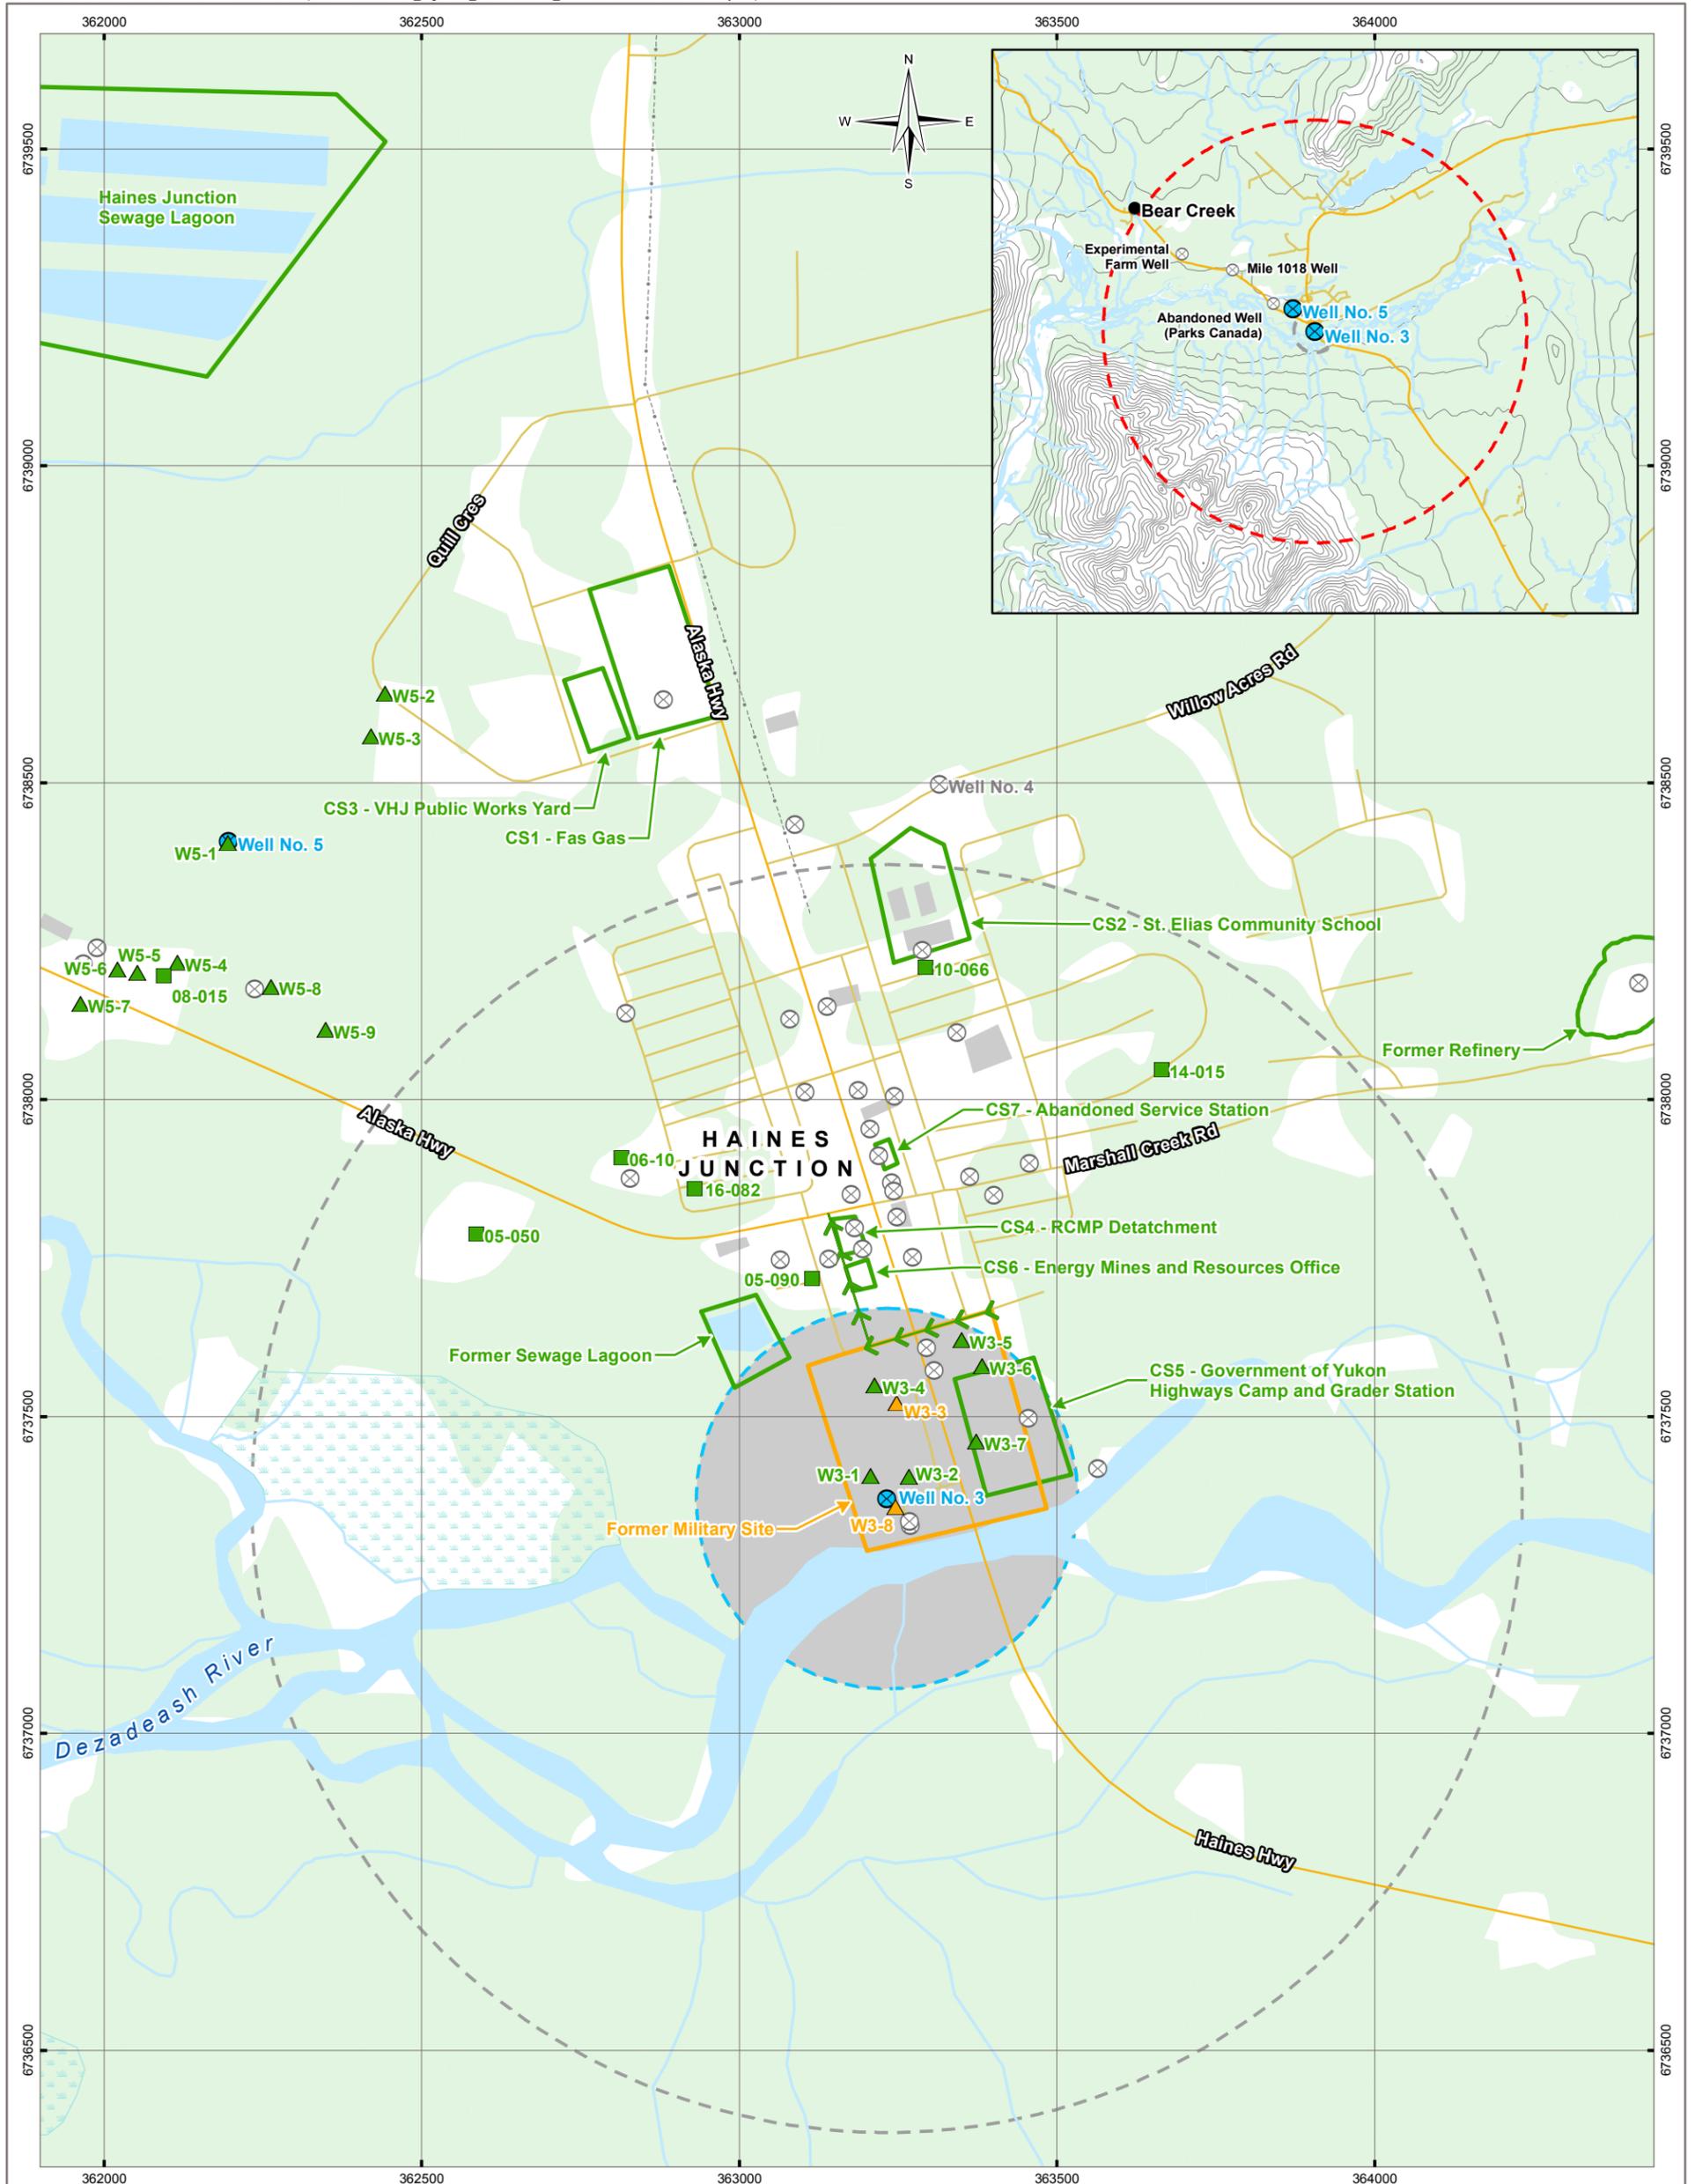
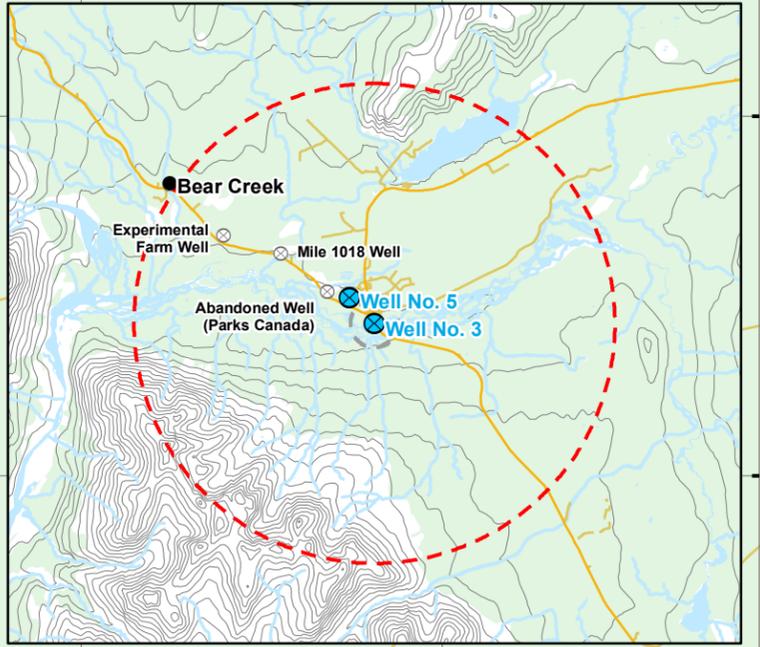
- Community Water Well
- Domestic Water Well
- Contaminated Site with ID Number
- Potential Source of Contamination
- Sewer
- Other Site Feature

Well No.3 is located adjacent to the Dezadeash River, just off the Haines Highway (Figure 3). Well No.3 was drilled in May 1980 by Midnight Sun Drilling Co. Ltd. The wellhead is completed in an enclosed, locked well house constructed upon a concrete slab foundation. The building consists of a metal wrapped insulated enclosure with surface casing extending to >1 m above ground surface. Well records do not show a surface sanitary seal for this well and based on this we assume for this AWHPP that no sanitary seal is present.

Well No.4, located adjacent to Willow Acres Road (Figure 3), is capped and not currently in use, and Tetra Tech understands that VHJ intends to decommission the well.

Other known groundwater well location in the VHJ area are shown on Figure 3. Where available, well completion details and aquifer characteristics are summarized in Table 1, attached. Some wells that have been decommissioned and/or may no longer exist are included for reference. There are likely other private wells in the community that are not captured in this summary and multiple abandoned wells located in VHJ may or may not have been properly decommissioned. Records of well decommissioning were not available for the purposes of this report. Water wells included in the summary are taken from previous well records included in Tetra Tech's 2003, *Resource Assessment for Heat Potential Study*, as well as from wells reported by private property owners during the site visit. Other abandoned well locations in the community were taken from the UMA 1988, *Village of Haines Junction Water System Improvements* and from the Terrain Analysis and Mapping Services (TAMS 1980) report *Geologic and Hydrogeologic Interpretations of Haines Junction, Destruction Bay, Burwash Landing and Champagne, Yukon Territories*.

The location of the sites identified with status indicated as: as minor contamination, unknown or contaminated in the Village of Haines Junction are identified on Figure 3 and Figure 4. These sites are summarized below:

Table 5-1 and Table 5-2, attached, present a summary of risk scenarios within the capture zones as identified in Table 3 and evaluated using the Risk Matrix. The risk rank results are presented on the Risk Maps compiled for both Well No.3 and Well No.5 and presented as Figure 3 and Figure 4 respectively.

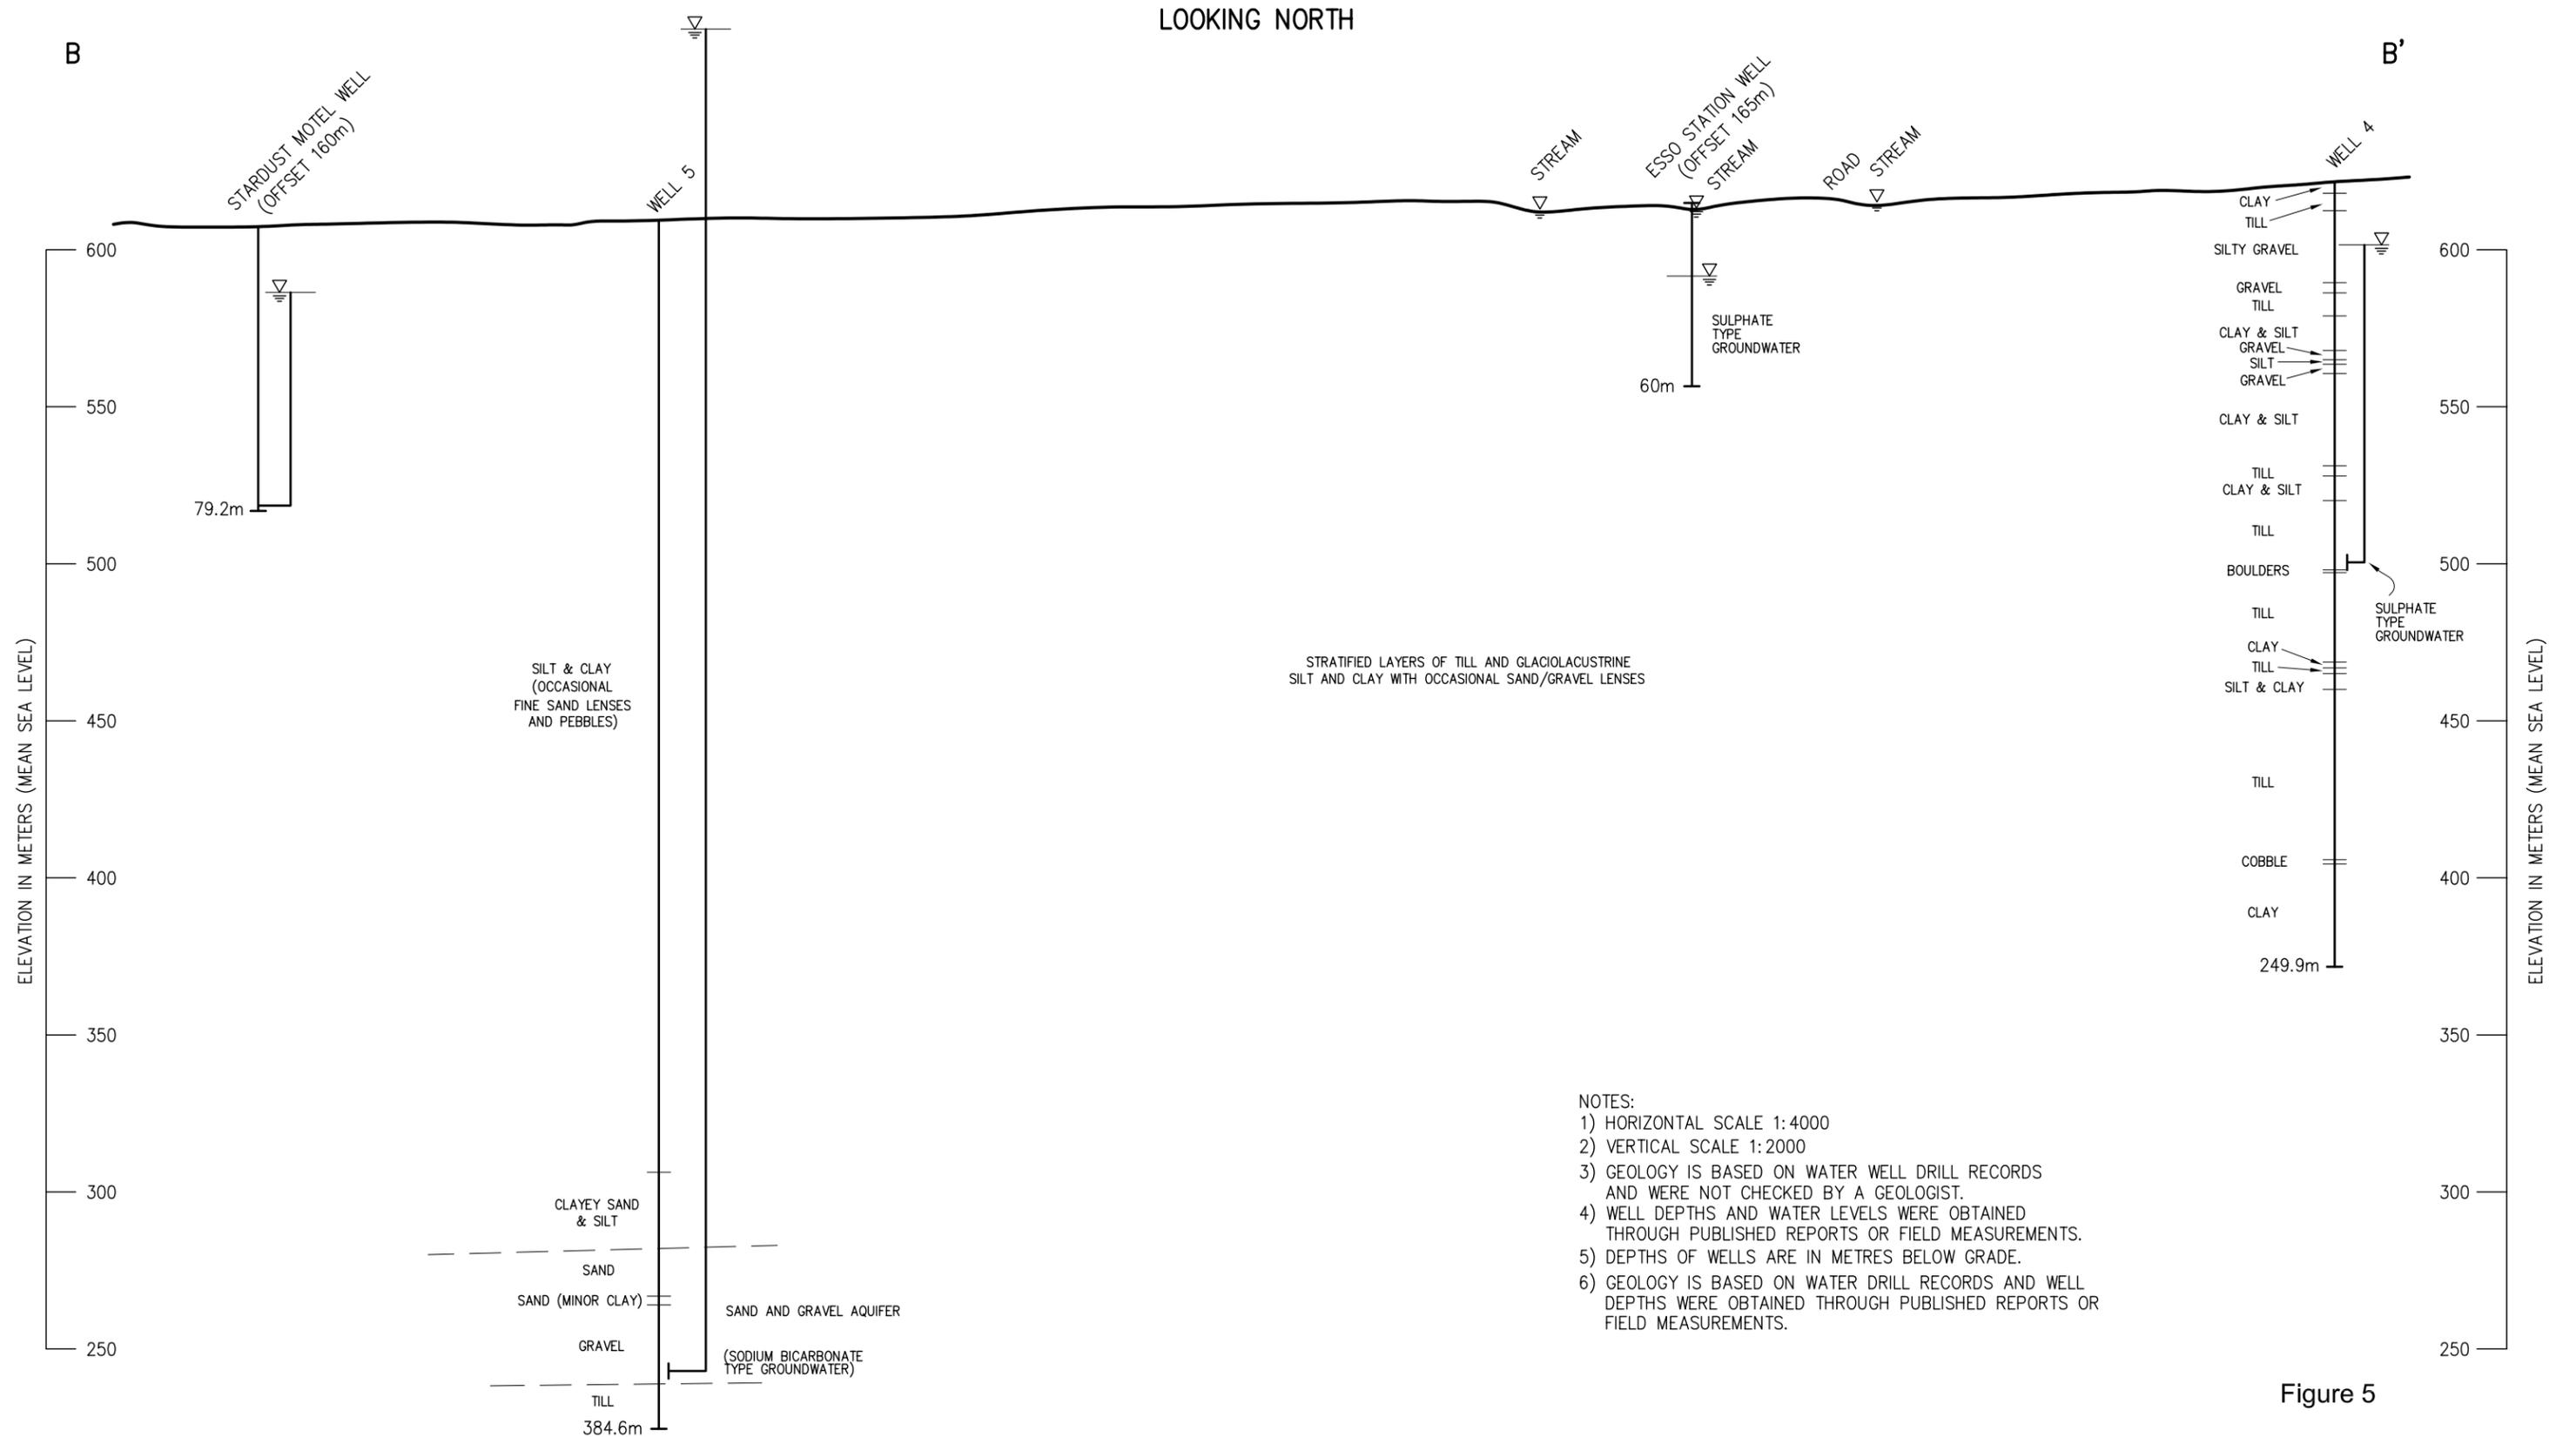
Figure 5

- NOTES:
- 1) HORIZONTAL SCALE 1:4000
 - 2) VERTICAL SCALE 1:2000
 - 3) GEOLOGY IS BASED ON WATER WELL DRILL RECORDS AND WERE NOT CHECKED BY A GEOLOGIST.
 - 4) WELL DEPTHS AND WATER LEVELS WERE OBTAINED THROUGH PUBLISHED REPORTS OR FIELD MEASUREMENTS.
 - 5) DEPTHS OF WELLS ARE IN METRES BELOW GRADE.
 - 6) GEOLOGY IS BASED ON WATER DRILL RECORDS AND WELL DEPTHS WERE OBTAINED THROUGH PUBLISHED REPORTS OR FIELD MEASUREMENTS.

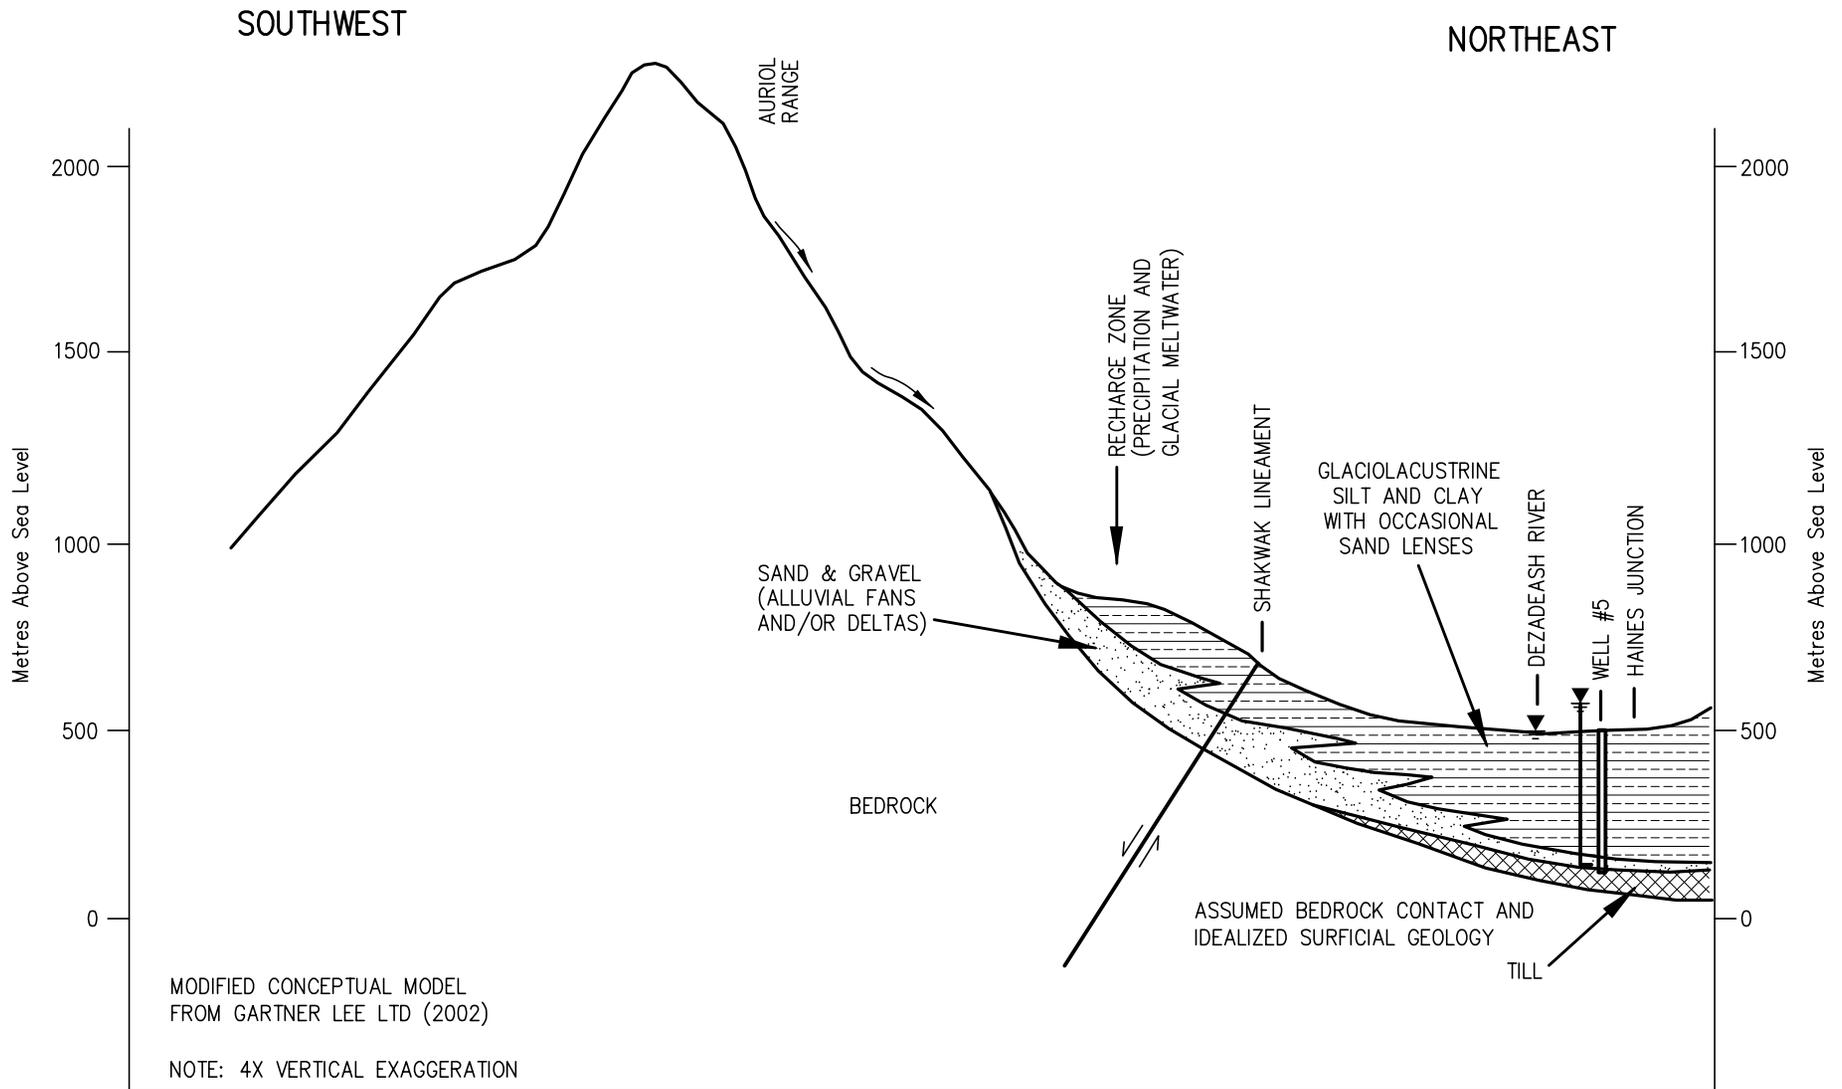
Figure 13, Pg. 60
Conceptual Hydrogeological Model of Well #5
Alluvial Fans/Deltas Control

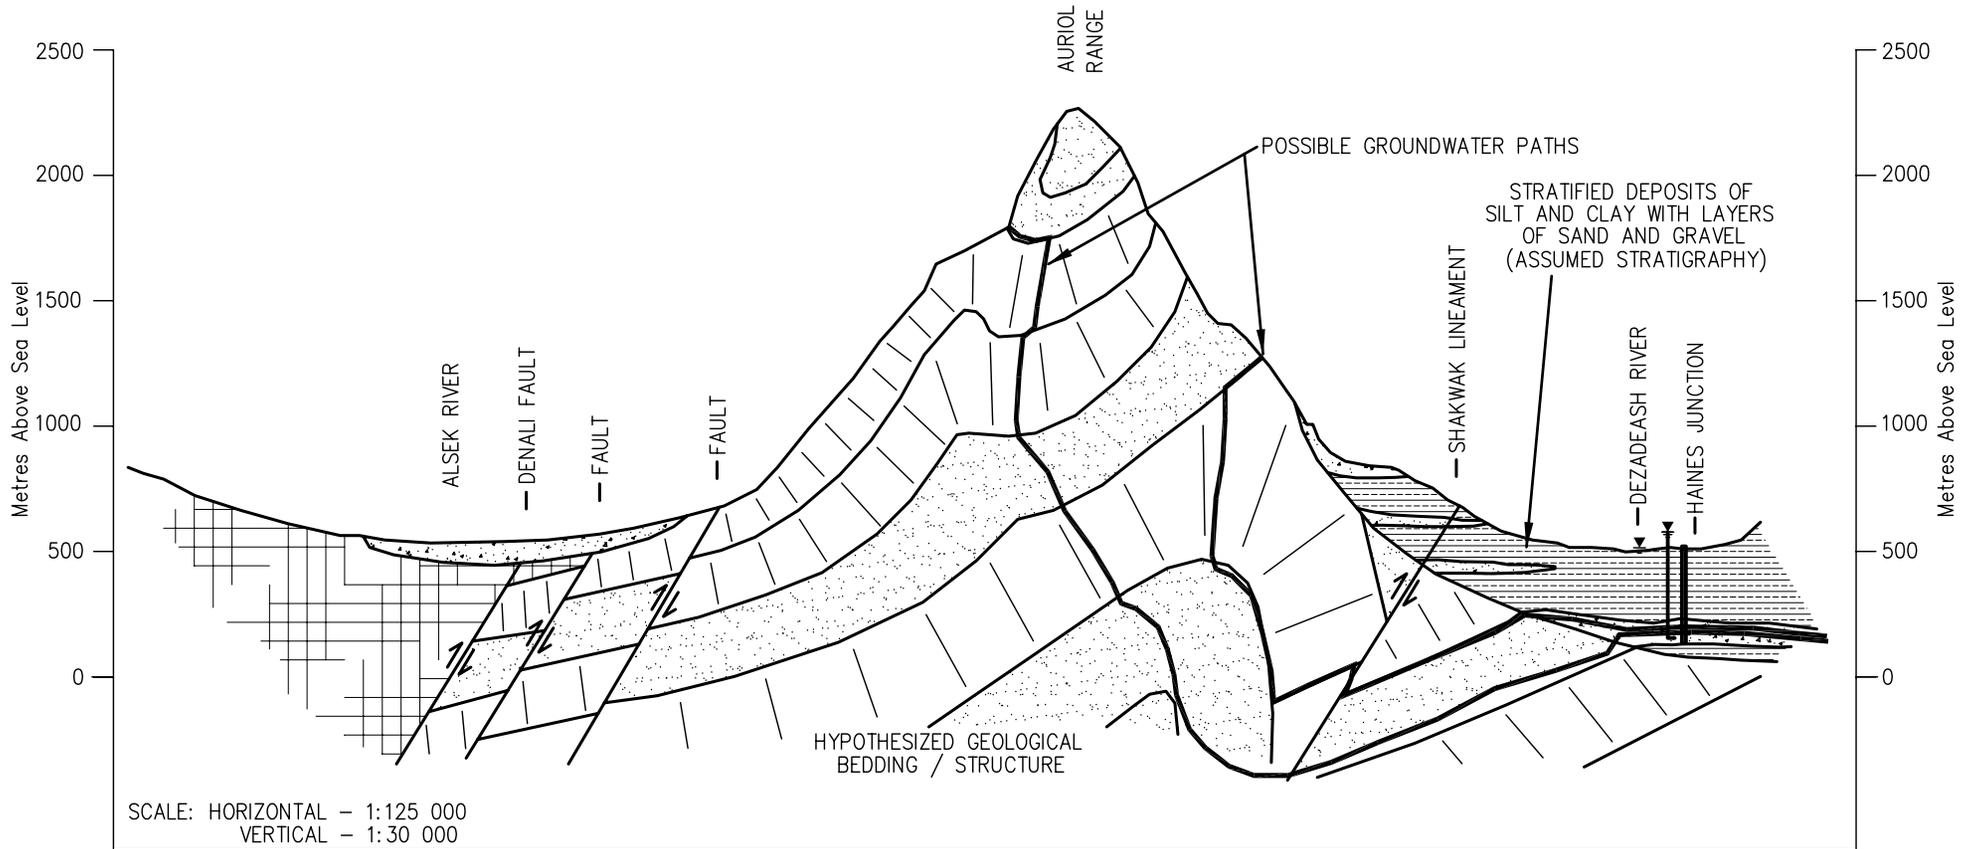
Figure 14, Pg. 62
Conceptual Hydrogeological Model of Well #5
Bedrock Structural Control
