MW14-06A / BH7 / CFD-0453

Coffee Creek Gold
 Project #: A362-4

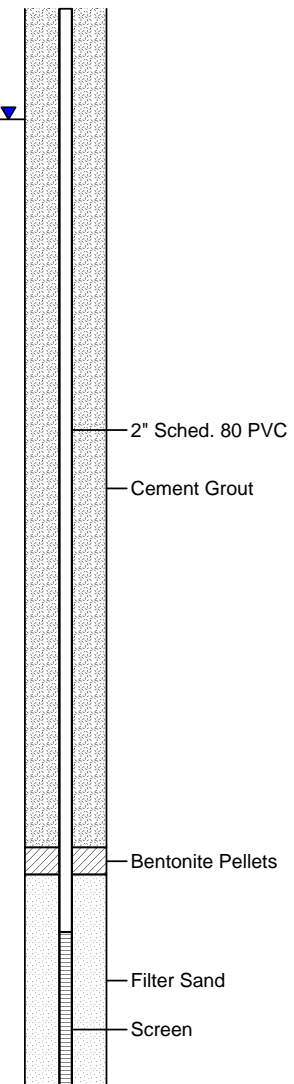
Well: MW14-06A
Elev.: 1183.9 m amsl (TOC)

Depth (m)	Elev. (m amsl) 1183.0	DESCRIPTION	RQD (%)		Fracture = Fr	Fault = Ft	Packer Test Interval (mbgs)	K (m/s)	Depth (m)
			0	50	100				
		Water Level: 1053.18 m amsl 07-Oct-14 @ 9:46							
120	1060	*Minor circulation loss noted at 127.5 m, possibly entering formation at ~25 m *Stronger iron staining at 129.5 to 130.5 m suggests presence of water							120
140	1040				N/A	N/A	N/A		140
160	1020	*Minor iron stained fracture zones suggesting presence of water at ~165, 175, 181, and 187 m							160
180	1000	Strongly foliated mixed felsic gneiss, bleached, weak carbonate alteration, white clay alteration to feldspars, weak fracture controlled limonite alteration 171.6 to 177.42 m Zone, mixed gneiss, possible early mafic dyke with weak alteration 177.4 to 179.17 m Strongly foliated mixed felsic gneiss, weak carbonate alteration 179.2 to 183.2 m							180
200	980	Mixed felsic gneiss, 187.3 to 187.8 m, and EOH fracture zone with limonite alteration							200

220	960	EOH @ 216 m *Comment from supervising hydrogeologist, all other descriptions provided by Kaminak N/A: Borehole not packer tested or logged for structure							220
240									240
