HYDROGEOLOGICAL ASSESSMENT	SELKIRK FIRST NATION	PROJECT NO. - BOREHOLE NO.
PELLY SEWAGE DISPOSAL FACILITY	DRILL: ODEX	W23103095-01-MW2013-01
PELLY CROSSING, YUKON		ELEVATION: 536.51 m

LOGGED BY: [REDACTED]	COMPLETION DEPTH: 35.05m
	REVIEWED BY: [REDACTED]	COMPLETE: 13/08/21
	DRAWING NO: 23103095-01	Page 1 of 2

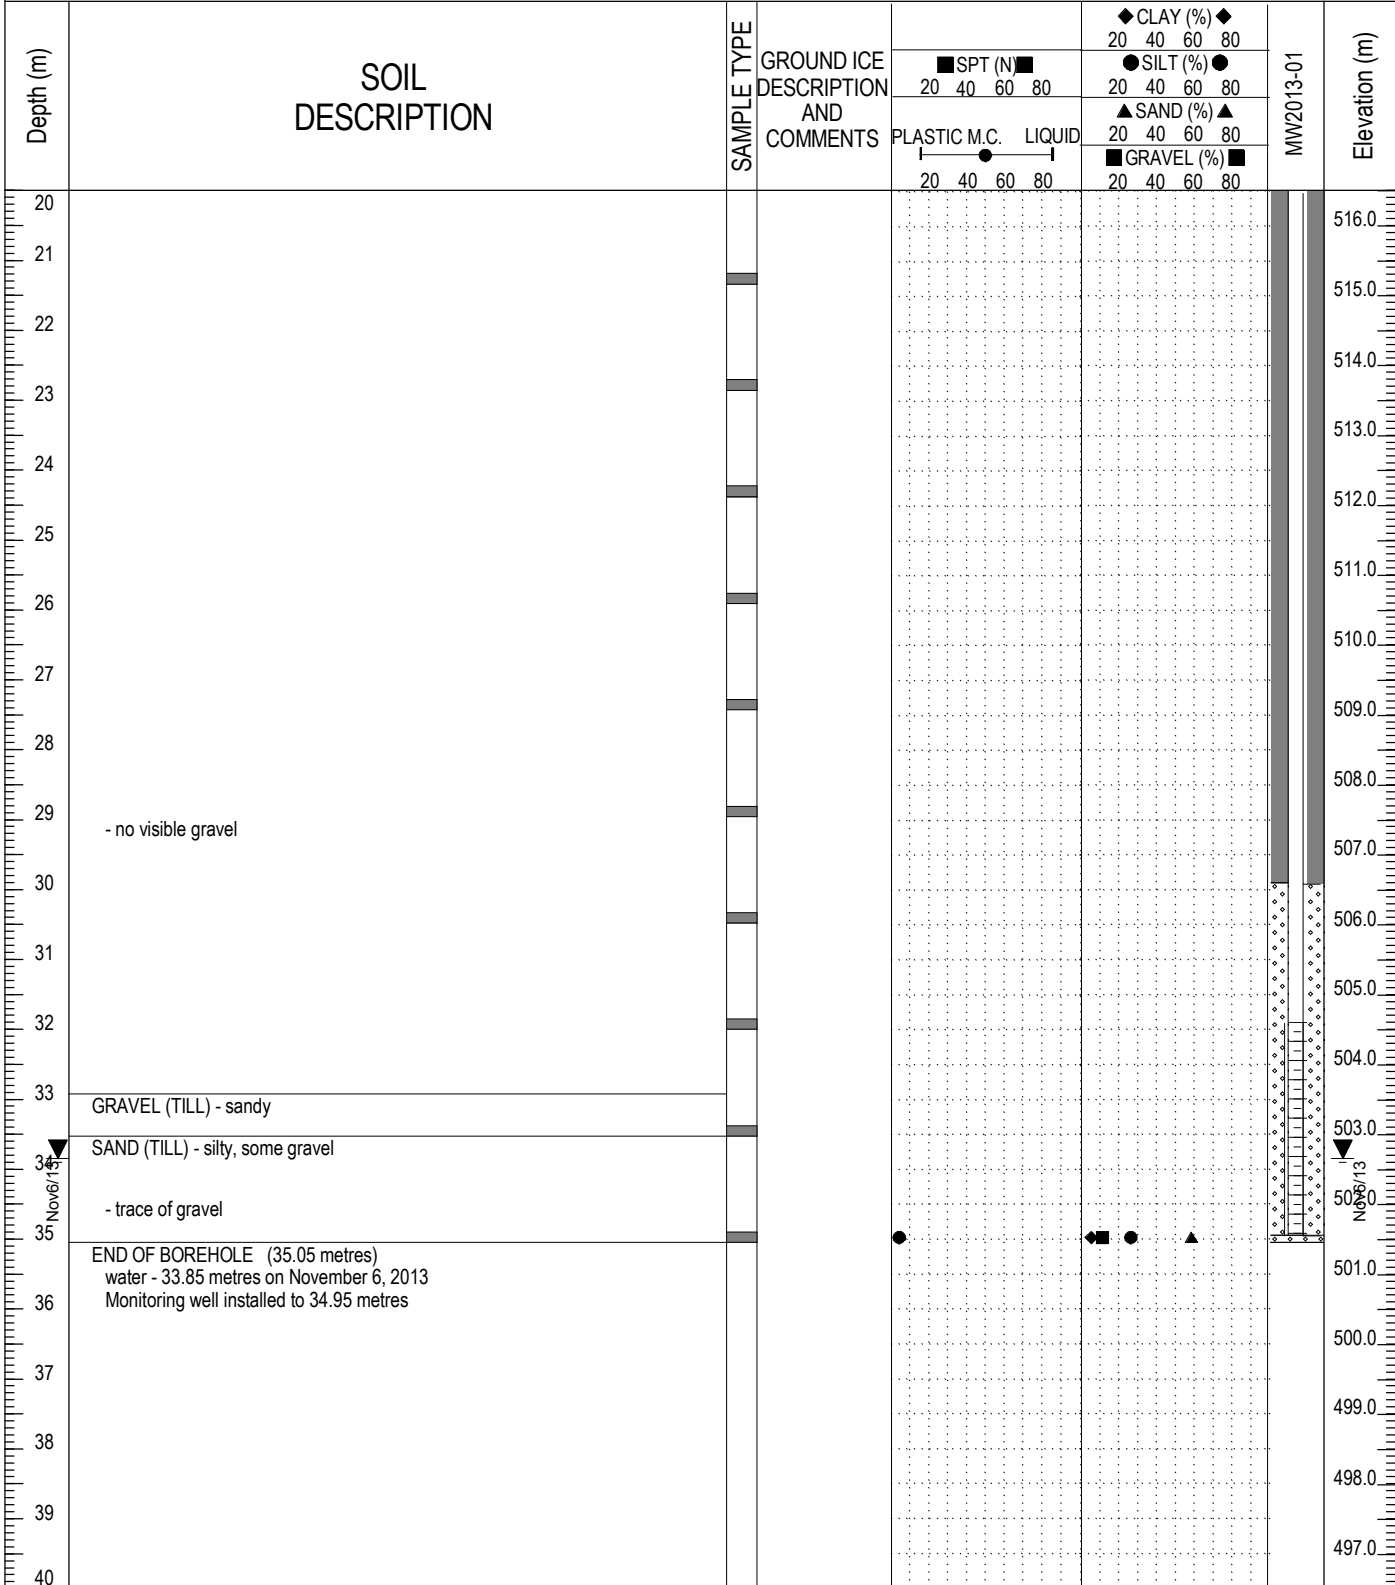
LOGGED BY: [REDACTED]	COMPLETION DEPTH: 35.05m
	REVIEWED BY: [REDACTED]	COMPLETE: 13/08/21
	DRAWING NO: 23103095-01	Page 2 of 2

HYDROGEOLOGICAL ASSESSMENT	SELKIRK FIRST NATION	PROJECT NO. - BOREHOLE NO.
PELLY SEWAGE DISPOSAL FACILITY	DRILL: ODEX	W23103095-01-MW2013-01
PELLY CROSSING, YUKON		ELEVATION: 536.51 m
